## Habitat Restoration Opportunities for Cloiche Wind Farm – Site Visit Report

Alba Ecology Ltd.

**September 2021**

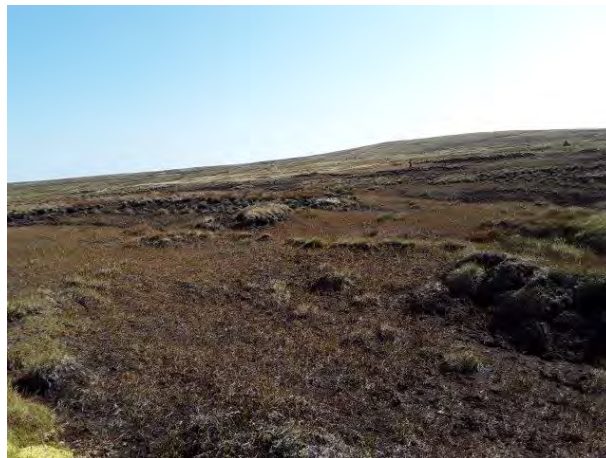
Deer hoof prints were common across the bare peat areas and were demonstrably causing and exacerbating erosion.

*Photo 1: View of an extensive bare peat pans.*

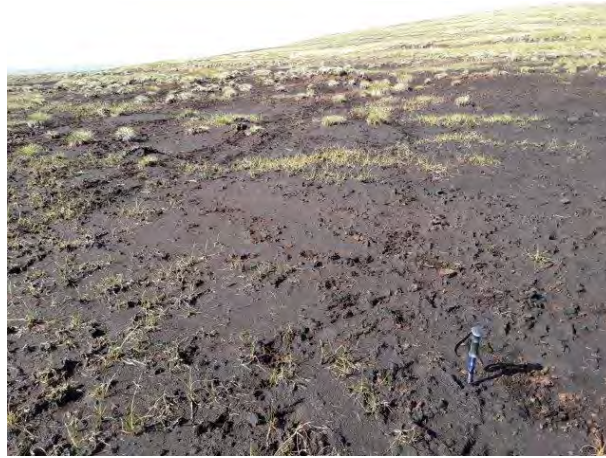
*Photo 2: An area of bare peat which was likely >1m in depth with a little common cottongrass colonisation but active erosion clearly evident.*

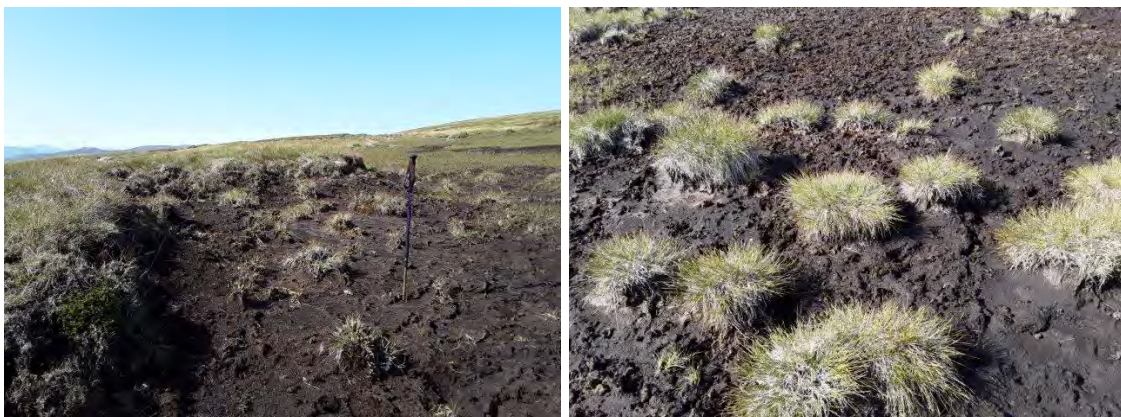
Around the edges of the bare peat pans there were two main types of erosion: erosion hagg faces and tussocks of remaining bog vegetation surrounded by bare peat.

*Photo 3 and 4: Examples of erosion at the edge of the bare peat pans. Photo on the left is an example of an erosion faces around the edge of bare peat pan. The photo on the right is an example of tussocks of hare's-tail cottongrass with bare peat surrounding them. This was on a gentle slope on the edge of a peat pan.*

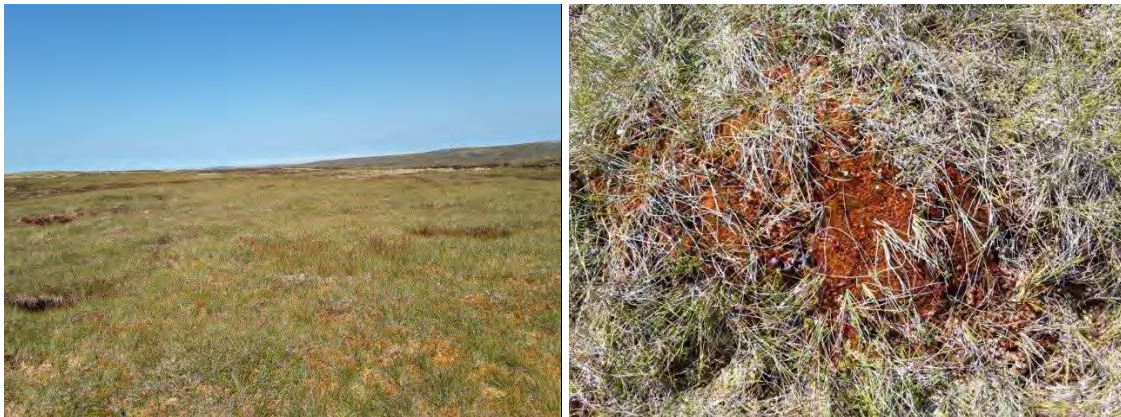
*Photo 5 and 6: A fragment of blanket bog vegetation with bog pools and hummocks of rusty bog-moss.*

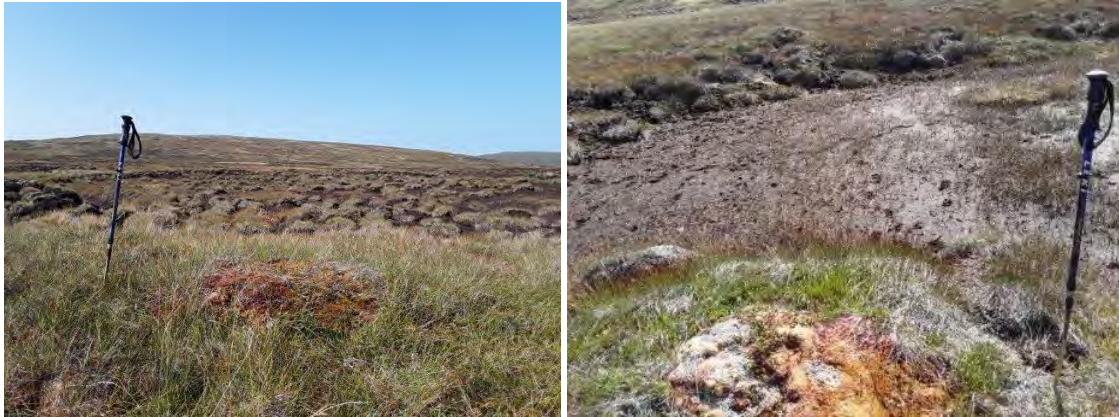
*Photo 7 and 8: Rusty bog-moss hummocks within a few meters of extensive bare peat pans.*

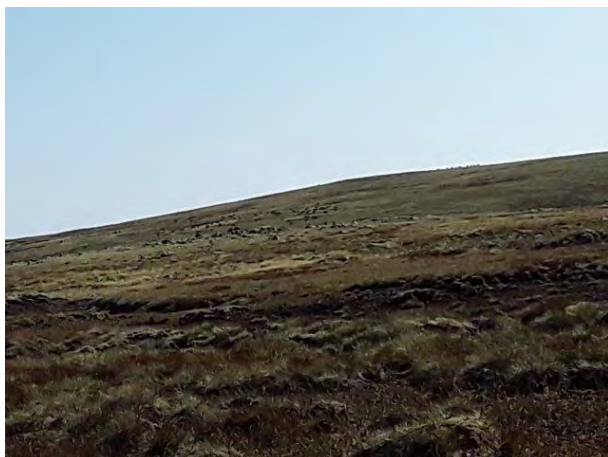
There was widespread evidence of deer across the Search Area. This included hoof marks and deer trails clearly visible in the bare peat. Deer were regularly seen during the Site Visit including a large dispersed herd of up to 350 head of red deer seen on the lower slopes of Carn Odhar na Criche. It was considered highly likely that impacts from deer were the causal factor of the widespread erosion within the Search Area. Combined with the cold climate and short growing season associated with the high altitude of the Search Area natural re-colonisation and the ability of the blanket bog to recover from the impacts of deer at these densities are likely to be severely limited.

*Photo 9: Ca. 350 deer on the slopes of Carn Odhar na Criche.*

Success of any peatland restoration is considered likely to be entirely reliant on a substantial and sustained reduction in deer numbers. Currently the pressure on the peatland from deer in the Search Area is such that deer prints are widespread and notable, and they are likely to be the causal factor of the widespread peat erosion. If deer numbers are not substantially reduced then peatland restoration will likely fail and the current situation will continue and so deteriorate further with exposed peat eroding and the bare peat areas expanding into the small remaining fragments of blanket bog habitat that remain.

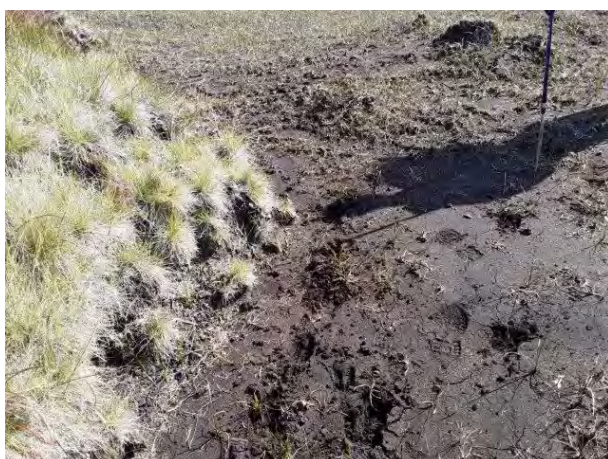
*Photo 11: Hoof prints clearly visible on bare peat – common across the Search Area.*

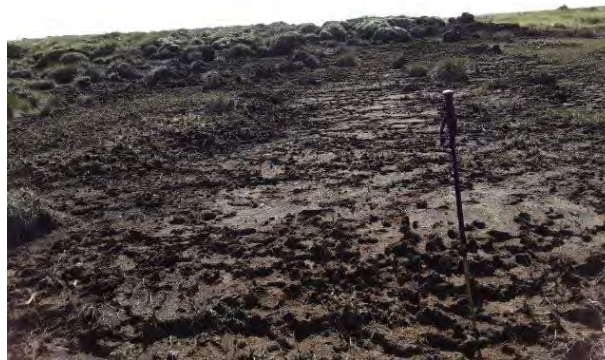
For example, in the south of the Search Area, within the Monadhliath SAC, there were large expanses of bare peat that were clearly actively eroding. In some areas there was deep peat, demonstrating a large carbon store which is currently eroding. The Monadhliath SAC blanket bog is of international importance and restoration of these bare peat areas in the upper catchment of the Allt Mór and Allt Cam Ban would reduce the erosion of the internationally important peatland, prevent the expansion of eroded areas within the internationally important blanket bog, reduce particulate matter entering these watercourses and slow the movement of water into the lower catchments.

*Photo 12: A bare peat pan suitable for peatland restoration which forms part of the Monadhliath SAC internationally important blanket bog.*

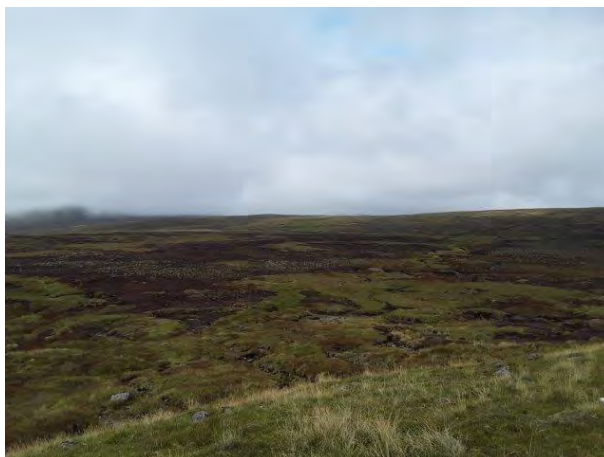
A further example of restoration potential and opportunity was in the north of the Search Area in the upper catchment of the Allt Cam nan Croc where there was considered great potential to revert the eroded areas back to wet and potentially active blanket bog. This area had many small (ca. 10x 30m) fragments of bog habitat with bog-mosses present, including hummocks of rusty bog-moss, within a wide expanse of bare peat (ca. 500m x 500m) which appeared deep. The topography was generally flat with slopes rising around it. If deer pressure was substantially reduced, a suitable seed source provided and drainage routes blocked it was considered that this area would likely re-wet and support high quality blanket bog, probably with little other intervention.

*Photo 13: View of an area with high restoration potential in the north of the Search Area.*

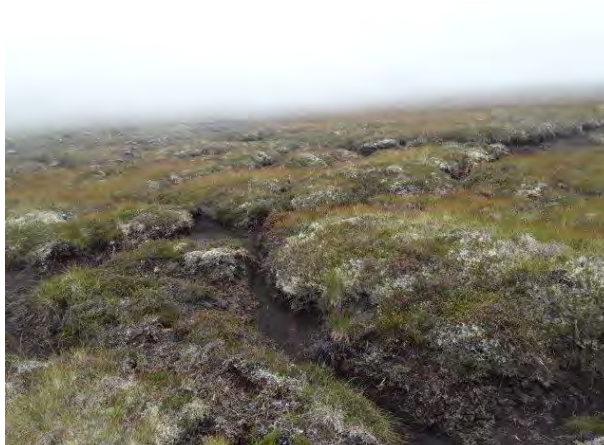
This type of eroded habitat was characteristic of much of the habitat that was driven through during the site visit and around Stronelairg Wind Farm and so it is considered likely that large areas (c.100 – 150ha) could be suitable for peatland restoration.

*Photo 14: A network of erosion gullies within the blanket bog habitat.*

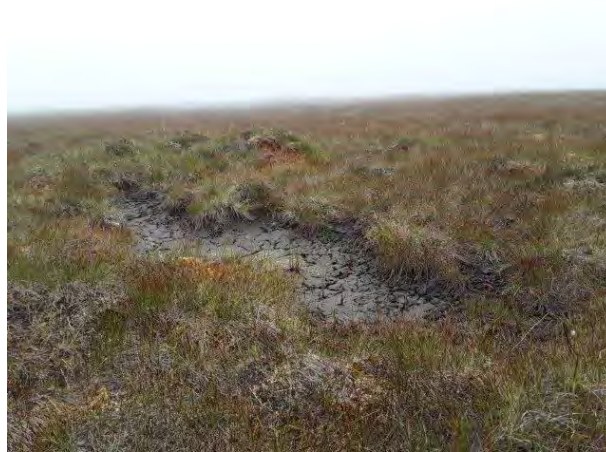
The blanket bog vegetation was made up of deergrass, heather and patches of red bog-moss and papillose bog-moss and some remnant hummocks of rusty bog-moss. There were occasional dried out pools within some areas of more intact blanket bog. If the water table was raised these pools would likely restore naturally.

*Photo 15: Dried out pool within the blanket bog vegetation.*

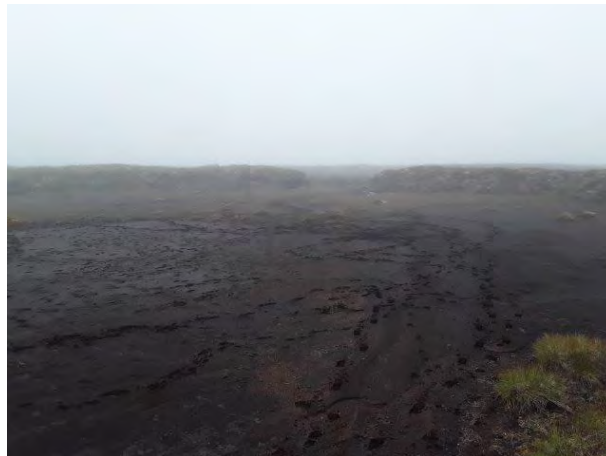
Notably, there was a large former lochan present (at OS grid reference NH 47906 04673) which, at the time of the walkover site visit had a bare peat surface, with deer prints across it. On the OS map it was mapped as a lochan, but the lochan wall had eroded at a single breach point and the water had drained away. Blocking and securing the breach point would likely result in the lochan re-wetting. Several other smaller lochans within the immediate vicinity were also identified at risk of being lost through erosion of lochan walls (including one at OS grid reference NH 47936 04581). Peatland restoration around these lochans would ensure they remained.

*Photo 16: A former lochan with a breach in the lochan wall.*

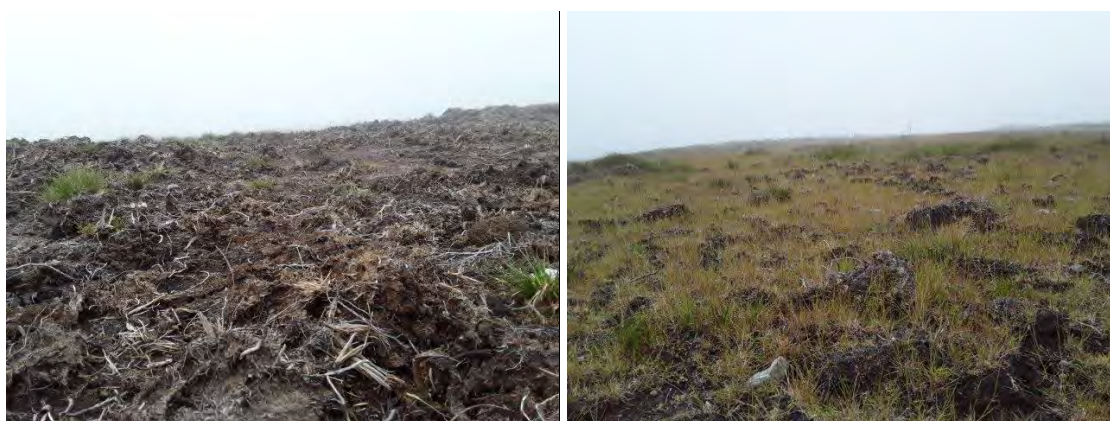
In some areas the nurse seeds, of variable grass species, had resulted in near completed cover of the peat surface, whereas in other areas, often near to or adjacent to successful areas, the redistributed peat was bare, with little evidence of colonisation.

*Photo 17 and 18: Redistributed peat with little evidence of colonisation (on the left) and better cover of vegetation (on the right).*

The success or failure may, in part, be due to the slow growth at high altitude, but there were areas where re-seeding was clearly successful/partly successful. Therefore, the quantity/quality/timing of seed application may have also played a role in the areas that were not successful. Additionally, the detrimental impact of deer is clearly high and may also have had a role to play in the limited success of the re-instatement. Re-applying a seed mix of suitable upland species (e.g. deergrass, common cottongrass and heather), plus a nurse seed mix of grasses across the redistributed peat should increase the success rate, especially if deer pressure is widely and effectively reduced.

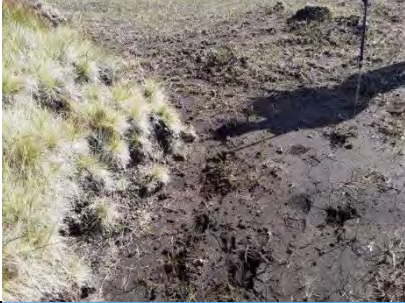
4	NH 58878 03534	Bare peat pan.	There was an area of bare peat, partially stabilised with common cottongrass. There were small active erosion gullies within the bare peat pan, caused by water flow demonstrating active erosion.

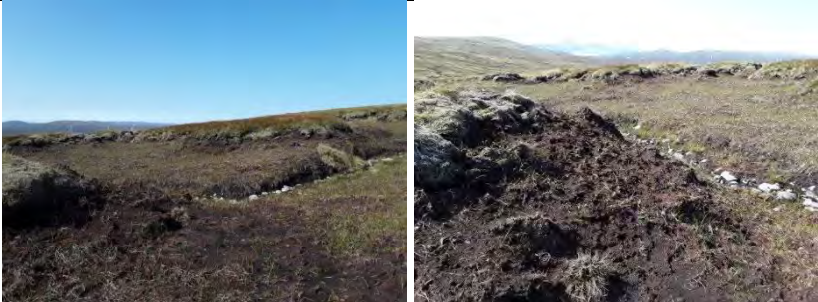
5	NH 58955 03581	Bare peat partly recolonised.	Large bare peat pan ca. 100m x 120m. Some natural re-colonisation (ca. 70% cover) but it was restricted to common cottongrass. The re-colonisation was not uniform, with patches showing clear sign of active erosion. There was ca. >1m of peat below the pan, demonstrating a large resource of peat that was exposed and eroding. Recommend: Reduce grazing pressure hugely. Mulch and re-seeding. Re-profile edges of pan to prevent it further expanding.

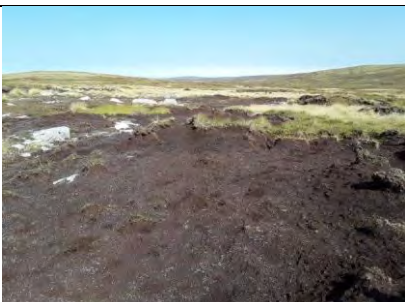
15	NH 59318 03489	Bare peat to mineral soil.	The bare peat pan had reached mineral soil. It was estimated there was a loss of ca. 1m of peat to expose the mineral soil. Recommend: Reduce deer pressure substantially and effectively. Re-profile edges to prevent expansion of pan. Seed and mulch the bare peat to reduce further loss.

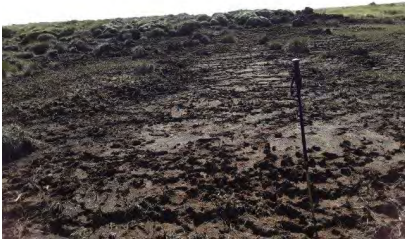
18	NH 59338 03361	Evidence of expanding bare peat pan.	There was a large bare peat pan which appeared to be expanding in size, through erosion at the edge. The slope here had remaining tussocks of vegetation at the uppermost slope, with no vegetation lower down. The blanket bog vegetation is being lost through active erosion. Recommend: reduce grazing pressure substantially, re-profile, re-seed and mulch.

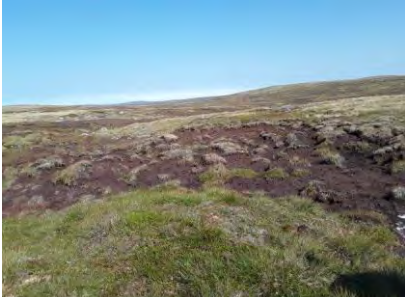
19	NH 59354 03343	Evidence of active erosion.	These tussocks are remains of blanket bog vegetation, including hare's-tail cottongrass and woolly fringe moss. The bare peat was spreading around the root bases and deer paths between the tussocks could be seen. Recommend: flatten, seed and mulch.

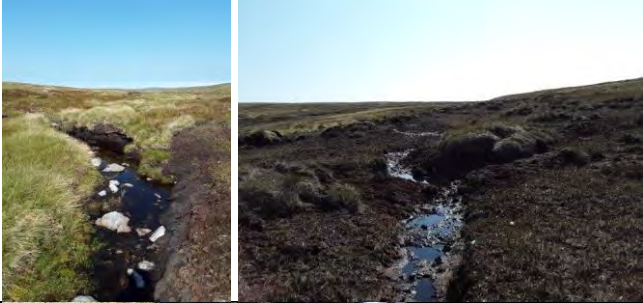
TG	Grid	Note	Comment	Photos
20	NH 59453 03538	Evidence of active erosion.	The water in the small stream was stained brown with peat particles seen in the water demonstrating active erosion.

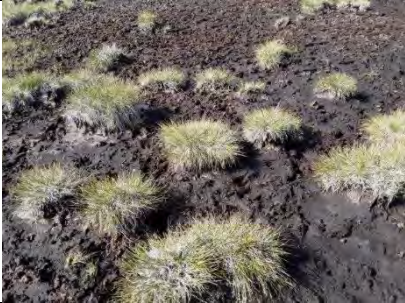
25	NH 59534 03961	Hare's-tail cottongrass tussocks.	These hare's-tail cottongrass tussocks demonstrate that active blanket bog was once present, but it has been heavily degraded. Deer prints were surrounding the remaining tussocks. Recommend putting heather brush and seed between the tussocks, with coir bails to hold it in place.

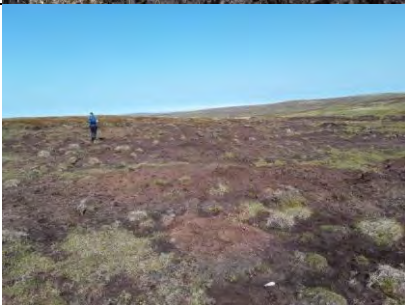
27	NH 59335 04365	Bare peat pan.	A smaller bare peat pan, (ca. 30m x 70m). With evidence of active erosion. Would require re-profiling the edges mulching and seeding the bare peat.

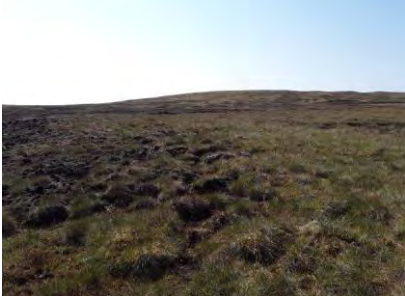
30	NH 59275 04400	Evidence of active erosion.	There was erosion of the edge of the area containing the M17a blanket bog and M2 pools. It was next to a bare peat pan, which showed evidence of erosion. This demonstrates that the remaining, remnant blanket bog was under threat from erosion.

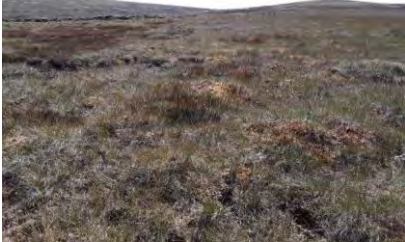
TG	Grid	Note	Comment	Photos
31	NH 59271 04441	Deer damage in good bog.	There were deer prints in the M17a blanket bog fragment.

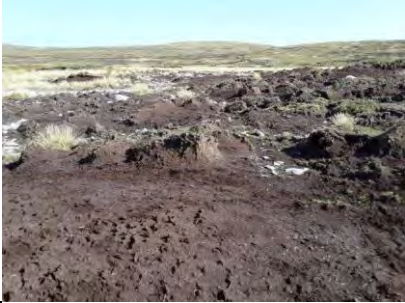
TG	Grid	Note	Comment	Photos
39	NH 59343 04995	Bare peat.	Some places here appeared to have lost nearly all the peat. Recommend using species that are naturally colonising, to prevent further erosion of remaining peat. These include wavy hair-grass, deergrass, stiff sedge and mat grass. There were some areas that still supported ca. 1.5m deep peat which was un-vegetated and likely to erode away. Deer hoof prints were evident.

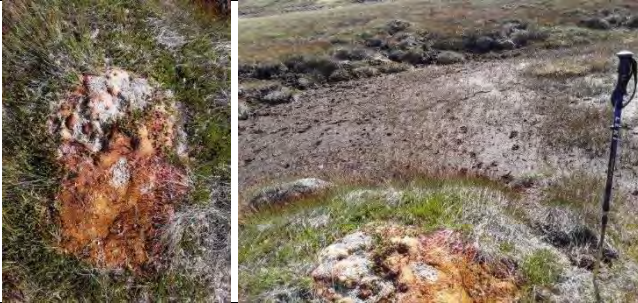
47	NH 59141 05213	Rusty bog-moss.	The hummock of rusty bog-moss was in poor condition, with about 50% dried out. It was beside a bare peat pan.

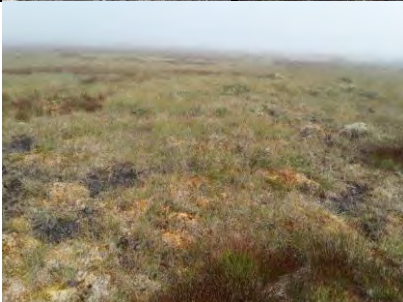
60	NH 58389 05395	Blanket bog vegetation being lost.	Hummocks of papillose bog-moss, hare's-tail cottongrass, crowberry, bearberry and deergrass were present as M20b blanket bog which was being degraded and lost through deer prints creating bare patches.

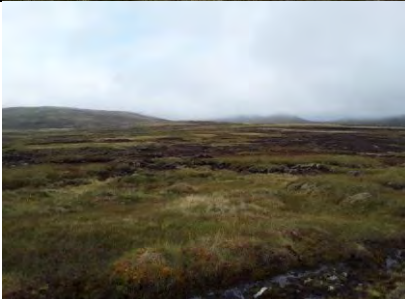
72	NH 60310 06500	Erosion face.	The erosion faces (haggs) around the outside of the bare peat pan were ca. 1m to 1.5m in height. Recommend re-profiling them to prevent expansion of bare peat area.

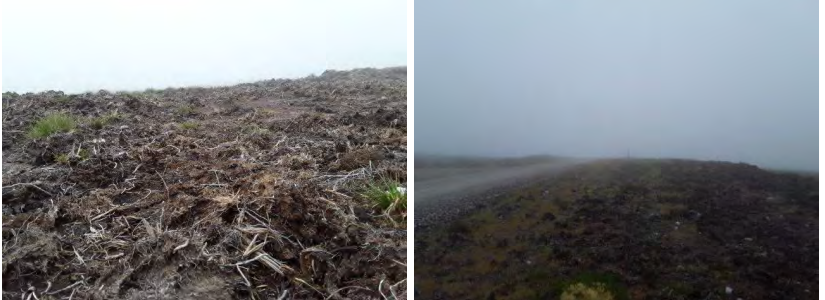
79	NH 56130 03943	Stronelaig failed re-instatement.	Beside the track there was a 10m to 15m wide area of bare redistributed peat from construction of Stronelaig Wind Farm. There were occasional very small tussocks of deergrass, heather, blaeberry, but it was mostly bare peat. There were occasional tiny patches of bog-mosses present. This is a failed attempt to cover the bare peat surfaces with a nurse crop.

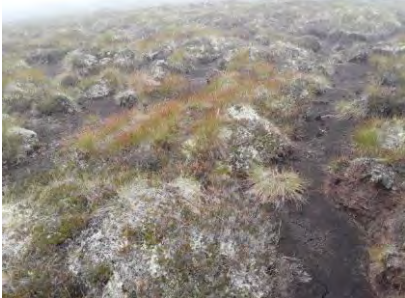
87	NH 47947 04674	Evidence of active erosion.	The erosion was not in the same state as in the Option Area. There was more vegetation present, and there were often erosion gullies which were shallow, ca. 20cm deep. Recommend substantially reducing numbers of deer, and placing in coir bunds between the remnant bog, blocking erosion gullies and re-seeding.
