**Tangy III Wind Farm:
Fish habitat and population assessments**

Commissioned Report to Environ UK Ltd.

December 2013

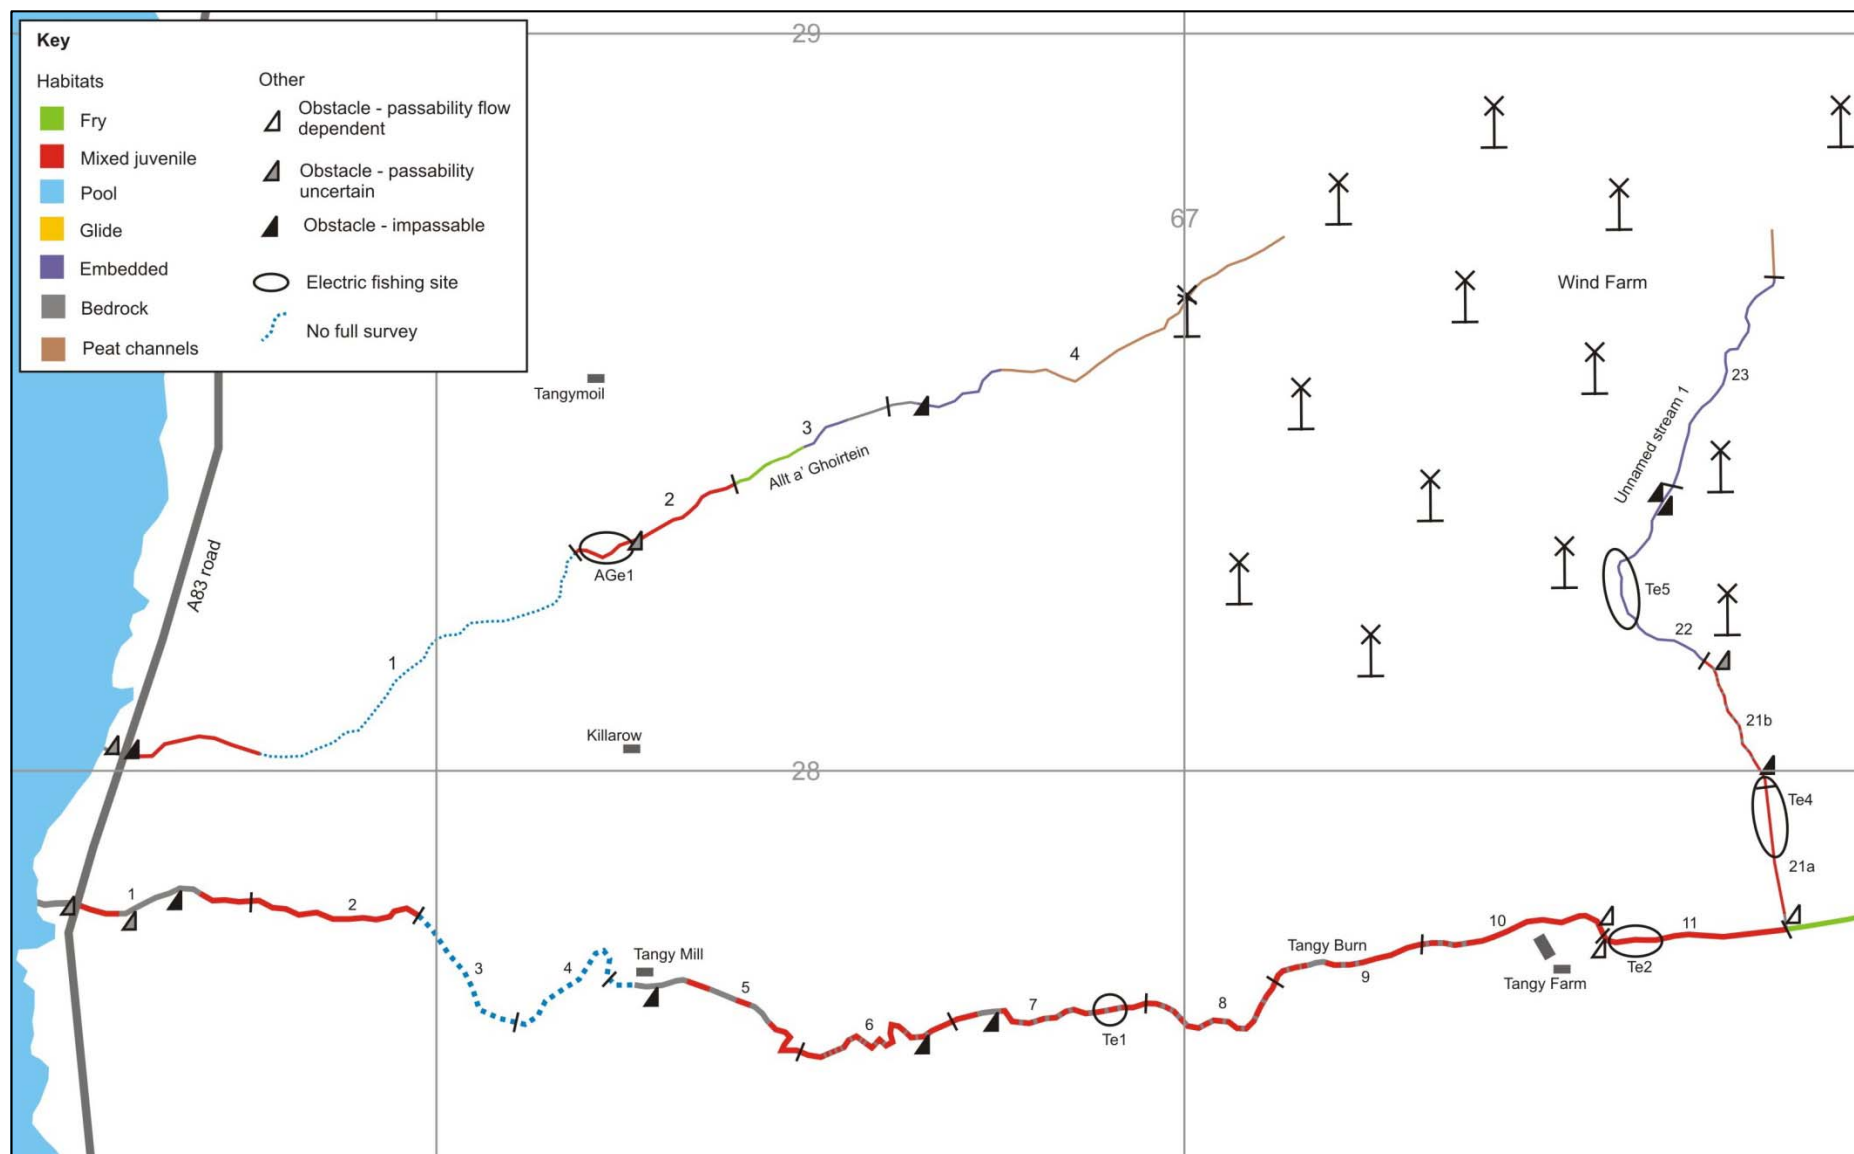
Figure 1.1 Tangy Burn (lower) and Allt a' Ghoirtein fish habitat distribution

The lower 250 m of Tangy Burn, survey section TB1, are steep and flow through an incised gorge with heavy shading from broadleaf trees. Obstacles in this gorge are described above and are likely to prevent access by salmon or sea trout. Much of the habitat in the gorge is dominated by bedrock. The gradient eases in section TB2, where the stream flows between high, sloping, tree-clad banks. Here the stream is typically between 2 m and 3 m wet width with substrates of cobble, boulder and pebble and patches of bedrock.

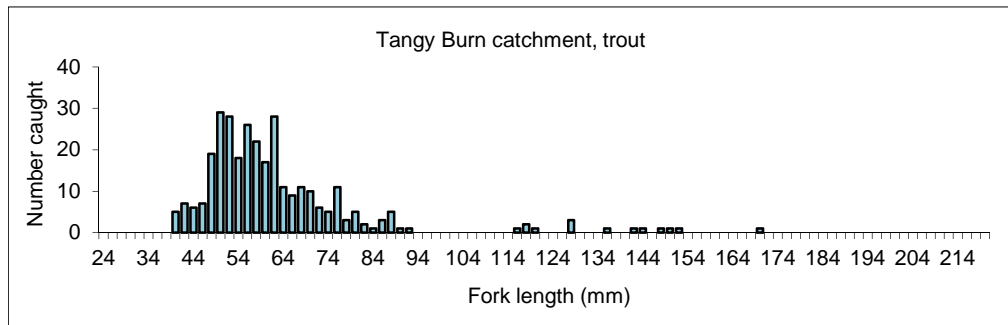
Figure 2. Trout size distribution, Tangy Burn catchment

Mean fry density in Tangy Burn itself was 53.7 per 100 m², good by regional standards. Parr densities were consistently low and the mean of 1.7 parr per 100 m² would be classified as very poor. The majority of parr were aged 1+ years.

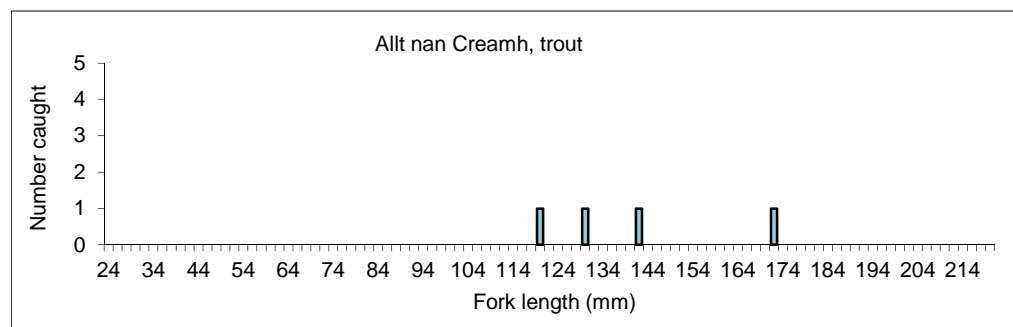
Figure 3. Trout size distribution, Allt nan Creamh catchment

Trout were present at unusually low density in Allt nan Creamh. No trout were seen during the habitat survey and their scarcity was subsequently confirmed by electric fishing. Three large sites were surveyed in habitat that had been judged suitable for trout production, but only three parr were found. While physical habitat quality was not high, stream structure suggested that moderate numbers of fry and parr should have been expected. The reason for the scarcity of trout in this stream is unknown, but might reflect water quality issues or, possibly, a pollution event. No other fish species were found, but given the presence of a very large waterfall in the lower reaches none was expected.

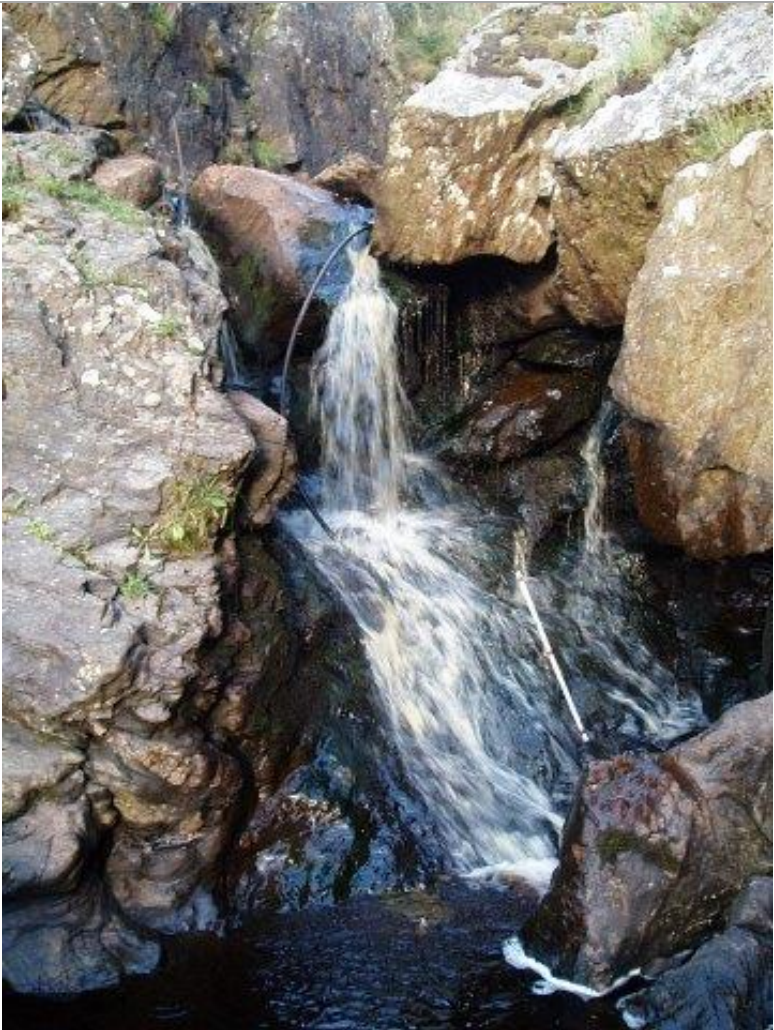
<p>Allt a' Ghoirtein Obstacle AG1.1</p> <p>NR 6556 2803</p> <p>This culvert is immediately upstream of the normal tidal limit. It was not clear whether it might inundate on a high spring tide, potentially allowing salmonid access.</p>
 	<p>Allt a' Ghoirtein Obstacle 4.1</p> <p>NR 6660 2849</p> <p>This 3 m high stepped cascade is impassable due to its steepness and lack of pools.</p>
 	<p>Allt nan Creamh Obstacle 1.1</p> <p>NR 6583 2984</p> <p>Sumps, choke stones and cascades create a difficult obstacle. Passability uncertain.</p>

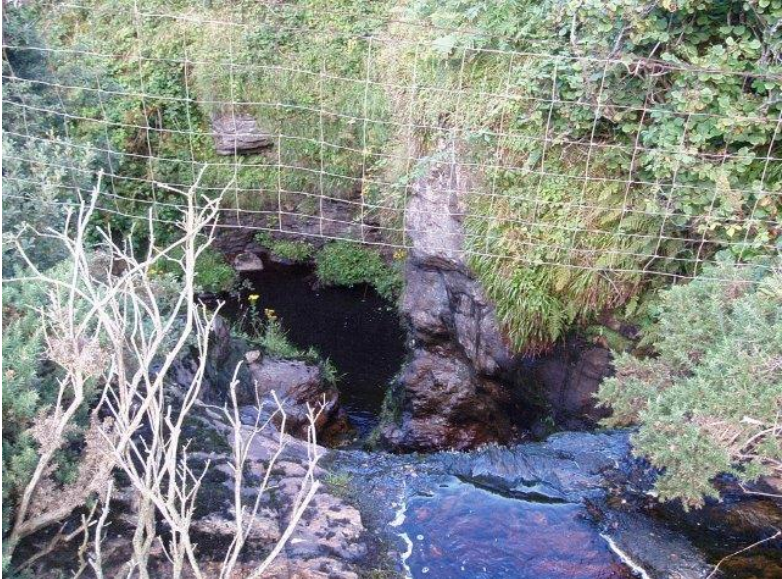
<p>Allt nan Creamh Obstacle 1.2</p> <p>NR 6584 2982</p> <p>This obstacle was judged to be impassable due to the difficult take off and the shallow ledge at 1.8 m height.</p>

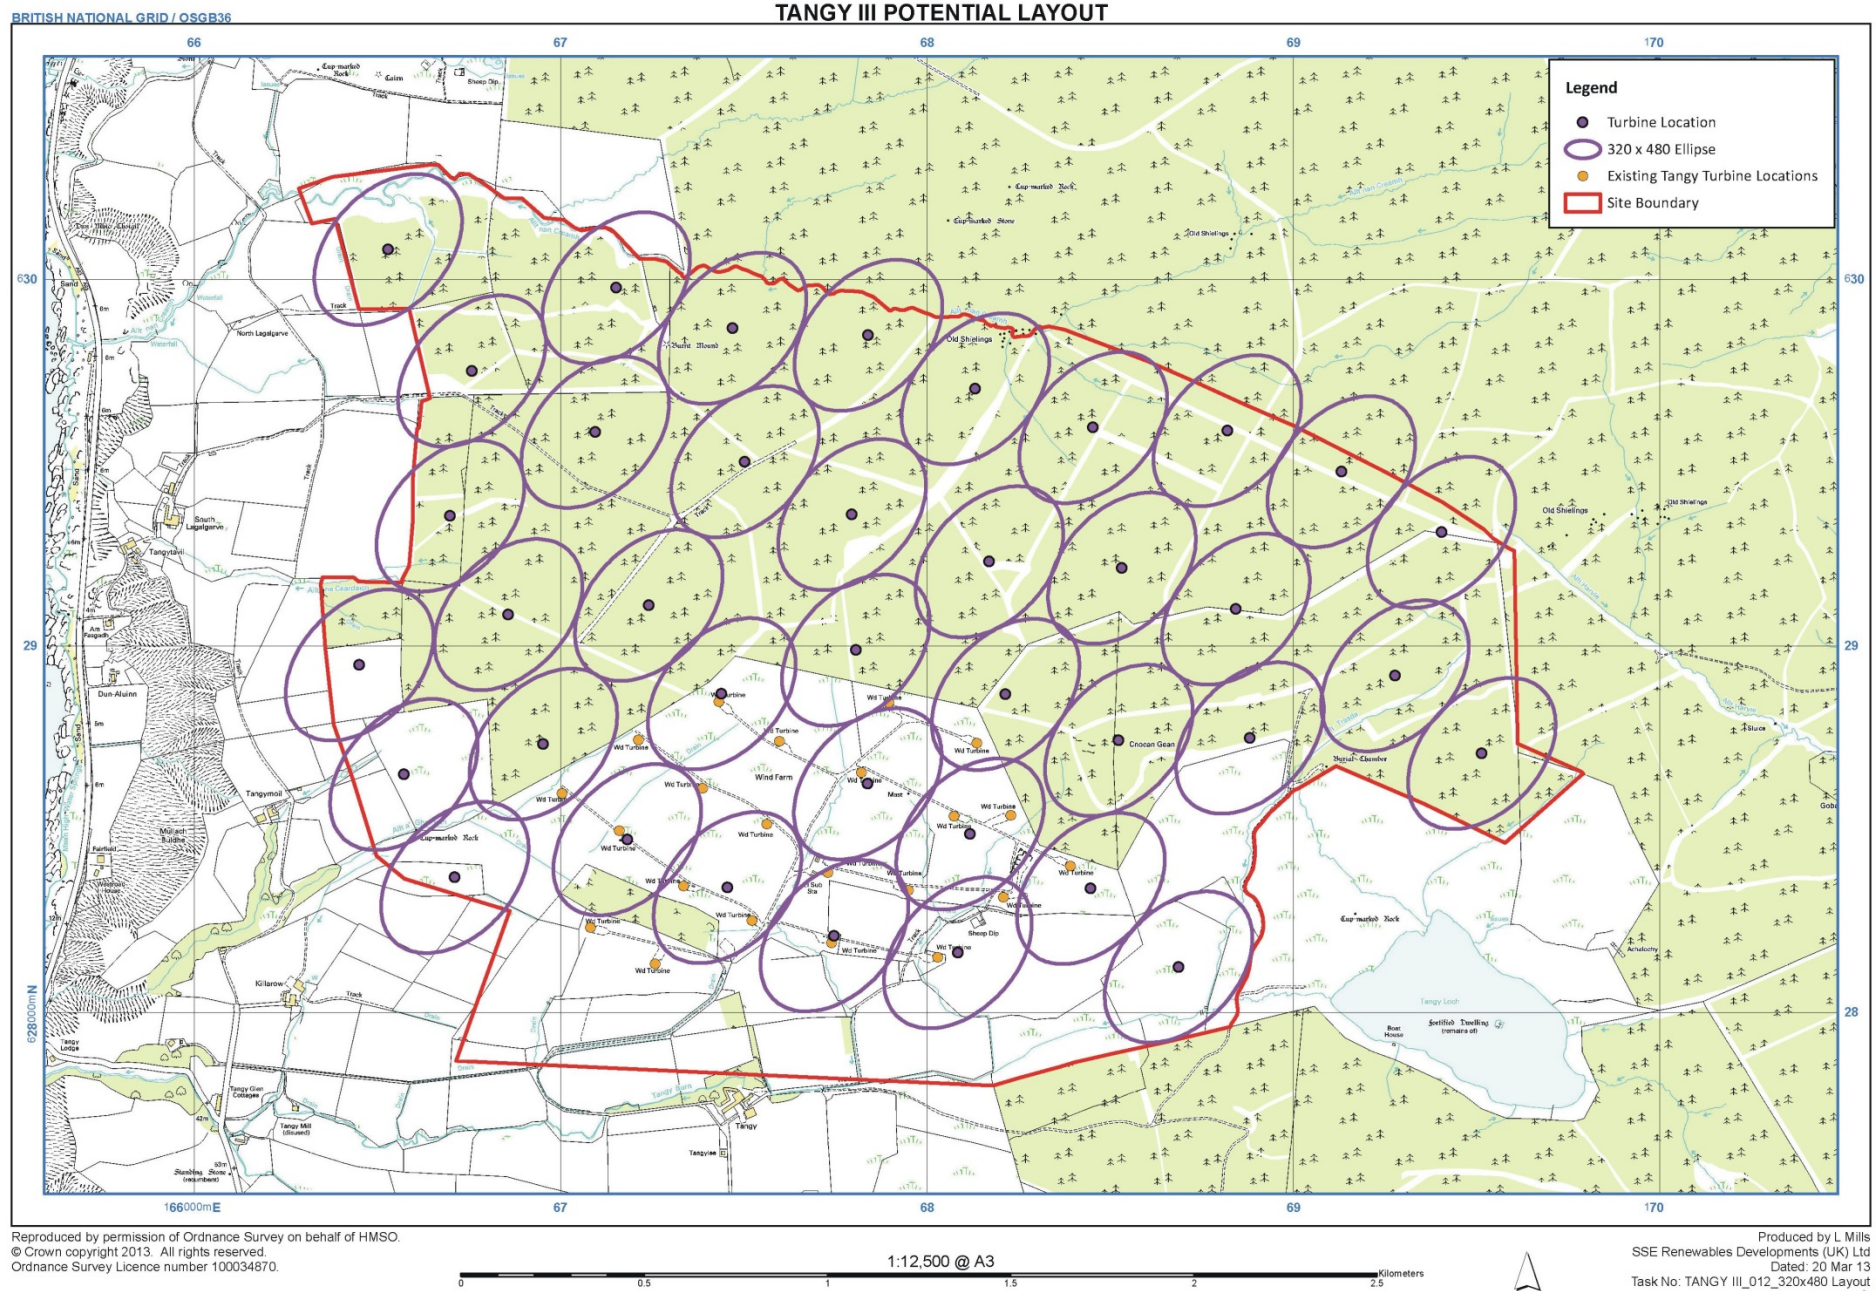
Annex 1. Tangy III Wind Farm. This iteration of the layout formed the basis for the fisheries surveys (note that the layout was later revised and number of turbines reduced).
