GORDONBUSH WIND FARM EXTENSION

Technical Appendix 9.1
Borrow Pit Assessment

SLR Ref: 405.00660.00025
Version No: rev3
January 2019

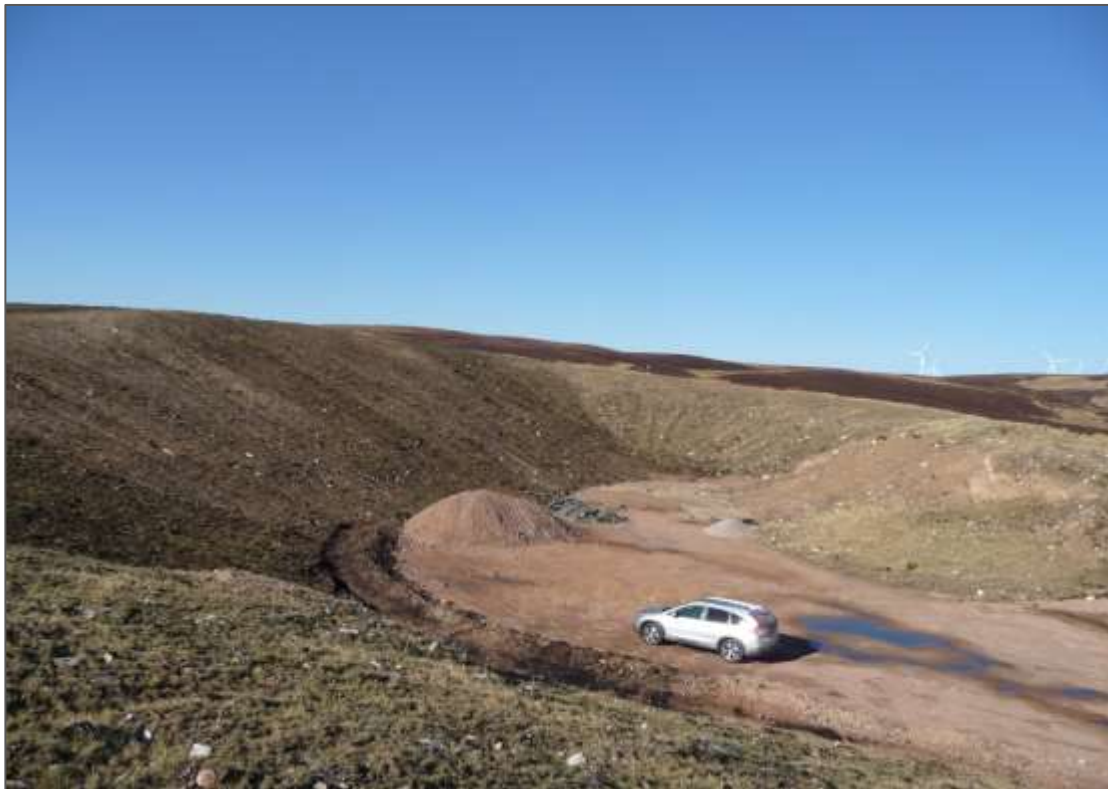
Photo 3-1
Restored original Borrow Pit Site BP1

Site BP1 is situated to the south-east of the Revised Development with potential to extend towards the west.

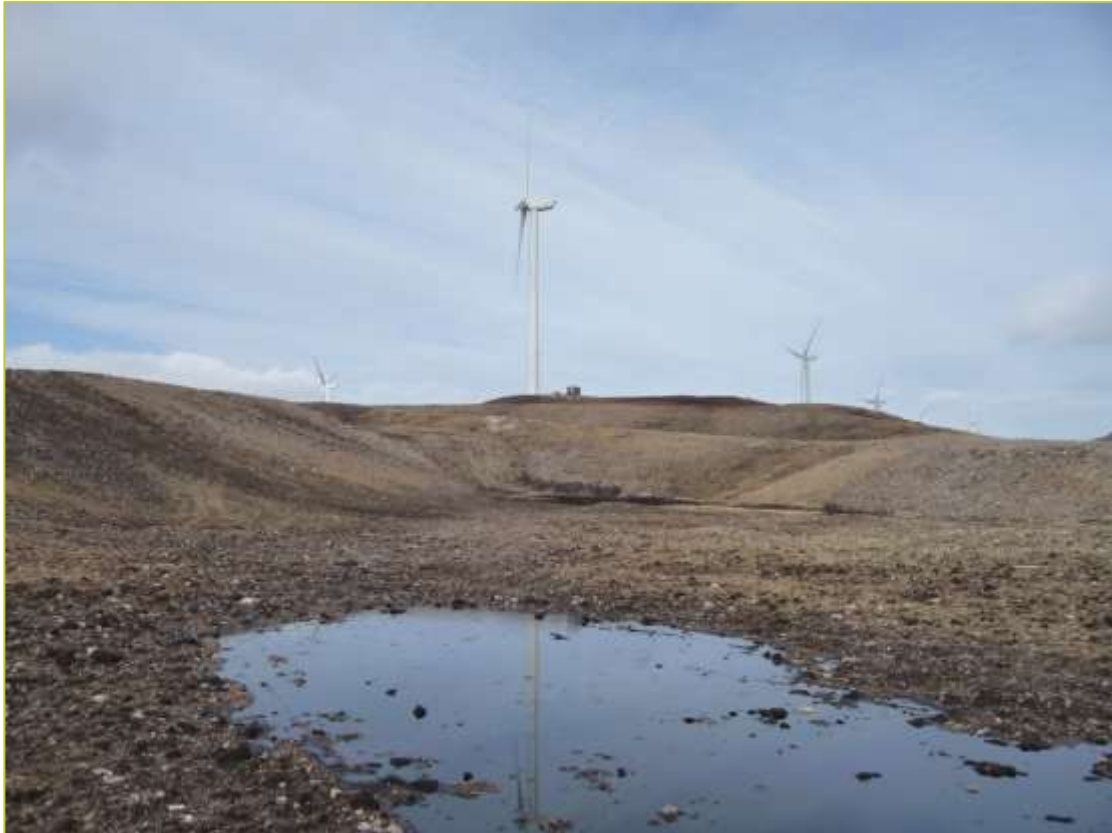
Photo 3-2
Restored original Borrow Pit Site BP2

Site BP2 is situated to north-west of Revised Development with potential to extend towards the west.

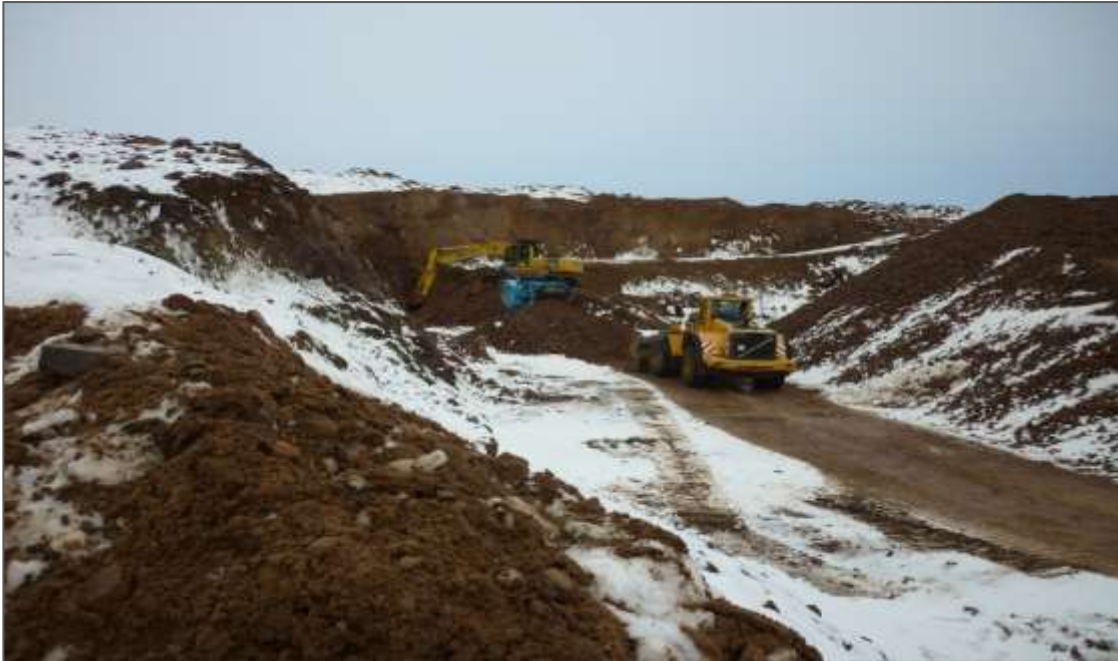
Photo 3-3
Borrow Pit BP1 in operational stage showing vertical high wall.

Previous photographs of each borrow pit in its operational stage would suggest that the high wall is relatively vertical and therefore this allows a good estimation to be made of volumes of rock that could be extracted from each borrow pit.

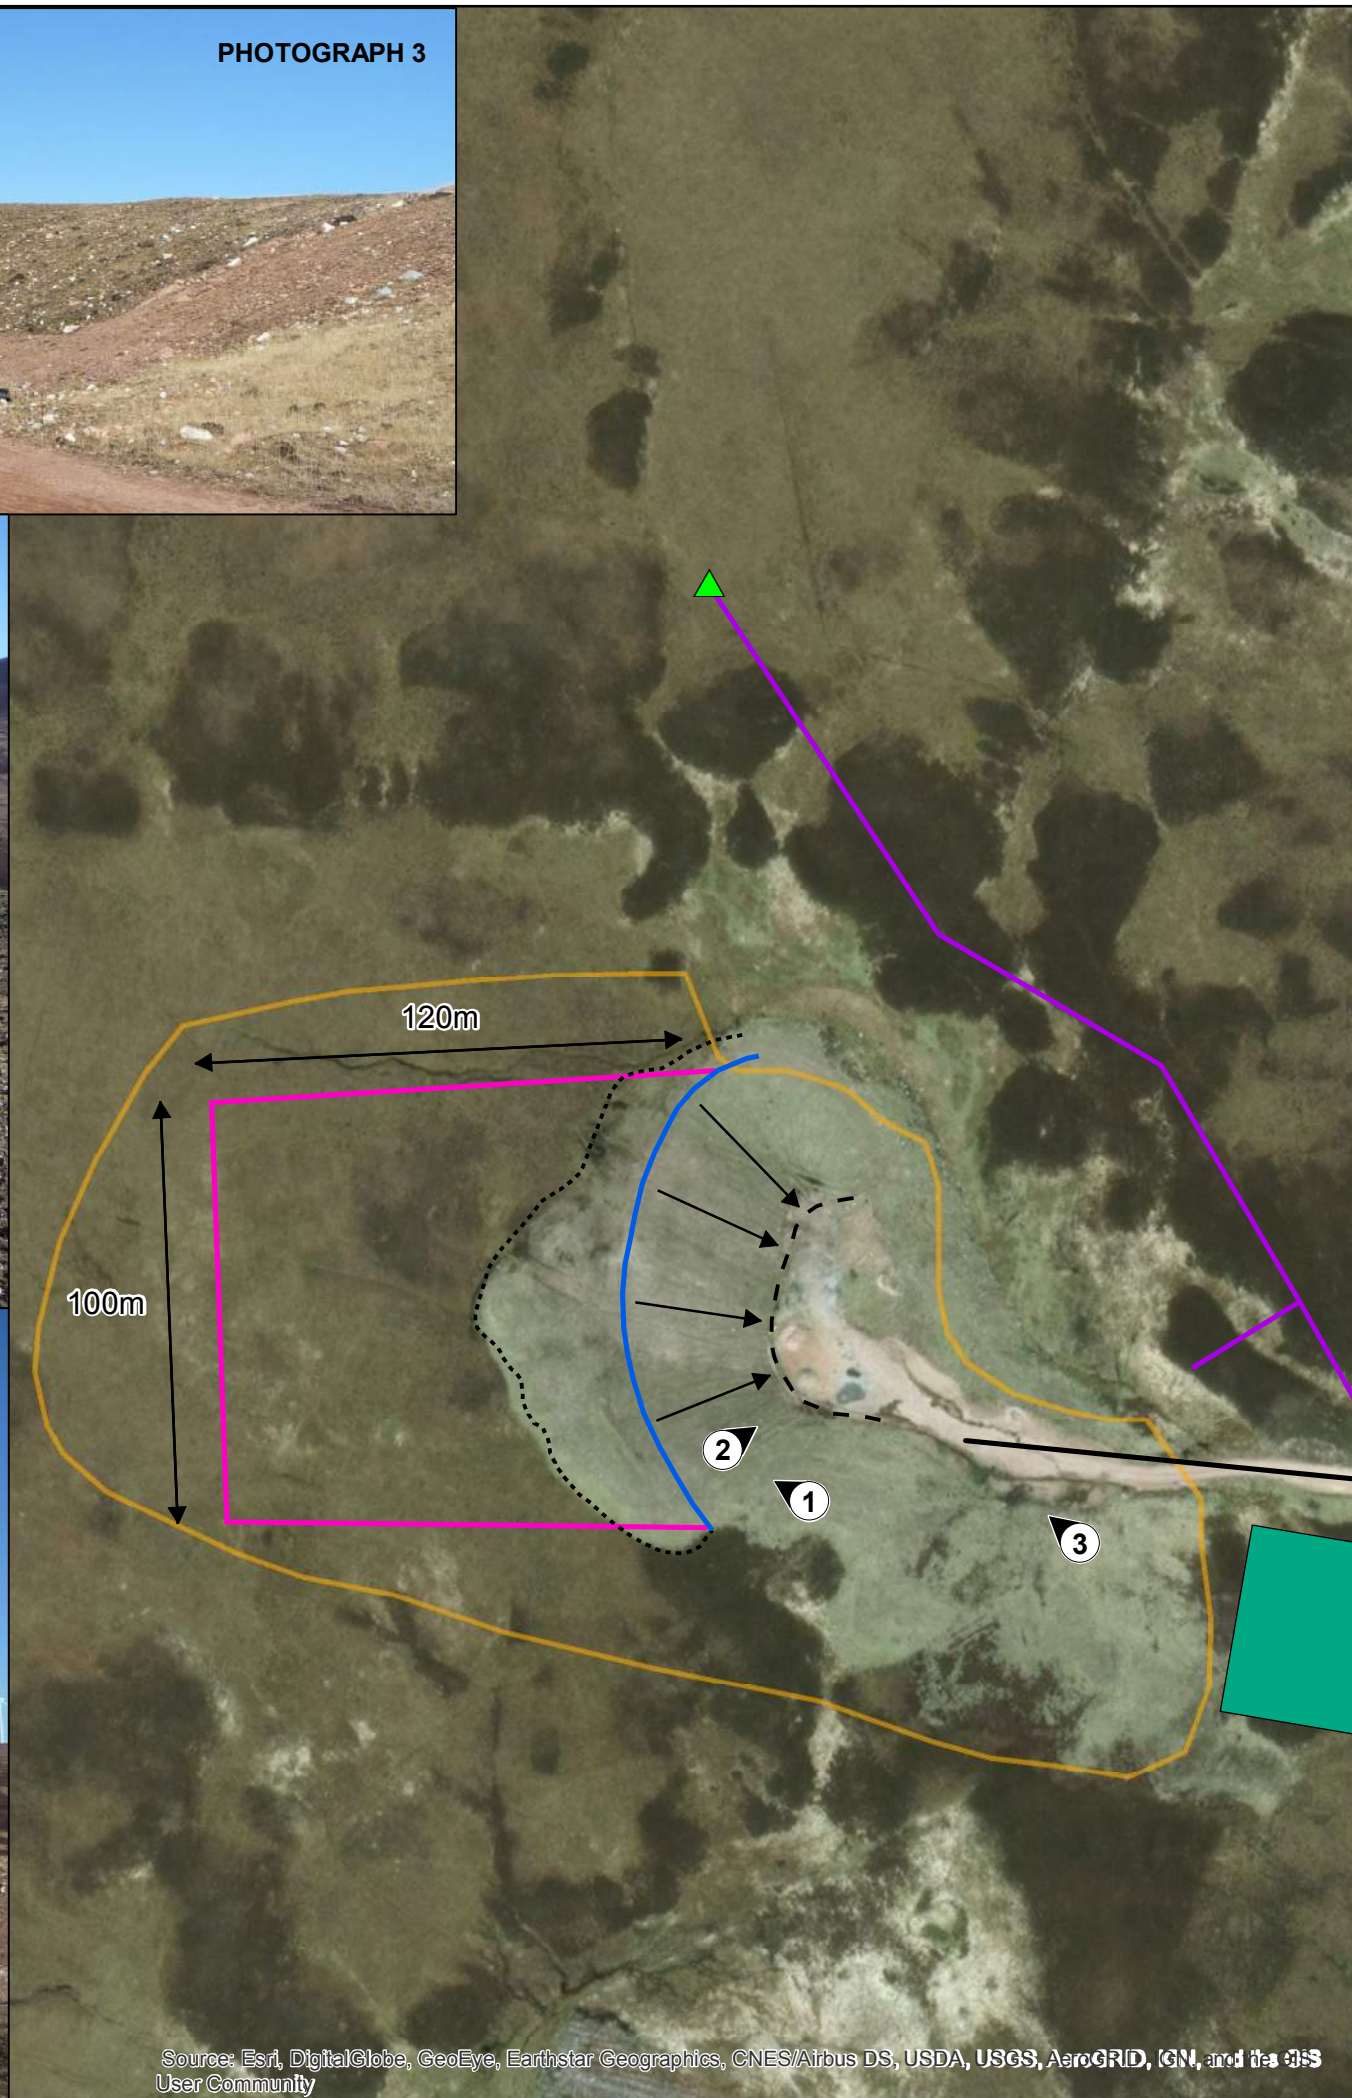
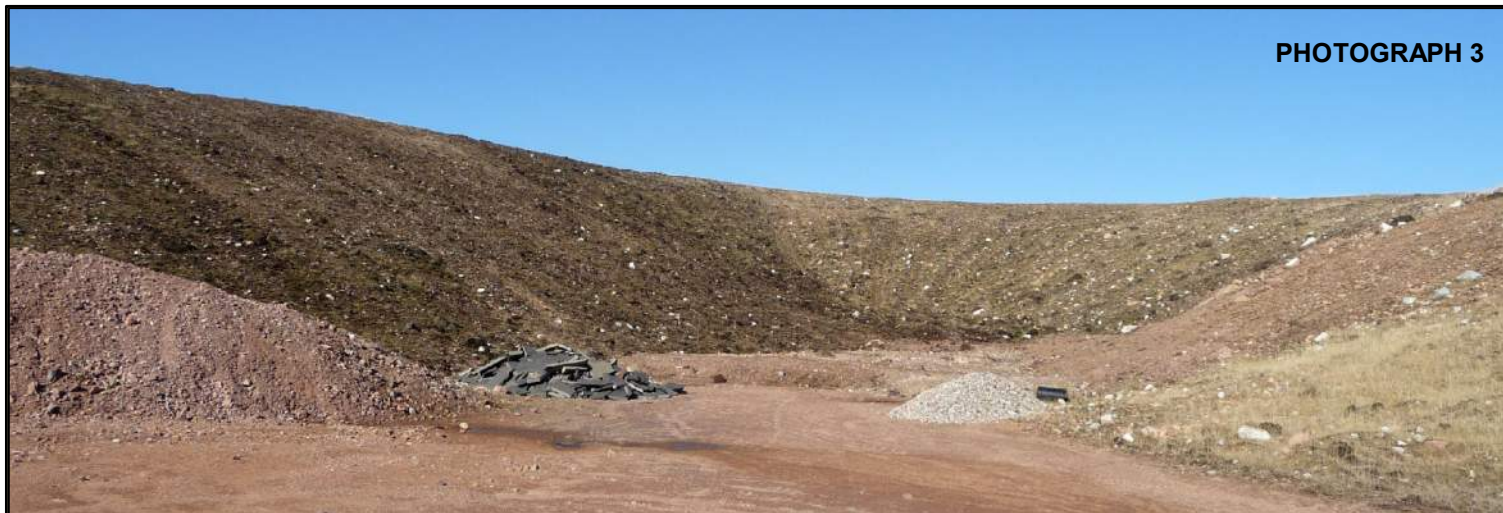
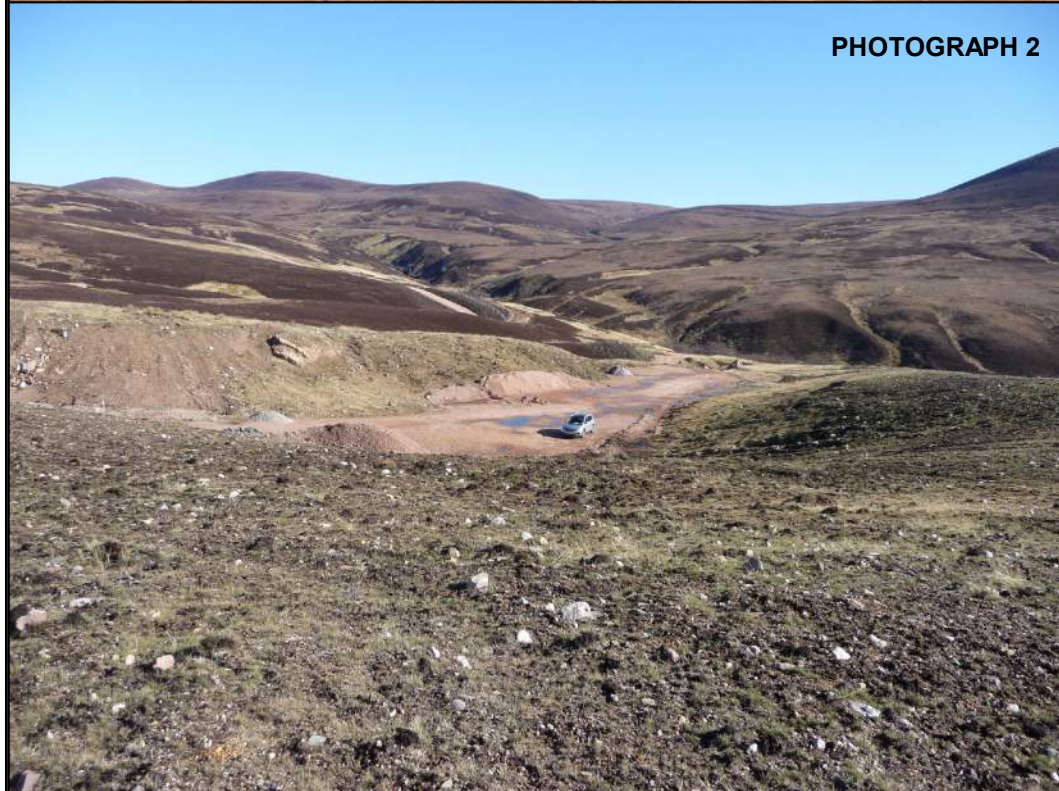
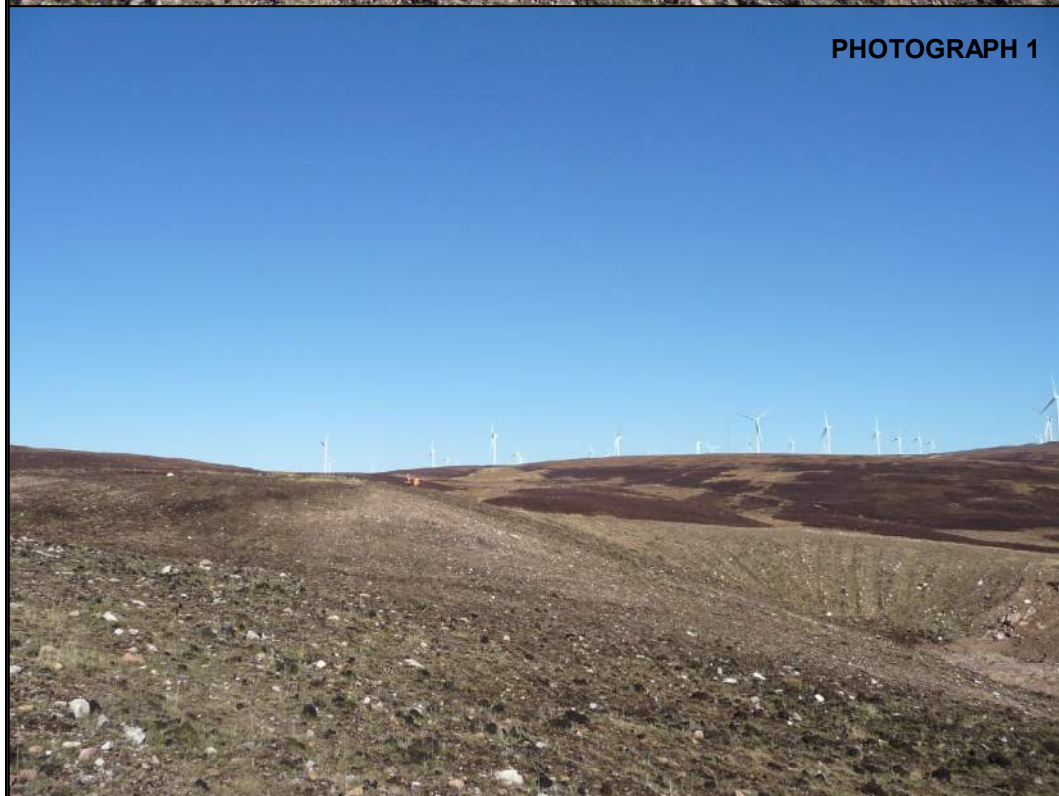
Figure 4.0
Potential Borrow Pit Reuse - BP1

The indicative borrow pit reuse designs are shown in Figures 4.0 & 5.0. The indicative borrow pit profiles have been designed to best utilise the borrow pits based on the previous excavation profiles. Following removal of the overburden material, excavation will commence on the historical high wall, continuing the previous excavation operation. A rectangular shaped excavation has been proposed within each of the borrow pits in order to meet the estimated requirements for construction materials. Based upon the indicative borrow pit profiles a total maximum in situ excavation volume of 145,200 m³ could be achieved by the two pits combined.

120m x 100m x 8m = 105,600m³
(Assuming 8m Depth)

As discussed in section 4.0, the total required volume of material is ~109,000 m³. The current borrow pit profile for the larger of the two borrow pits BP1 is 120m x 110m, giving a volume of ~105,600m³ while the smaller of the two borrow pits BP2 is based on a cut of 120m x 60m by a cut depth of 5-6m, giving a volume of 39,600 m³ as described in Table 3-2.

- The footprint area of each excavation is outlined in Figure 4.0 & 5.0 for each proposed borrow pit;
- The proposed individual faces do not exceed a gradient of 2 (V) in 1 (H);
- The borrow pit floor is excavated to a nominal depth but would in practice be inclined gently down slope into the pit;
- The maximum height of any single face would be no more than 12.5m; however, based on the current design the maximum total cut will only be ~8m; and
- Drainage would be managed using a peripheral cut off ditch.

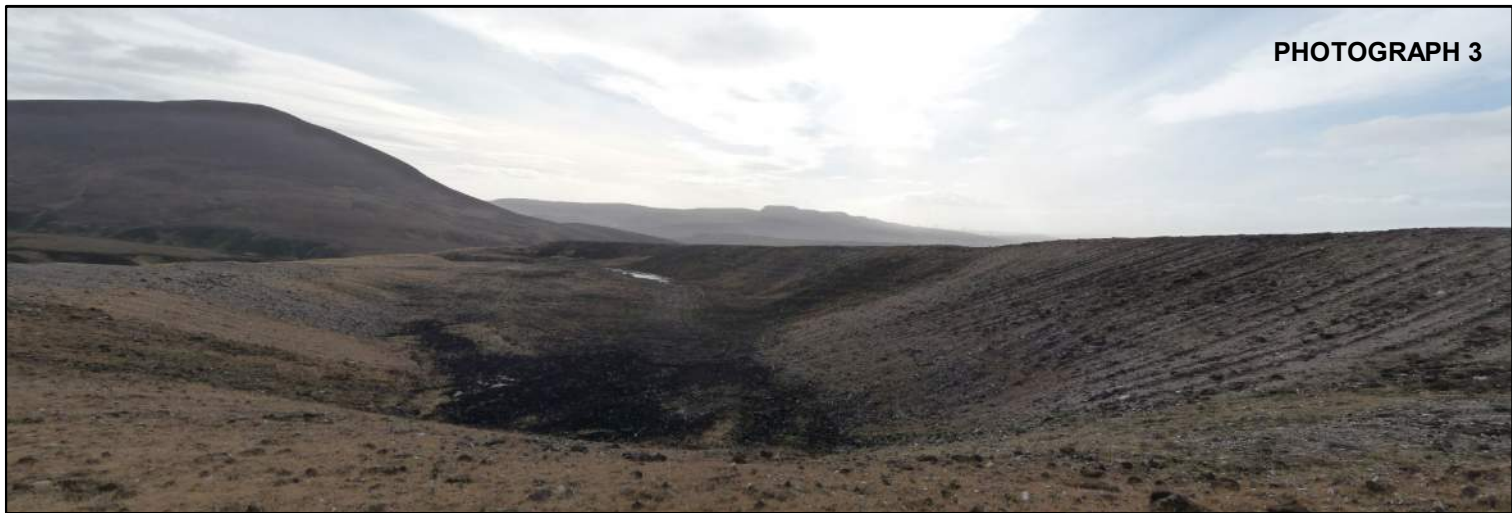
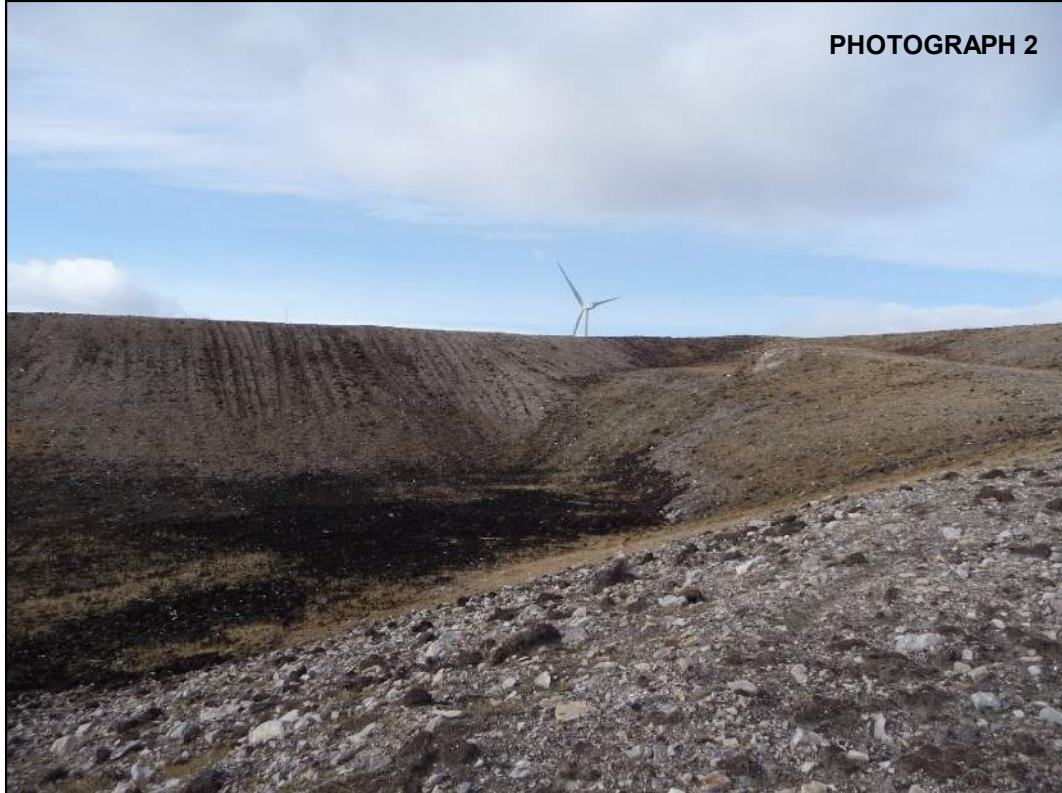
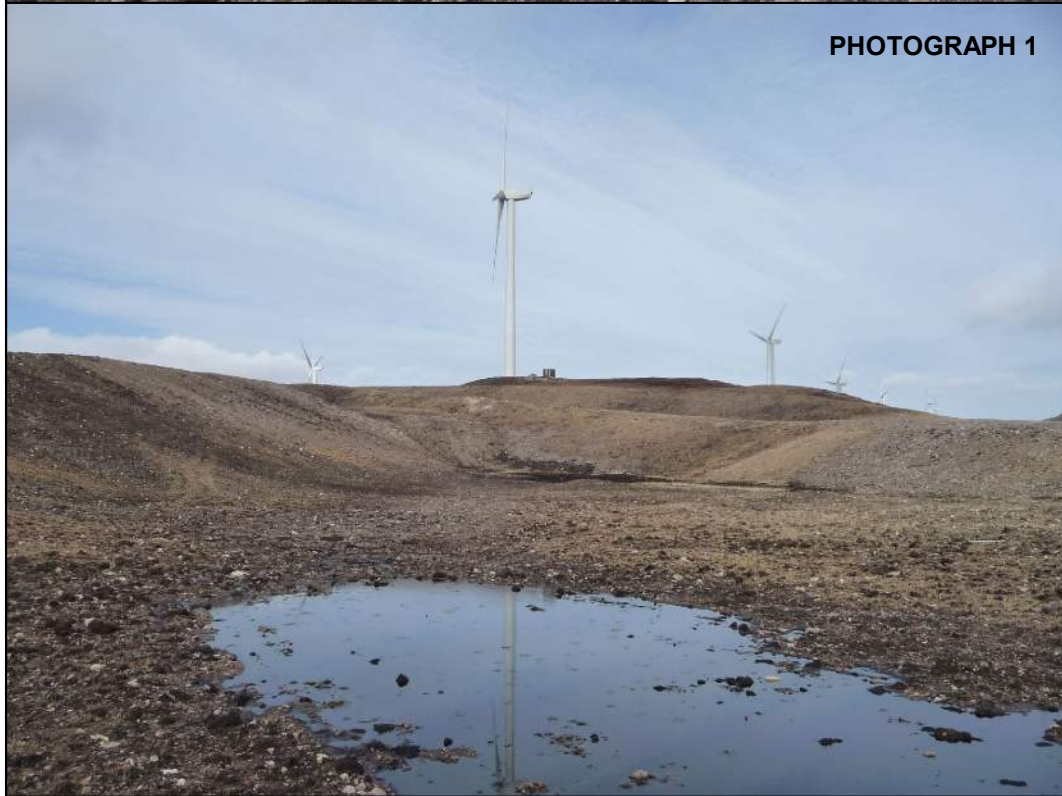
Figure 5.0
Potential Borrow Pit Reuse - BP2

120m x 60m x 5.5m = 39,600m³
(Assuming 6m Depth)
