Gordonbush Wind Farm Extension

Appendix 9.4

Borrow Pit Assessment

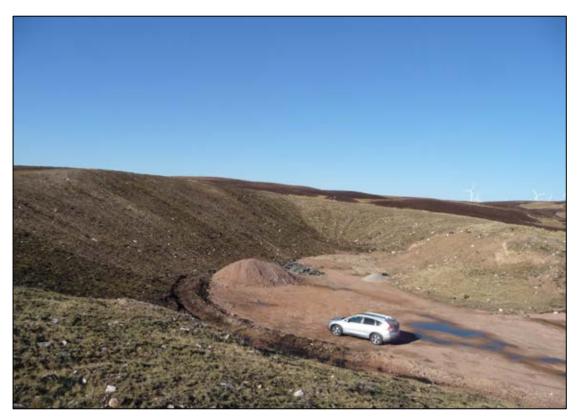
Photo 1 – Restored original Borrow Pit Site BP1 to the south-east of the proposed Development. Potential to extend towards the west.

There are limited options within the Development area for the potential to develop new borrow pits. On review and assessment of the borrow pits used during the construction of the operational Gordonbush Wind Farm, it has been established that there is potential to reopen borrow pits BP1 (Photo 1) and BP2 (Photo 2). Both these borrow pits are in good locations to assist in the development of the proposed extension and have the potential to be extended to provide adequate volumes of material. BP1 is located towards the south east of the proposed Development close to the proposed turbine T13, and BP2 is located towards the north west of the Development site close to the proposed T4 turbine. BP1 has a good established access track from their previous operation; the track at BP2 has been partially restored and will require reinstating.

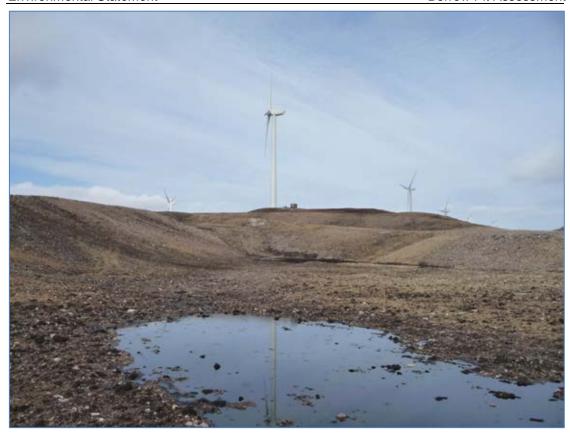
Photo 2 – Restored original Borrow Pit Site BP2 to north-west of proposed Development. Potential to extend towards the west.

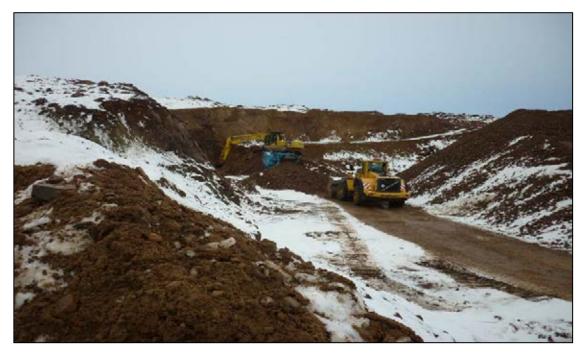
Photo 3 – Borrow Pit BP1 in operational stage showing vertical high wall.

Photograph's 3 and 4 illustrates each borrow pit in its operational stage would suggest that the high wall is relatively vertical and therefore this allows a good estimation to be made of volumes of rock that could be extracted from each borrow pit.

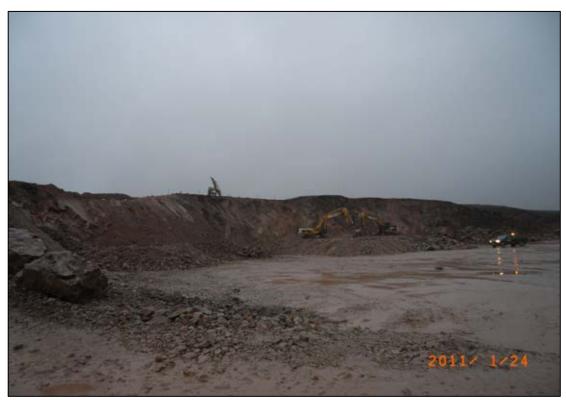
Photo 4 – Borrow Pit BP2 in operational stage showing vertical high wall.

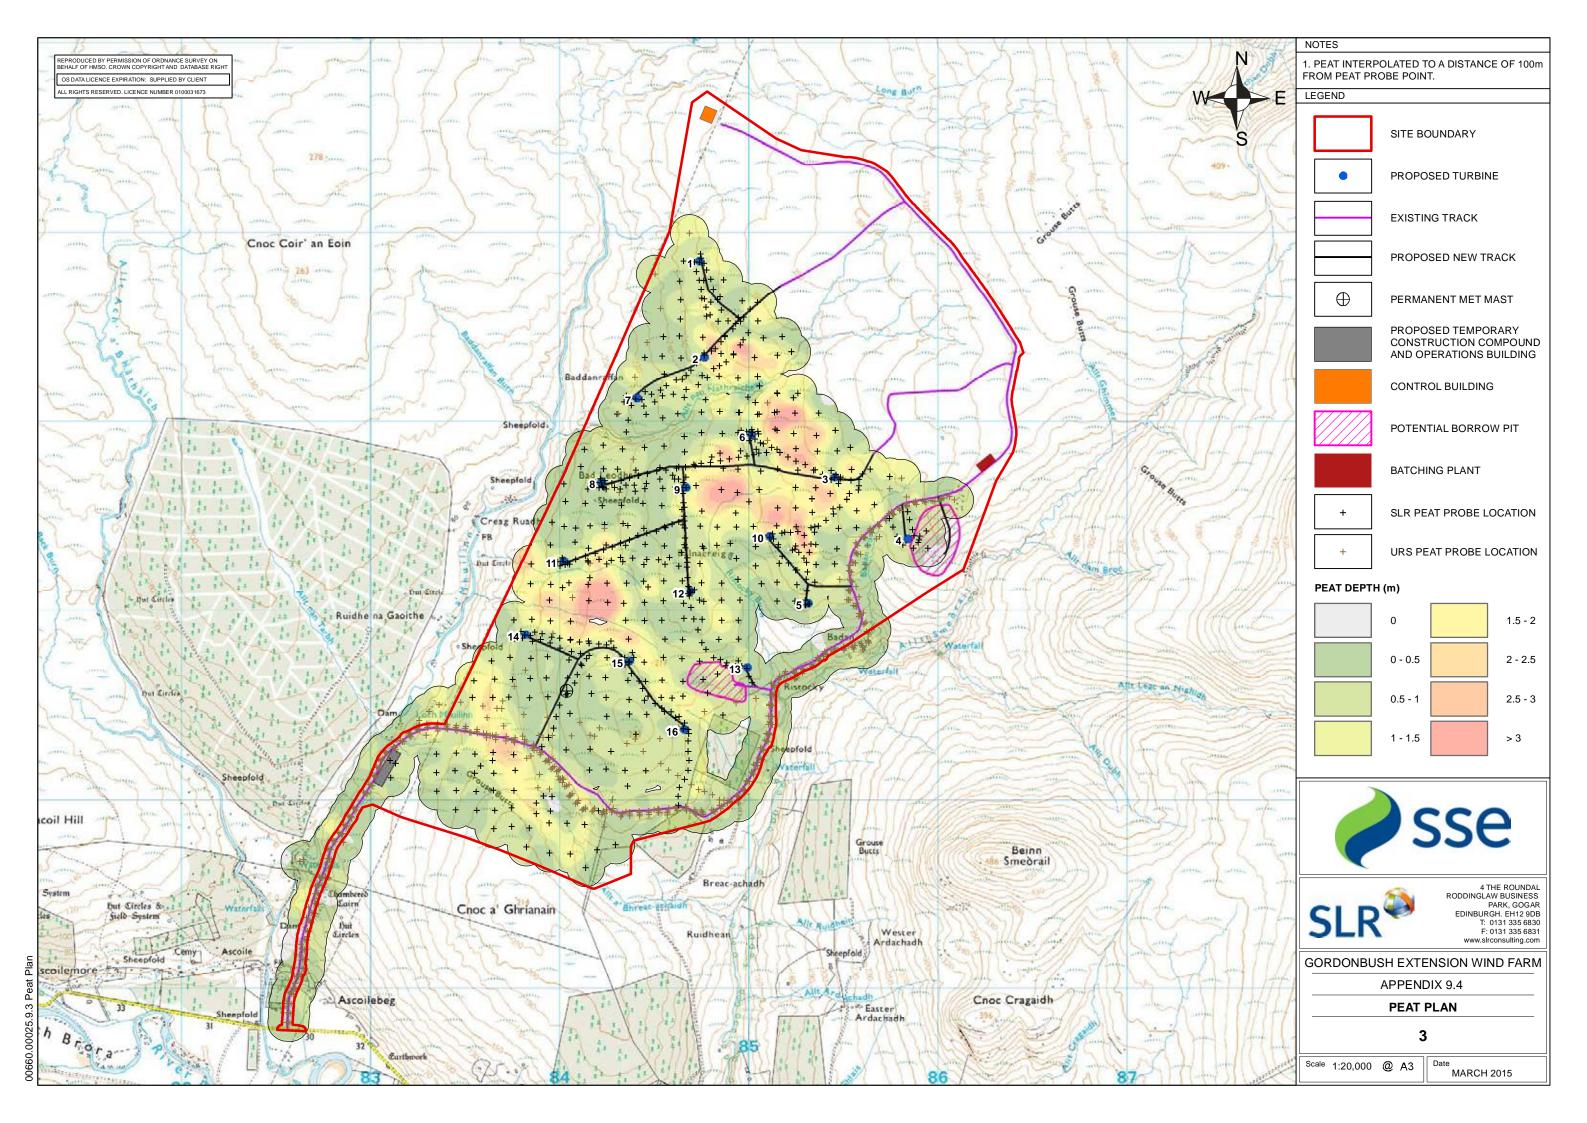
should offer a significant volume of material. The rock comprises primarily psammite. No significant peat cover exists at this location over the virgin excavation area (see Figure 3).

The borrow pit is located on bedrock comprising Kildonan metasedimentary rocks. This borrow pit is the larger of the two. This proposed borrow pit extension is located on shallow bedrock and is situated on the eastern flank of slope and has a suitable profile for maximising extraction from the borrow pit once it is reopened. It is anticipated that once the restoration overburden is removed from the borrow pit, it should offer a significant volume of material and the largest volume of the two borrow pits. The rock comprises psammite. No significant peat cover exists at this location over the virgin excavation area (see Figure 3).

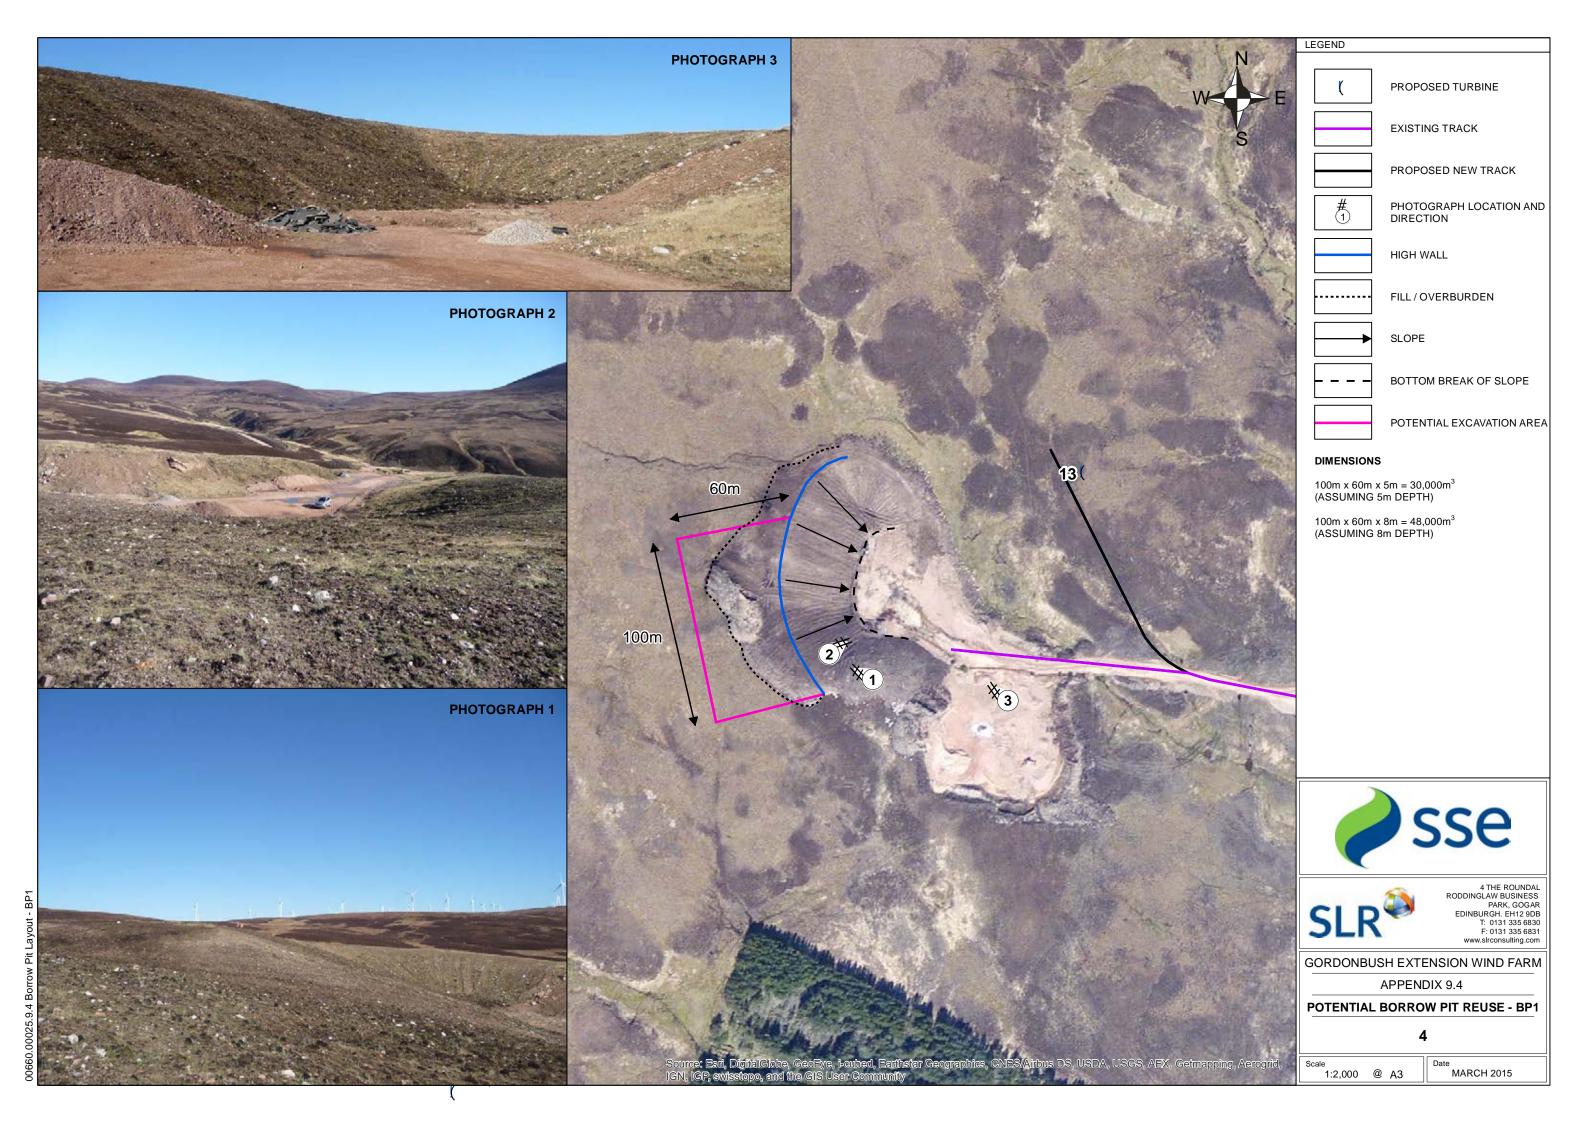
The indicative borrow pit reuse designs are shown in Figures 4 & 5. The indicative borrow pit profiles have been designed to best utilise the borrow pits based on the previous excavation profiles. Following removal of the overburden material, excavation will commence on the historical high wall, continuing the previous excavation operation. A rectangular shaped excavation has been proposed within each of the borrow pits in order to meet the estimated requirements for construction materials. Based upon the indicative borrow pit profiles a total maximum in situ excavation volume of 144,000m³ could be achieved by the two pits combined.

- The footprint area of each excavation is outlined in Figure 4 & 5 for each proposed borrow pit;
- The proposed individual faces do not exceed a gradient of 2 (V) in 1 (H);
- The borrow pit floor is excavated to a nominal depth but would in practice be inclined gently down slope into the pit;
- The maximum height of any single face would be no more than 12.5m; however, based on the current design the maximum total cut will only be ~8m; and
- Drainage would be managed using a peripheral cut off ditch.

Table 3-1: Borrow Pit BP1 (NGR 284827, 912623)		
	Maximum dimensions – Potential Excavation	
Site Area	Area	
	100 m length, 60 m width	
Height of Excavation	8 m maximum	
Area of land impacted*	~6,600 m ²	
Gradient of floor during construction	Slope increases to the east at 1 in 100	
Details of Extraction	Combination of ripping and blasting	
	Restoration soils present from former	
	restoration works. Approximate volume of	
	27,000m ³ to be removed prior to any	
Overburden type and depth	extraction. Within the virgin excavation area	
	of the proposed excavation there is limited	
	soil cover, peaty soil less than ~0.5 m but not	
	an extensive cover.	
Extent of Aggregate Extraction	An approximate volume of 48,000m ³ of rock	
Extent of Aggregate Extraction	depending on excavation depth.	
Aggregate Composition	These rocks are described as psammite.
