Technical Appendix 8.2B: Vegetation Survey of Proposed Turbine Locations Survey Report for Achany Extension

Alba Ecology Ltd.

June 2021

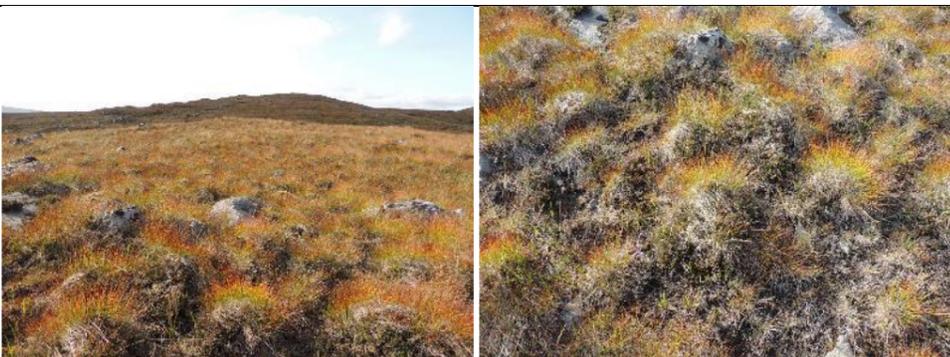
Turbine	Grid reference	NVC Community	Comment	Photos
T01	NC 45111 11116	M15c	<p>Vegetation: Rocky and species poor deergrass dominated M15c.</p> <p>Moss layer: Little to no bog-mosses present.</p> <p>Grazing impacts: Deergrass dominance and bare peat patches are likely associated with grazing pressure.</p> <p>Erosion: Micro-erosion features evident as bare peat through open vegetation.</p> <p>Pools: No bog pools present. Ground surface dry.</p> <p>PCA: Modified.</p> <p>Peatland category: Intermediate.</p> <p>Evidence for peat formation: Area unlikely to be normally peat forming.</p>

Initial design layout as provided on 11/09/20 Additional turbine locations evaluated by Wood (italics)	Grid reference	Decision during Design Workshops	Rationale	Final layout
T01	NC 45108 11121	Further micro-siting	Minor turbine positioning optimisation over wet heath habitat considered unlikely to be normally peat forming.	NC 45164 11083
T02	NC 44607 10839	Further micro-siting	Optimise turbine positioning over wet heath habitat considered unlikely to be normally peat forming, minimising potential impact to small area of blanket bog.	NC 44595 10950
T02 - Option	NC 44550 10839	Removal	Removal due to presence of M19 and M17a, considered unlikely to be normally peat forming.	
T03	NC 45656 10892	Removal	Removal due to presence of M17a blanket bog considered to be partially active.	
<i>T03 - Option</i>	<i>NC 45618 10923</i>	Further micro-siting	Optimise turbine positioning over wet heath and marshy grassland, minimising impact to blanket bog in an area unlikely to be normally peat forming.	NC 45618 10922

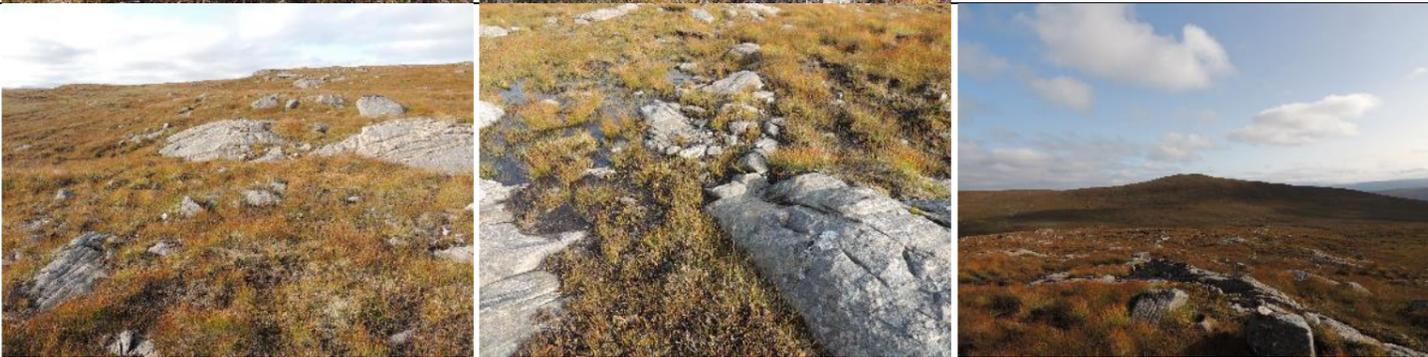
T02	NC 44613 10841	M15c	<p>Vegetation: Rocky and species poor deergrass dominated M15c.</p> <p>Moss layer: Little to no bog-mosses present.</p> <p>Grazing impacts: Deergrass dominance and bare peat patches are likely associated with grazing pressure.</p> <p>Erosion: Micro-erosion features evident as bare peat through open vegetation.</p> <p>Pools: No bog pools present. Occasional surface water over peat.</p> <p>PCA: Modified.</p> <p>Peatland category: Intermediate.</p> <p>Evidence for peat formation: Area unlikely to be normally peat forming.</p>

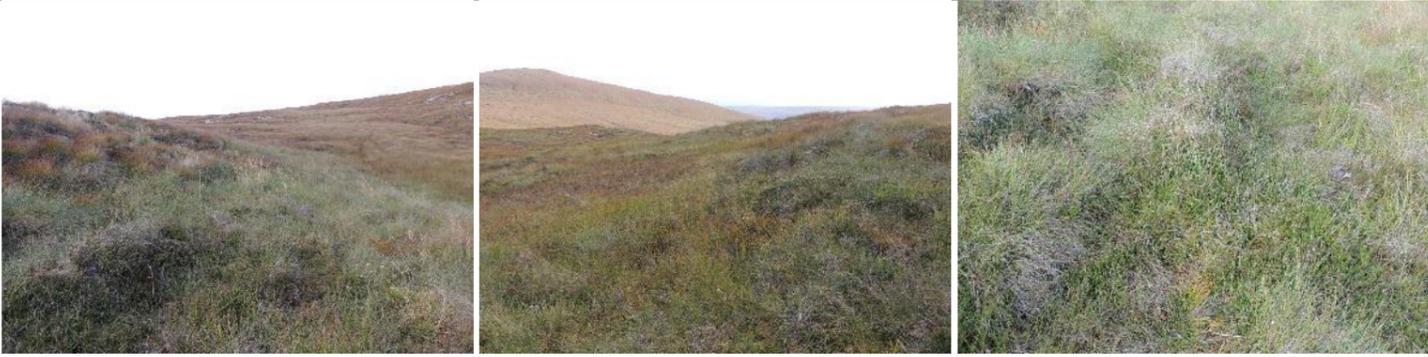
T02 – Option	NC 44549 10836	M19 on a slope. M15c beside it.	<p>Vegetation: A very small patch of M19 on a small slope. It was adjacent to an area of M15c on higher ground. Below the slope there was M25a and M17a in small valley. The M19 patch was dominated by hare’s-tail cottongrass with heather abundant.</p> <p>Moss layer: Red bog-moss and feather mosses were present.</p> <p>Grazing impacts: Heather and hare’s tail-cottongrass dominance likely associated with grazing pressure.</p> <p>Erosion: No evidence of erosion features in this patch.</p> <p>Pools: No bog pools present.</p> <p>PCA: Modified.</p> <p>Peatland category: Intermediate.</p> <p>Evidence for peat formation: There were no hummocks and hollows present, and no bog pools present. Surface water was not a feature. Area unlikely to be normally peat forming.</p>

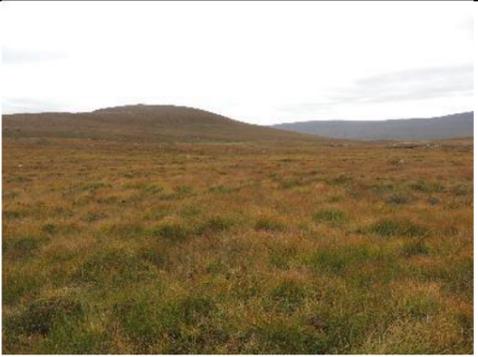
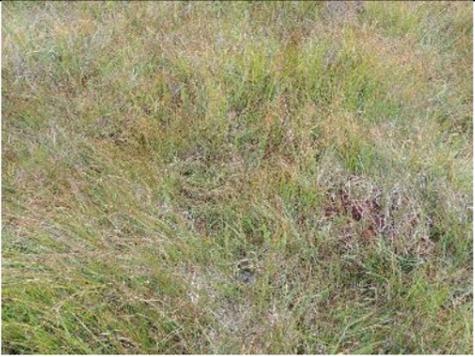
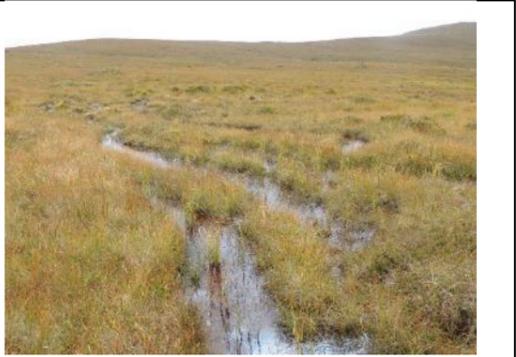
T03 was on marshy grassland M25a community, a community associated with riparian habitats.

T03	NC 45653 10891	M25a, beside M17a	<p>Vegetation: On a patch of M25a dominated by purple moor-grass with a little cross-leaved heath. To one side there was M15c, the other side was M17a but likely on fairly shallow peat as some rocks were evident.</p> <p>Moss layer: Wet bog-mosses were not in hummocks, but formed a partial carpet.</p> <p>Grazing impacts: Dung was evident in the vegetation.</p> <p>Erosion: No erosion features in this patch.</p> <p>Pools: There were some elongated pools with bottle sedge in them. The area was generally wet.</p> <p>PCA: Modified.</p> <p>Peatland category: Intermediate.</p> <p>Evidence for peat formation: Surface water was a feature and there was a partial carpet of bog-mosses. The area may have been partially active.</p>

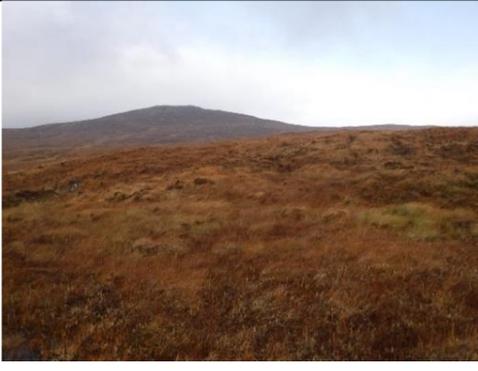
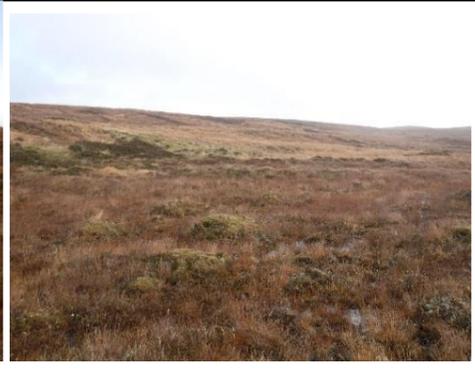
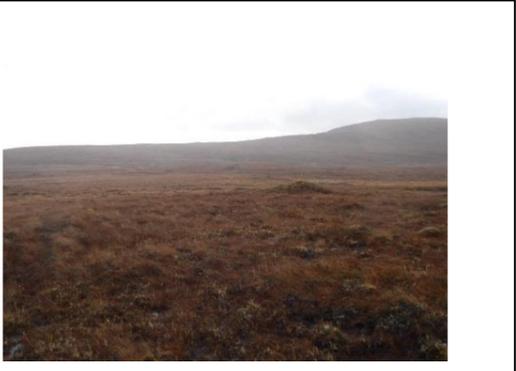
T03 – Option (completed by Wood, October 2020)	NC 45618 10923	M15c	<p>Vegetation: On wet heath adjacent to a patch of M25a dominated by purple moor-grass with a little cross-leaved heath. On fairly shallow peat as some rocks were evident.</p> <p>Moss layer: Little to no bog-mosses present.</p> <p>Grazing impacts: Dung was evident in the vegetation.</p> <p>Erosion: Occasional micro-erosion features present.</p> <p>Pools: No bog pools present. Occasional surface water over peat.</p> <p>PCA: Modified.</p> <p>Peatland category: Intermediate.</p> <p>Evidence for peat formation: Area unlikely to be normally peat forming.</p>

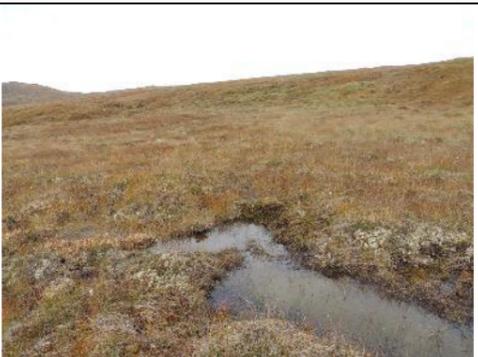
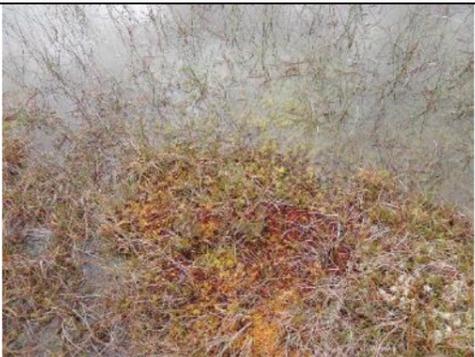
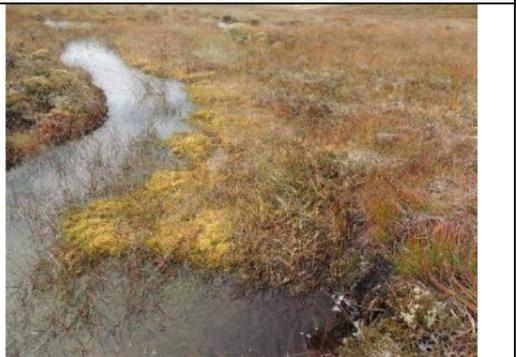
It was considered that much of the blanket bog was unlikely to be actively forming peat. However, some of the blanket bog, e.g. the M17a blanket bog, particular at particularly at T04 (original location, now microsited away), T16 and T20, was considered to be better condition and may be partially or actively forming peat.

T04	NC 46135 10678	M17a	<p>Vegetation: The vegetation was M17a with an even mixture of heather, deergrass, purple moor-grass, hare's-tail cottongrass and common cottongrass with round-leaved sundew and bog asphodel.</p> <p>Moss layer: Papillose and red bog-mosses were frequent to abundant, but not a complete carpet. Low hummocks and lawn developed around M2a pools.</p> <p>Grazing impacts: Grazing impacts were low.</p> <p>Erosion: Some old erosion features nearby and some patches of bare peat in the vegetation.</p> <p>Pools: M2a pools with feathery bog-moss. Small lawns of bog-mosses around pools with a variety of species including magellanic bog-moss. Round-leaved and great sundews present.</p> <p>PCA: Near Natural</p> <p>Peatland category: Good.</p> <p>Evidence for peat formation: Bog-mosses were abundant in places. Low hummock formation and lawns around bog pools. The areas was wet with surface water. Area likely to be active forming peat.</p>

T04	NC 46140 10678	Removal	Removal due to presence of near natural blanket bog, an area likely to be active forming peat.	
<i>T04 - Option</i>	<i>NC 45979 10739</i>	No change	Optimise turbine positioning over wet heath, minimising impact to blanket bog and avoidance of near natural blanket bog. Sited in an area unlikely to be normally peat-forming.	NC 45980 10740
T05	NC 44780 10490	Further micro-siting	Optimise turbine positioning over wet heath, minimising impact to blanket bog. Sited in an area unlikely to be normally peat forming.	NC 44768 10506
T06	NC 46023 10241	No change	Optimise turbine positioning within area of blanket bog (M19) considered unlikely to be normally peat forming; surrounding M17b blanket bog identified through PCA as modified/drained/actively eroding.	NC 46023 10241
T07	NC 45487 10137	Further micro-siting	Optimise turbine positioning over wet heath and lower quality blanket bog (identified through the PCA as modified/drained/actively eroding), minimising impact to area of M17a where peat formation was considered possible.	NC 45495 10095

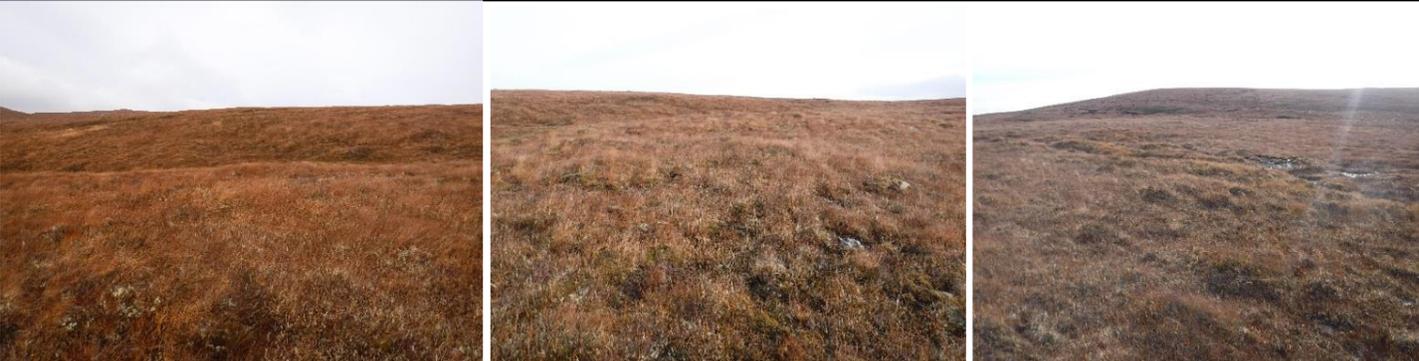
<p>T04 – Option (completed by Wood, October 2020)</p>	<p>NC 45979 10739</p>	<p>M15c</p>	<p>Vegetation: Rocky and species poor deergrass dominated M15c. Moss layer: Little to no bog-mosses present. Grazing impacts: Deergrass dominance and bare peat patches are likely associated with grazing pressure. Erosion: Micro-erosion evident as bare peat through open vegetation. Pools: Water pooling on thin peat and rocky areas. PCA: Modified Peatland category: Intermediate- bad. Evidence for peat formation: Area unlikely to be normally peat-forming</p>

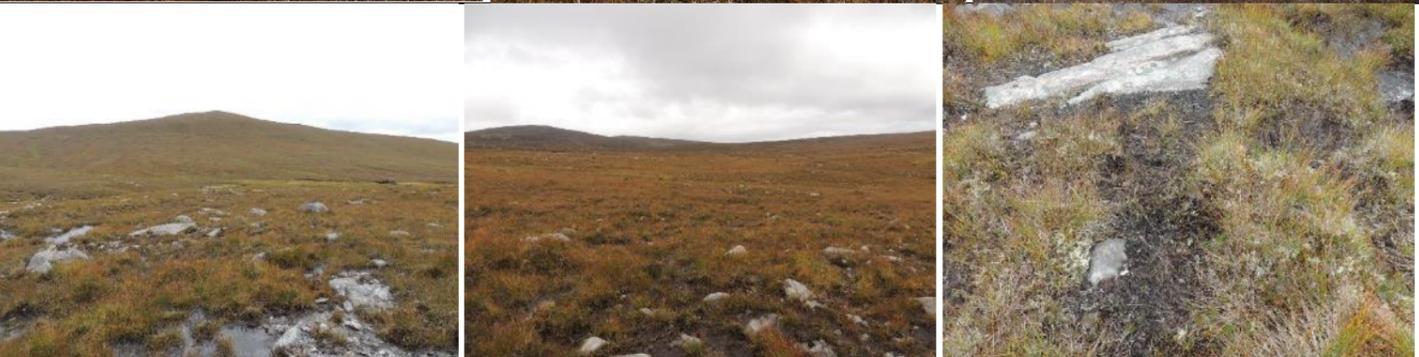
<p>T05</p>	<p>NC 44785 10482</p>	<p>M15c</p>	<p>Vegetation: Rocky and species poor deergrass dominated M15c. Moss layer: Little to no bog-mosses present. Grazing impacts: Deergrass dominance and bare peat patches are likely associated with grazing pressure. Erosion: Micro-erosion evident as bare peat through open vegetation. Pools: Water pooling on thin peat and rocky areas. PCA: Modified. Peatland category: Intermediate-bad. Evidence for peat formation: Area unlikely to be normally peat forming.</p>

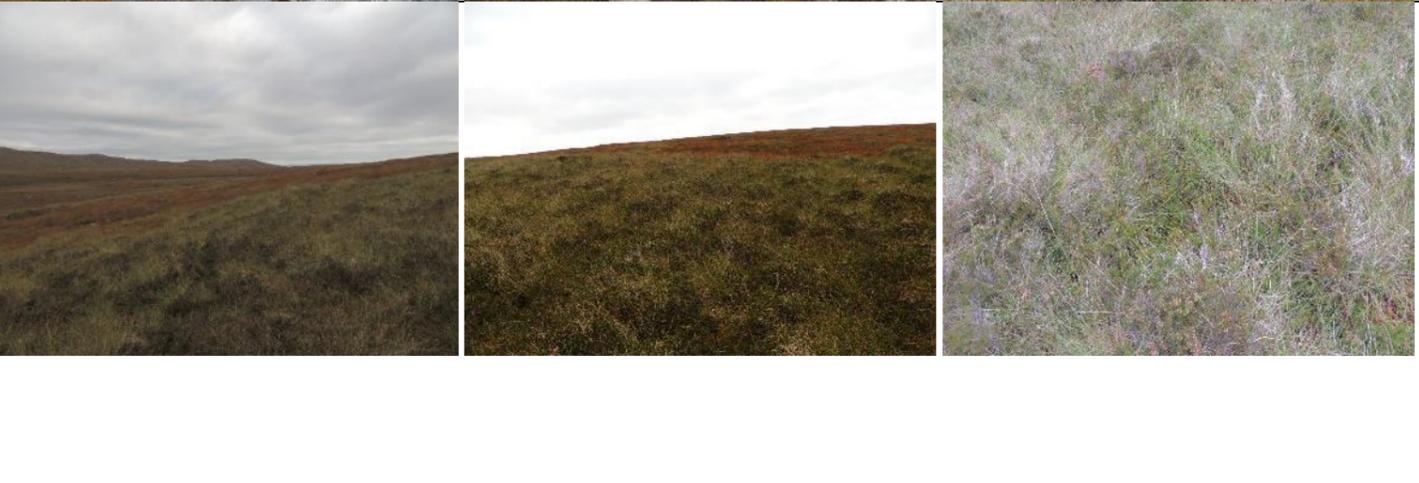
<p>T06</p>	<p>NC 46019 10242</p>	<p>M19</p>	<p>Vegetation: On a patch of M19. The wider hill slope was of M17b. The M19 included hare's-tail cottongrass, tussocks of heather with crowberry and some patches of red bog-moss and glittering wood-moss. Moss layer: Patches of red bog-moss and feather mosses between hare's-tail cottongrass tussocks. Grazing impacts: Vegetation type may be associated with grazing pressure. Erosion: No obvious erosion features. Pools: There were no hummocks or hollows present and no bog pool communities. Surface water was not a feature. PCA: Modified. Peatland category: Intermediate. Evidence for peat formation: The area had patchy bog-moss cover and was not very wet underfoot. Area unlikely to be normally peat forming.</p>

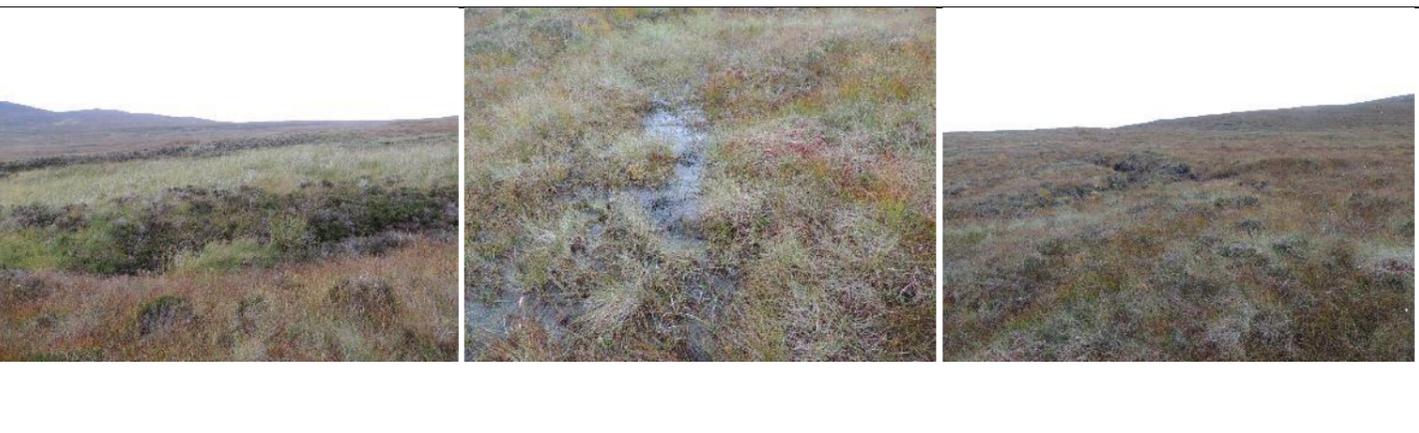
<p>T07</p>	<p>NC 45481 10136</p>	<p>M17a</p>	<p>Vegetation: This location was characterised by M17a blanket bog. It was beside a M6c flush with moving water. The flush was within a patch of M19 blanket bog. Moss layer: It was wet underfoot with bog-mosses present, although not forming a complete carpet. Grazing impacts: Hoof prints seen in the vegetation. Bare peat patches likely from grazing pressure. Erosion: There were bare peat patches within the vegetation and an old erosion feature nearby. Pools: The M17a did not have many bog pools within it. PCA: Modified. Peatland category: Intermediate. Evidence for peat formation: The area had patchy bog-moss cover and was fairly wet underfoot with a little surface water. Peat formation possible.</p>

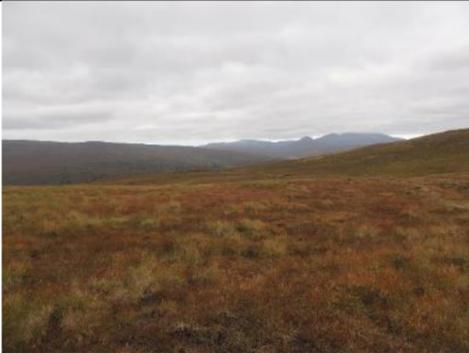
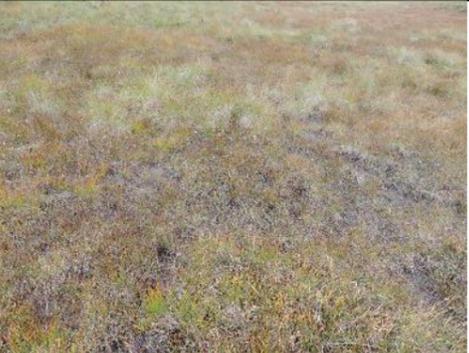
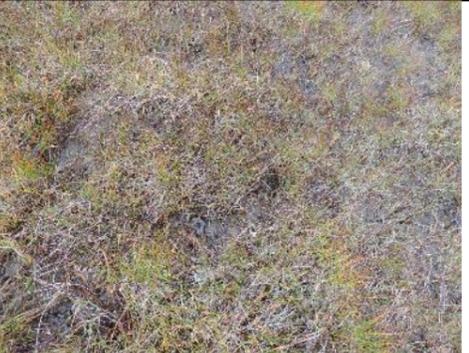
T08	NC 44869 10012	M17/M15c	<p>Vegetation: On a patch of blanket bog that was at a transitional point between M15c and M17. There was some M19 beside it. Hare's-tail cottongrass was only occasional.</p> <p>Moss layer: Some bog-mosses present in a depleted layer.</p> <p>Grazing impacts: Hoof prints and dung were common. Bare peat patches were likely from grazing pressure.</p> <p>Erosion: Micro-erosion features were evident with many bare peat patches.</p> <p>Pools: There were no hummocks and hollows. No pools.</p> <p>PCA: Modified.</p> <p>Peatland category: Intermediate.</p> <p>Evidence for peat formation: The vegetation surface was fairly dry with few bog-mosses present. The area was unlikely to be normally peat forming.</p>

T08	NC 44872 10018	No change	Optimise turbine positioning minimising impact to a transitional wet heath/blanket bog habitat considered unlikely to be normally peat forming.	NC 44872 10018

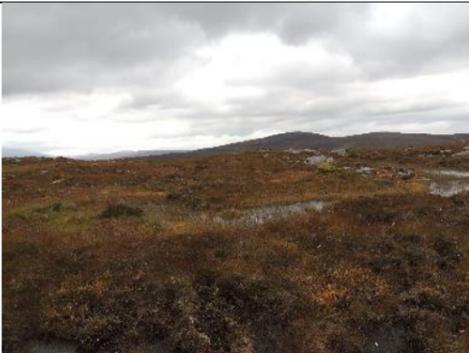
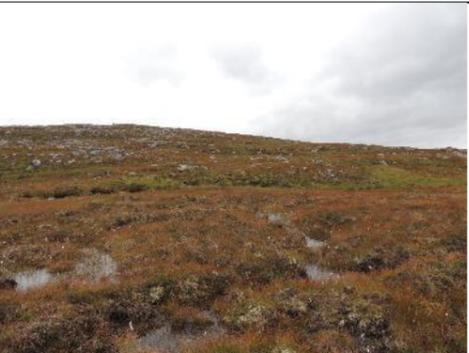
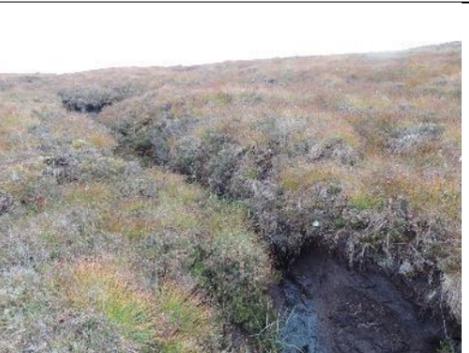
T09	NC 45563 09700	M17b	<p>Vegetation: This area was M17b blanket bog with many M3 pools on a flat bit of ground between areas of M15c.</p> <p>Moss layer: Some bog-mosses present in a depleted layer.</p> <p>Grazing impacts: Hoof marks and dung was common. Bare peat patches were likely from grazing pressure.</p> <p>Erosion: Bare peat patches evident in the vegetation as micro-erosion features. There were some small erosion features that were likely to be actively eroding.</p> <p>Pools: M3 pools and surface water evident. Hummocks and hollows poorly developed.</p> <p>PCA: Modified and actively eroding.</p> <p>Peatland category: Intermediate-bad.</p> <p>Evidence for peat formation: The area was wet, but there was a depleted bog-moss layer. Unlikely to be normally peat forming, but some possible.</p>

T09	NC 45566 09700	Removal	Removal due to presence of M17b blanket bog considered unlikely to be normally peat forming, but some possible.	
T09 - Option	NC 45597 09765	No change	Optimise turbine positioning over wet heath minimising impact to blanket bog, in an area unlikely to be normally peat forming.	NC 45597 09695
T10	NC 46198 09516	No change	Minor turbine positioning optimisation in an area considered unlikely to be normally peat forming.	NC 46198 09516
T11	NC 46722 09421	No change	Minor turbine positioning optimisation in an area considered unlikely to be normally peat forming.	NC 46722 09421
T12	NC 46915 08855	No change	Minor turbine positioning optimisation in an area considered unlikely to be actively peat forming.	NC 46915 08855
T13	NC 46390 09004	No change	Minor turbine positioning optimisation in an area considered unlikely to be normally peat forming.	NC 46390 09004
T14	NC 45674 08931	Removal	Removal due to combination of potential pockets of deeper peat and wetter conditions.

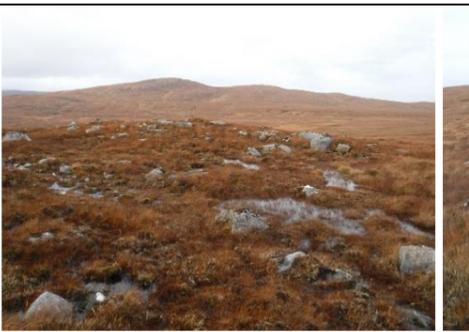
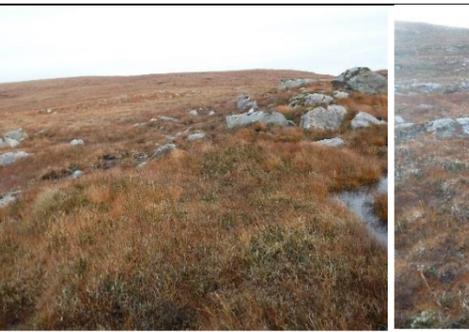
T09 - Option (completed by Wood, October 2020)	NC 45597 09765	M15c	<p>Vegetation: Rocky and species poor deergrass dominated M15c.</p> <p>Moss layer: Little to no bog-mosses present.</p> <p>Grazing impacts: Deergrass dominance and bare peat patches are likely associated with grazing pressure.</p> <p>Erosion: Micro-erosion features evident as bare peat through open vegetation.</p> <p>Pools: No bog pools present. Occasional surface water over peat.</p> <p>PCA: Modified.</p> <p>Peatland category: Intermediate.</p> <p>Evidence for peat formation: Area unlikely to be normally peat forming.</p>

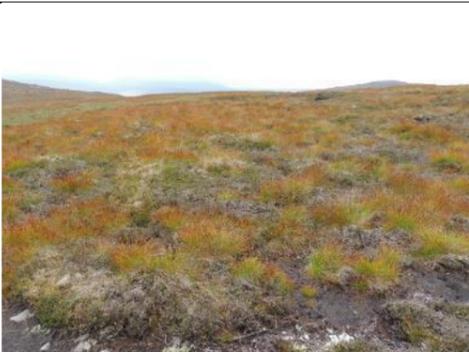
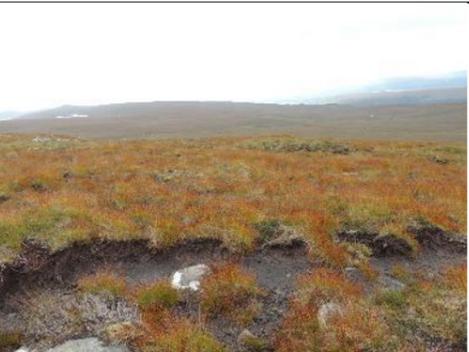
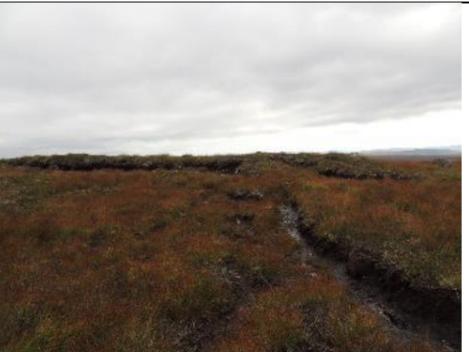
T10	NC 46198 09523	M15c	<p>Vegetation: Rocky and species poor deergrass dominated M15c.</p> <p>Moss layer: Little to no bog-mosses present.</p> <p>Grazing impacts: Deergrass dominance and bare peat patches are likely associated with grazing pressure.</p> <p>Erosion: Micro-erosion features evident as bare peat through open vegetation. Small erosion features also present.</p> <p>Pools: No bog pools present. Ground surface dry.</p> <p>PCA: Modified.</p> <p>Peatland category: Intermediate.</p> <p>Evidence for peat formation: Area unlikely to be normally peat forming.</p>

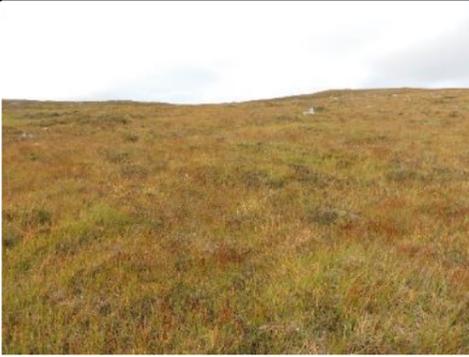
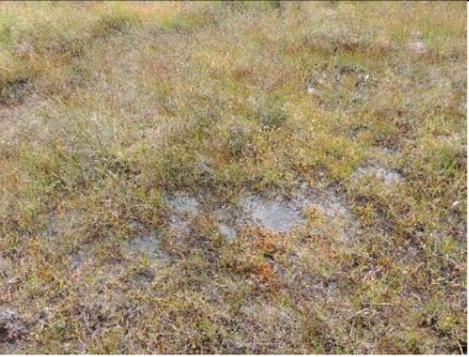
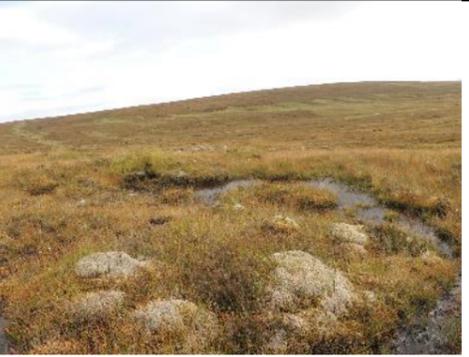
T11	NC 46713 09427	M15c	<p>Vegetation: A slope of rocky M15c with good cover of vegetation and a more even mix of species rather than deergrass dominated. Bog asphodel was common. There was some M25a and trickling water nearby.</p> <p>Moss layer: Some hummocks of woolly fringe moss beside M25a.</p> <p>Grazing impacts: Hoof prints were seen in the vegetation.</p> <p>Erosion: Small patches of micro-erosion features evident.</p> <p>Pools: There were several small pools.</p> <p>PCA: Modified.</p> <p>Peatland category: Intermediate.</p> <p>Evidence for peat formation: Wet area but unlikely to be normally forming peat as few bog-mosses present.</p>

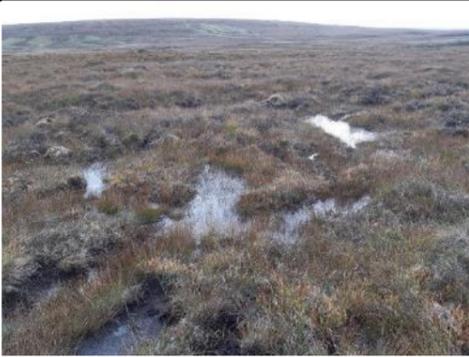
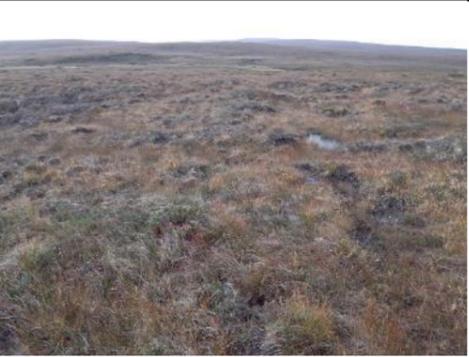
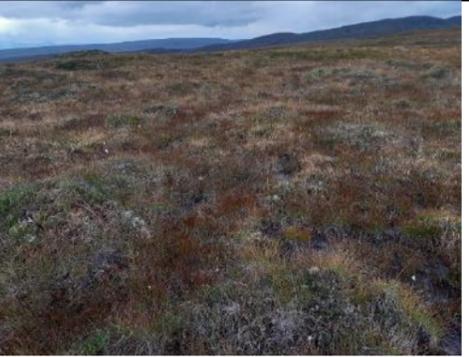
T12	NC 46915 08855	M15c and M17b	<p>Vegetation: A matrix of M17b and M15c. This was generally poor with more M15 present.</p> <p>Moss layer: Patchy, thin moss coverage, with some bare patches of soil.</p> <p>Grazing impacts: Some deer dung noted in this area, along with cropped vegetation.</p> <p>Erosion: Bare patches of peat, though no active erosion channels recorded.</p> <p>Pools: Water recorded pooling in bare areas, however, no bog pools record.</p> <p>PCA: Modified.</p> <p>Peatland category: Intermediate.</p> <p>Evidence for peat formation: While there was some coverage of bog-mosses and surface water, the area is unlikely to be actively peat forming.</p>

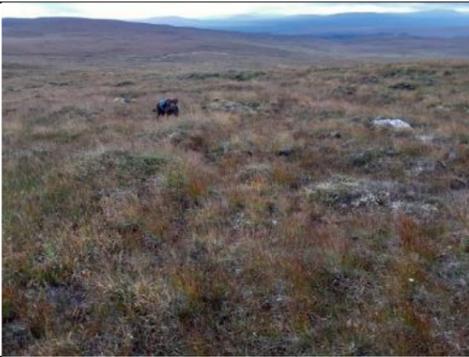
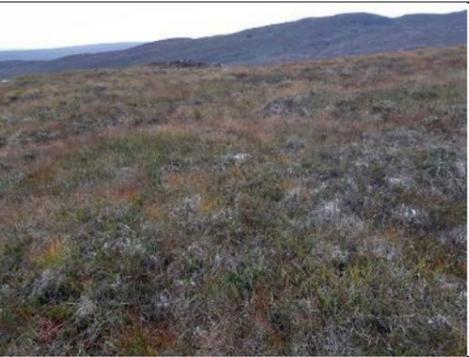
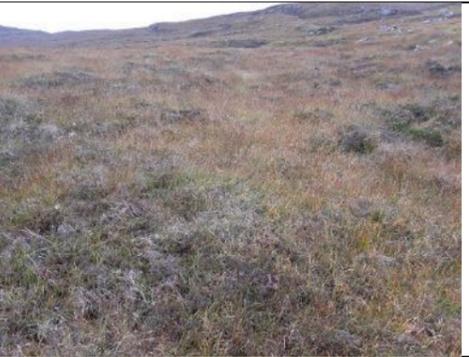
T13	NC 46390 09004	M15c	<p>Vegetation: M15c with bare patches.</p> <p>Moss layer: Little or no bog-mosses present.</p> <p>Grazing impacts: Deergrass dominance and bare peat patches are likely associated with grazing pressure. Evidence of cropped vegetation recorded.</p> <p>Erosion: Bare patches of peat, though no active erosion channels recorded.</p> <p>Pools: No bog pools recorded.</p> <p>PCA: Modified.</p> <p>Peatland category: Intermediate.</p> <p>Evidence for peat formation: Active peat formation considered unlikely.</p>

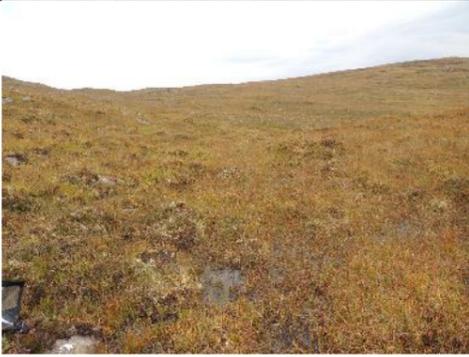
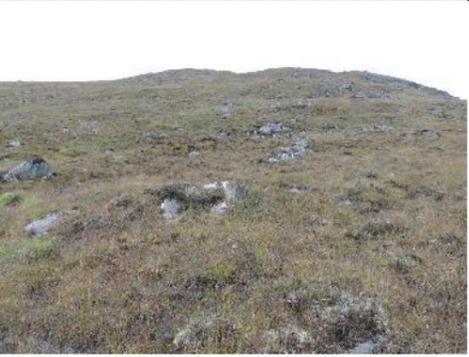
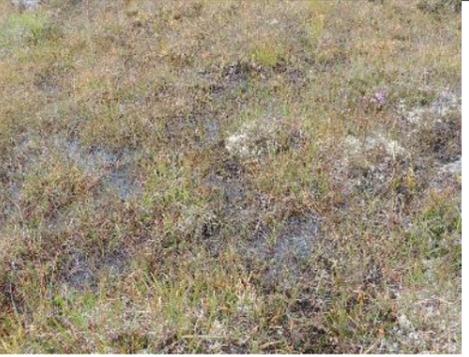
T14	NC 45672 08932	M15c	<p>Vegetation: M15c vegetation but might be small pockets of deeper peat present. Vegetation was open heather, deergrass and purple moor-grass. Bog asphodel was common.</p> <p>Moss layer: Woolly fringe moss was the most common moss. Bog-moss were only occasional.</p> <p>Grazing impacts: Grazing pressure was evident with hoof prints and dung.</p> <p>Erosion: Micro-erosion features were evident as small patches of bare peat.</p> <p>Pools: One pool at location with bog-mosses present.</p> <p>PCA: Modified.</p> <p>Peatland category: Intermediate.</p> <p>Evidence for peat formation: Fairly wet area but unlikely to be normally forming peat as few bog-mosses present.</p>

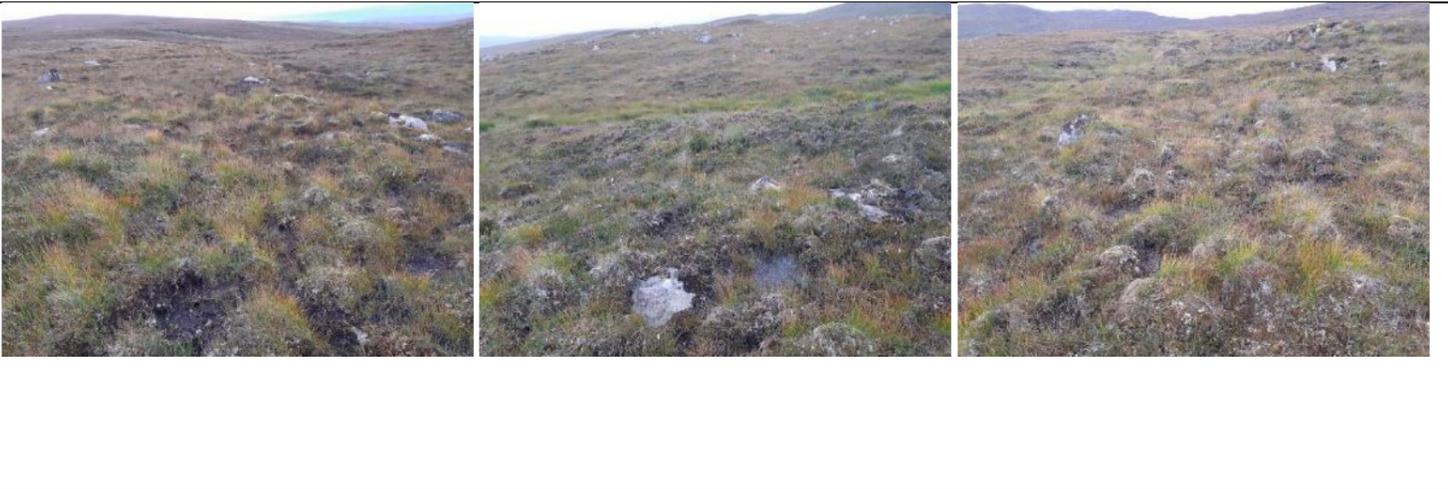
<p>T15</p>	<p>NC 46365 08448</p>	<p>M15c</p>	<p>Vegetation: M15c, with sparse coverage and several open bare areas. Area of M25a recorded roughly 10m from the GPS turbine location (visible as lighter green strip in second photo). Moss layer: Bog-mosses only present in small patches, and was thin where recorded. Grazing impacts: Hoof prints present. Deergrass dominance and bare peat patches are likely associated with grazing pressure. Erosion: Micro-erosion features were common. No large erosion features recorded. Pools: No pools recorded. PCA: Modified. Peatland category: Intermediate. Evidence for peat formation: Unlikely to be normally forming peat as few bog-mosses present and no surface water.</p>

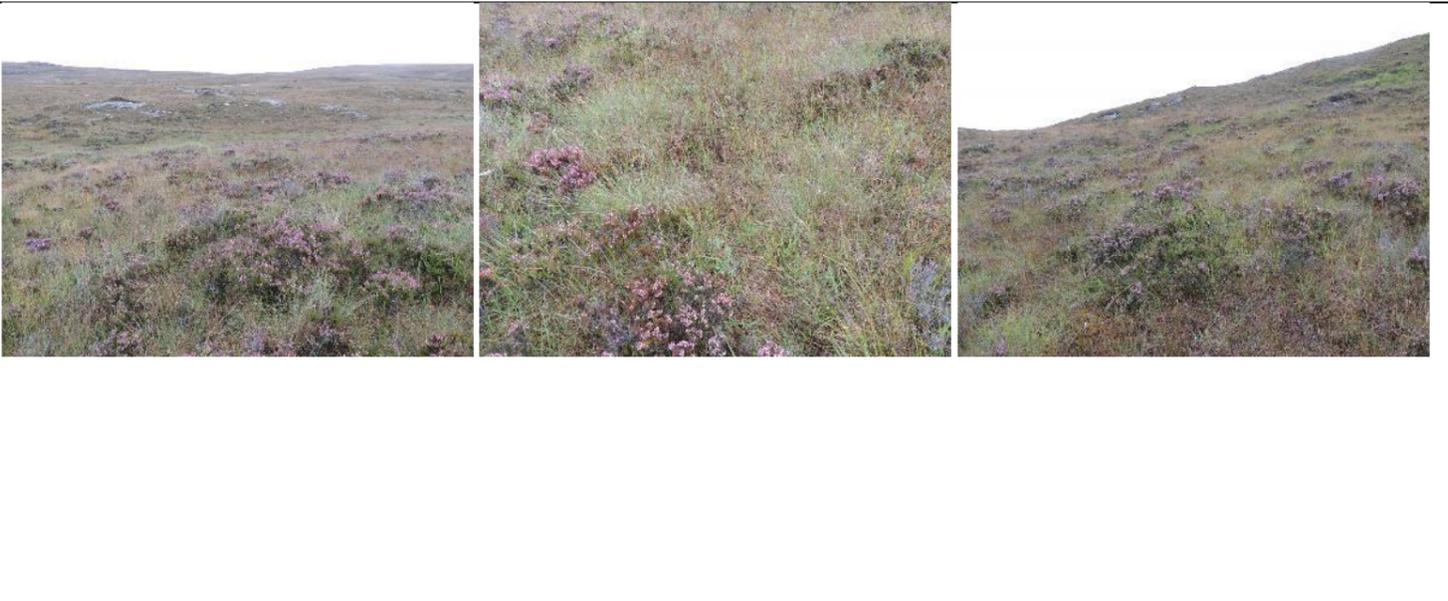
<p>T16</p>	<p>NC 45753 08286</p>	<p>M17a</p>	<p>Vegetation: There was a patch of M17a which extended in a small band to this location within M15c heath on the slopes. There was a fairly even mix of deergrass, purple moor-grass, heather, cross-leaved heath and bog myrtle over bog-mosses with occasional round-leaved sundews. There were tiny patches of M19 (ca. 2x2m). Moss layer: There was a near complete carpet of bog-mosses with a range of species, but no evidence of hummocks. Grazing impacts: Grazing impacts appeared relatively low. Erosion: There was no evidence of erosion at this location. Pools: There were no pools or surface water but it was wet underfoot. PCA: Modified. Peatland category: Intermediate-good. Evidence for peat formation: There was a near complete carpet of bog-mosses but no evidence of hummocks and hollows or surface water. Peat formation possible.</p>

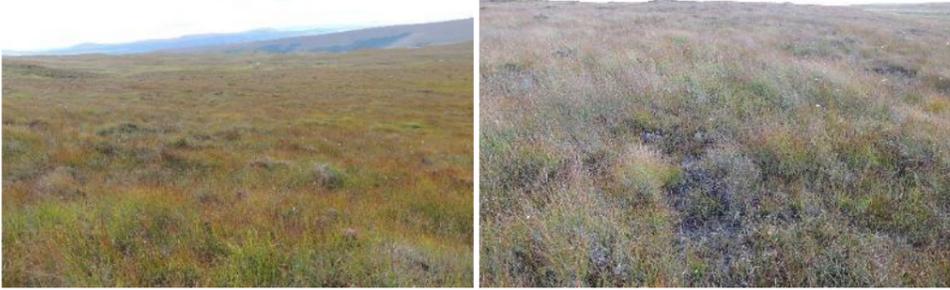
T17	NC 46588 07358	M15c	<p>Vegetation: An area of M15c, which appears to be on shallow peat. The vegetation was slightly taller than elsewhere with a mixture of purple moor-grass, deergrass, common cottongrass, heather and cross-leaved heath. Tormentil and bog asphodel were common. There was occasionally lousewort present. There was a small patch of M25a nearby.</p> <p>Moss layer: Little or no bog-mosses present.</p> <p>Grazing impacts: Grazed with some nibbled stems and bare peat areas with hoof prints.</p> <p>Erosion: Bare peat patches in the vegetation.</p> <p>Pools: No pools present.</p> <p>PCA: Modified.</p> <p>Peatland category: Intermediate.</p> <p>Evidence for peat formation: Unlikely to be normally forming peat.</p>

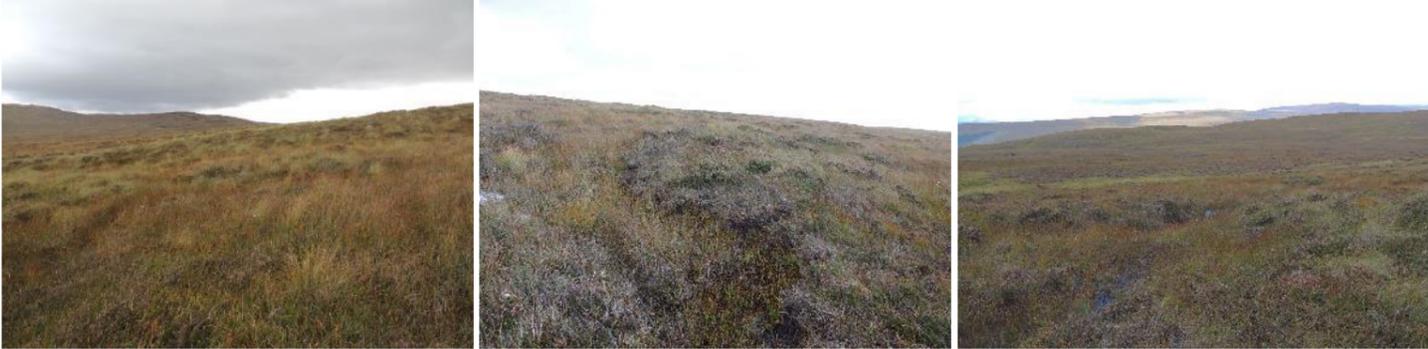
T17 – Option	NC 46566 07472	M15c	<p>Vegetation: M15c where heather, deergrass, purple moor-grass and cross-leaved heath were all evenly abundant. Nearby there was a line of water movement. Possible outflow of groundwater, but no spring head evident. Likely overland flow.</p> <p>Moss layer: There were some limited patches of bog-moss.</p> <p>Grazing impacts: Grazed with some nibbled stems and bare peat areas with hoof prints.</p> <p>Erosion: Micro-erosion features were evident with many small bare patches of peat.</p> <p>Pools: No bog pools were present.</p> <p>PCA: Modified.</p> <p>Peatland category: Intermediate.</p> <p>Evidence for peat formation: Unlikely to be normally forming peat.</p>

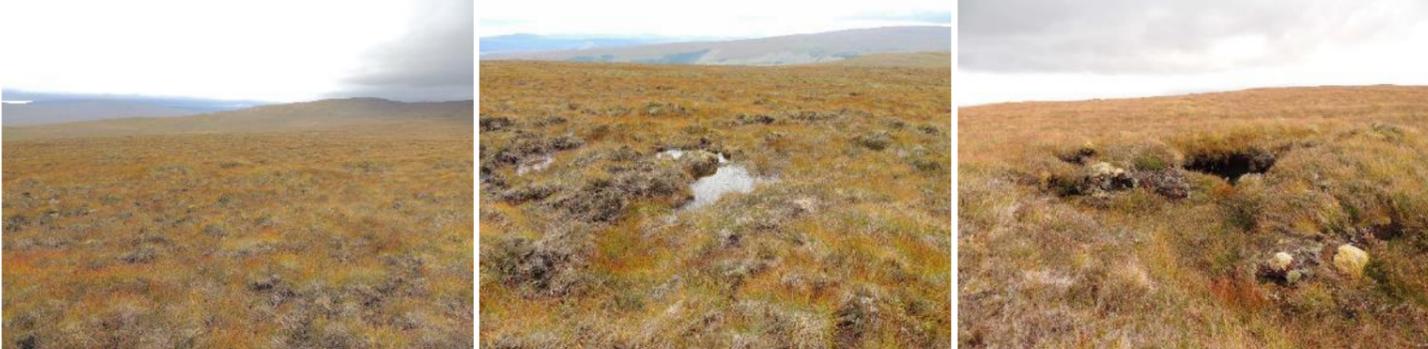
T18	NC 47088 07270	M15c	<p>Vegetation: Species poor deergrass dominated M15c. The peat depth was possibly deeper than 0.5m. Bumpy surface pattern from erosion and deergrass.</p> <p>Moss layer: Little to no bog-mosses present.</p> <p>Grazing impacts: Deergrass dominance is likely associated with grazing pressure.</p> <p>Erosion: Micro-erosion features evident as bare peat through open vegetation.</p> <p>Pools: Occasional pools, including one by turbine location.</p> <p>PCA: Modified.</p> <p>Peatland category: Intermediate.</p> <p>Evidence for peat formation: Area unlikely to be normally peat forming.</p>

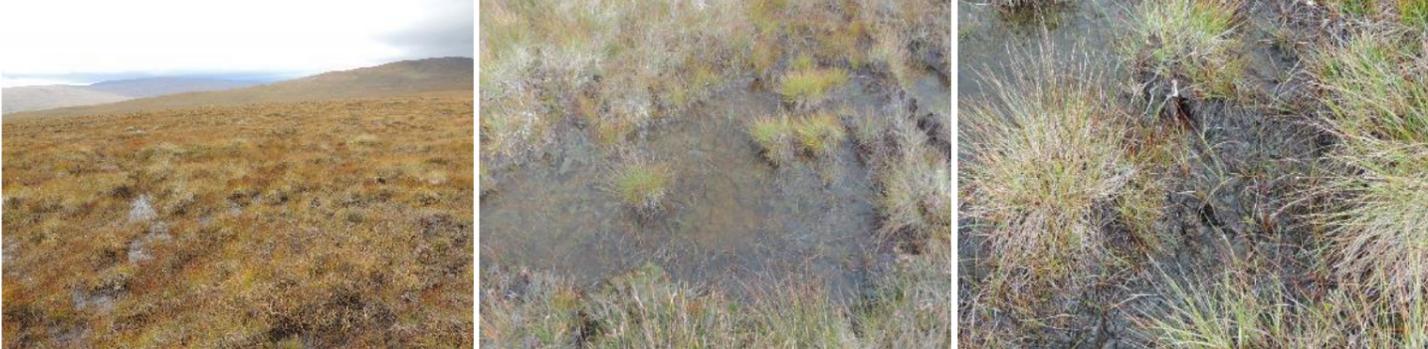
T18 - Option	NC 47028 07290	M15c	<p>Vegetation: This location was species poor, deergrass dominated, M15c but it was likely over deep peat (>0.5m). It had very little hare's tail-cottongrass.</p> <p>Moss layer: Little to no bog-mosses present.</p> <p>Grazing impacts: Deergrass dominance is likely associated with grazing pressure. Hoof prints were common.</p> <p>Erosion: Micro-erosion features evident as bare peat through open vegetation.</p> <p>Pools: Surface water was puddling in bare peat patches.</p> <p>PCA: Modified.</p> <p>Peatland category: Intermediate.</p> <p>Evidence for peat formation: Area unlikely to be normally peat forming.</p>

T18 – Option	NC 47025 07297	Removal	Removal due to the presence of species poor wet heath considered likely to be over deep peat.	
T19	NC 46860 06752	Further micro-siting	Optimise turbine positioning over an area of M15:M17 transitional habitat, considered unlikely to be normally peat forming.	NC 46838 06821
T20	NC 47531 06835	Further micro-siting	Optimise turbine positioning in order to avoid the area of M17a with elements of Near Natural habitat were considered present and some peat formation was likely. Sited onto transitional M15:M17 with presence of drainage ditches nearby.	NC 47468 06810

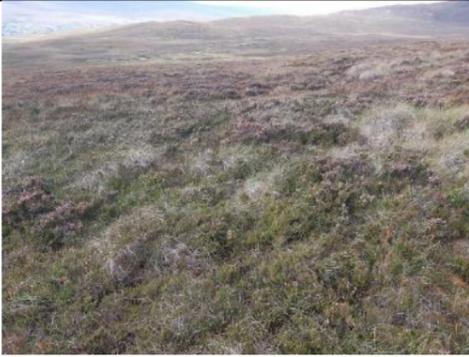
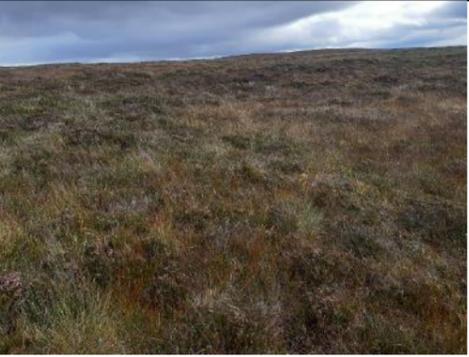
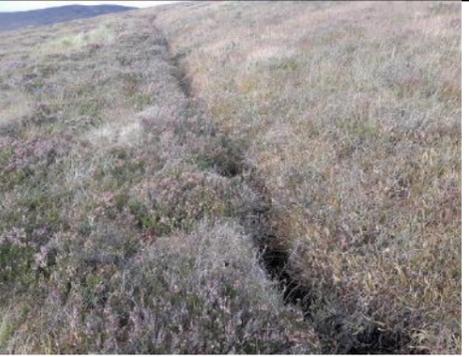
T19	NC 46860 06752	M15/M17	<p>Vegetation: A transition of M15/M17, though this particular area tended more towards M17.</p> <p>Moss layer: Bog-moss coverage was patchy, though could be somewhat thick where it was present.</p> <p>Grazing impacts: Impacts of grazing evident in the form of cropped vegetation and deer dung.</p> <p>Erosion: Several drainage ditches nearby, one of which was a few metres from the location.</p> <p>Pools: No evidence of pooling was recorded.</p> <p>PCA: Modified.</p> <p>Peatland category: Intermediate.</p> <p>Evidence for peat formation: Area unlikely to be normally peat forming.</p>

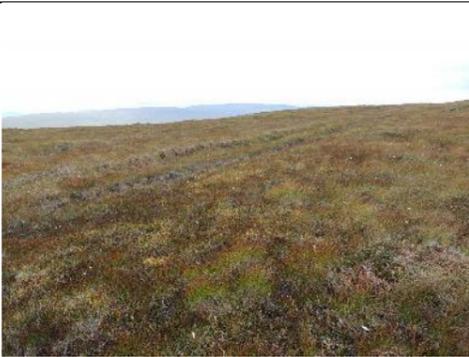
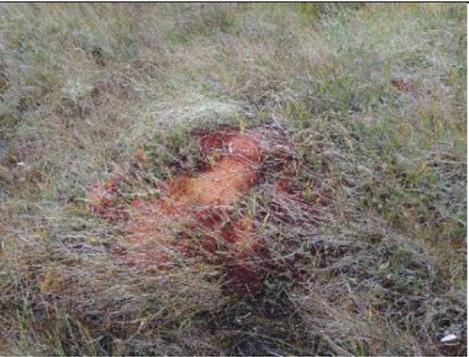
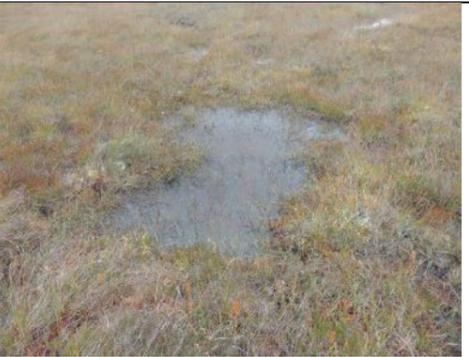
T20	NC 47532 06838	M17a	<p>Vegetation: This area was M17a, with a few M2a pools located nearby. The vegetation was open, with deergrass domain, but a mixture of other species present, including heather, cross-leaved heath, cottongrasses with round-leaved sundews and great sundew present beside the pools.</p> <p>Moss layer: Mostly red bog-moss or bare peat between the vegetation but occasional small bog-moss hummocks, ca. 20cm high including magellanic bog-moss. Bog-mosses were more common around the pools.</p> <p>Grazing impacts: Impacts of grazing evident in the form of cropped vegetation and deer dung.</p> <p>Erosion: Micro-erosion features were evident. There were drainage ditches nearby.</p> <p>Pools: M2a pools present.</p> <p>PCA: Modified and drained, but elements of Near Natural habitat remain.</p> <p>Peatland category: Intermediate-good.</p> <p>Evidence for peat formation: Bog-mosses were present and there were pools and surface water despite drains being nearby. Some peat formation was likely.</p>
