SSE Renewables

Cloiche Wind Farm Additional Information

Technical Appendix 4.5 - Outline
Habitat Management Plan

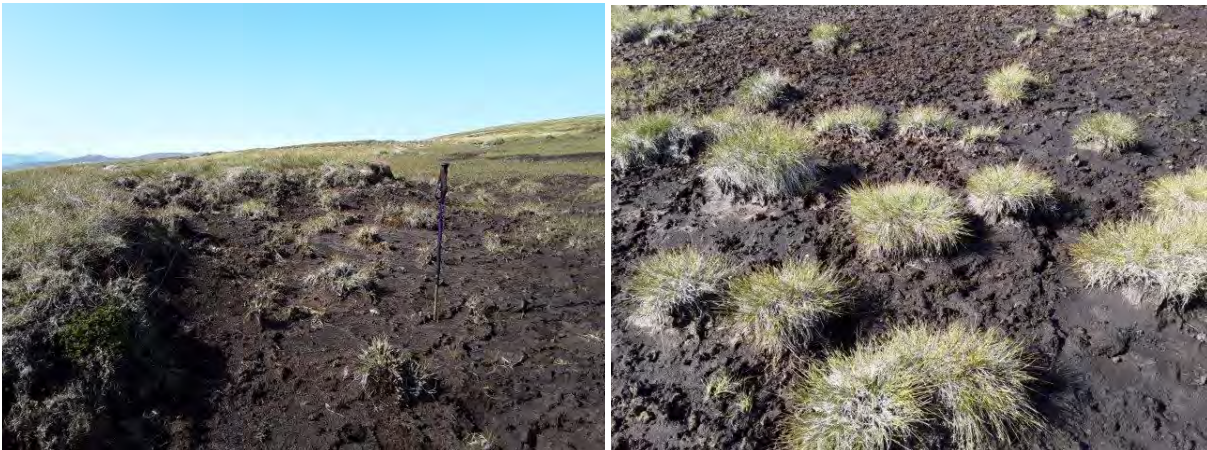
Photo 3.2 and 3.3: Examples of erosion at the edge of the bare peat pans. Photo on the left is an example of an erosion faces around the edge of bare peat pan. The photo on the right is an example of tussocks of hare's-tail cotton-grass with bare peat surrounding them. This was on a gentle slope on the edge of a peat pan.

- 3.1.2 Around the edges of the bare peat pans there were two main types of erosion: erosion hagg faces and tussocks of remaining bog vegetation surrounded by bare peat.

- 3.1.3 Erosion faces at the edge of bare peat pans were generally between c. 0.5m and 1.5m high with little vegetation cover and appeared to be actively eroding, causing the bare peat pans to expand. On gentler slopes, often at the transition to fragments of blanket bog habitat, there were tussocks, appearing to be held in places by the roots of either hare's-tail cotton-grass or deergrass, surrounded by bare peat that was eroding. These areas were clearly actively eroding and expanding into the fragments of remnant blanket bog.

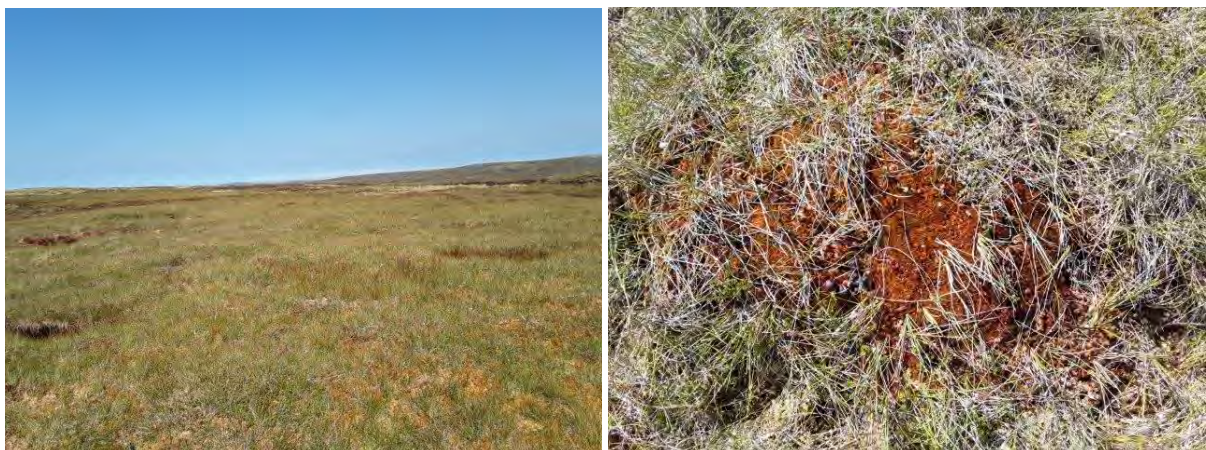
Photo 3.4 and 3.5: A fragment of blanket bog vegetation with bog pools and hummocks of rusty bog-moss.

- 3.1.4 Between the bare peat pans there were fragments of remnant blanket bog habitat. Occasionally these areas were of high-quality blanket bog, with hummocks and hollows present and carpets of bog-mosses, with occasional bog pools with feathery bog-moss. However, the scale of this high-quality blanket bog was very small in comparison to the scale of bare peat pans. Nevertheless, such remnant patches likely indicate what was once probably widespread and also what restoration could aspire to reach in terms of blanket bog habitat condition in some areas.

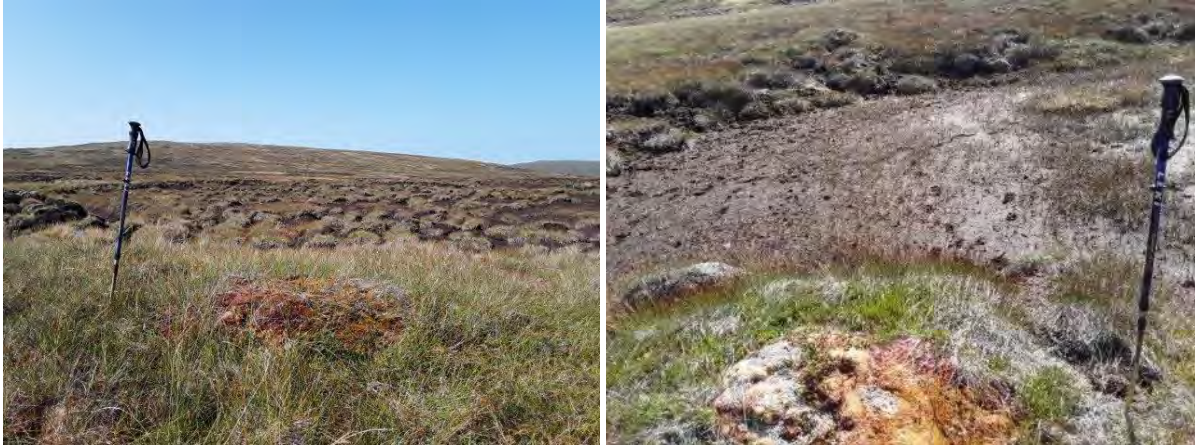
Photo 3.6 and 3.7: Rusty bog-moss hummocks within a few meters of extensive bare peat pans.

- 3.1.5 Several examples were identified in the centre and north of the off-site Search Area where the fragments of remnant bog were very small (e.g. 10m x 30m) (NVC communities M19 and M20). In these fragments there were hummocks of rusty bog-moss very close to bare peat pans.

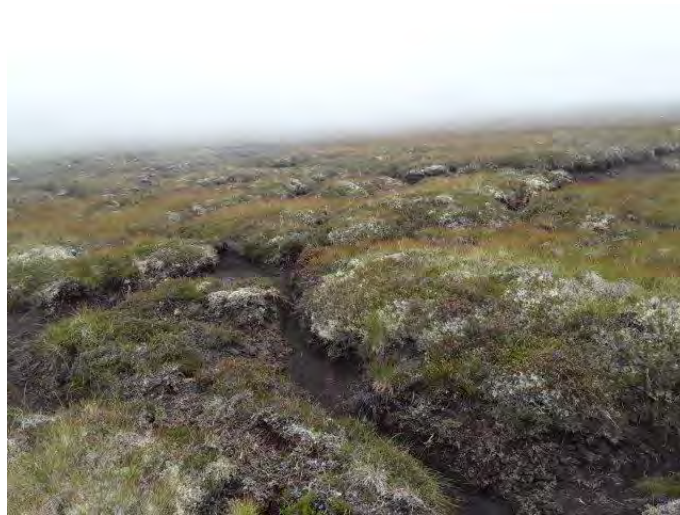
Photo 3.8: A network of erosion gullies within the blanket bog habitat.

- 3.1.6 There were numerous erosion gullies through fairly dry blanket bog habitat within on-site Search Area. These erosion gullies were c.1m deep and 1-2m wide and formed a network of actively eroding peat.

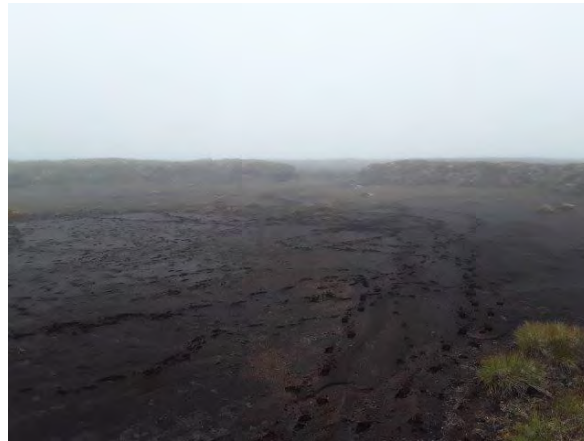
Photo 3.9: A former lochan with a breach in the lochan wall.

- 3.1.7 Drained lochans were identified within the on-site Search Area where lochan walls were found to have eroded at a breach-points and the water had drained away. Blocking and securing the breach point would likely result in the lochan re-wetting. Several other smaller lochans within the immediate vicinity were also identified at risk of being lost through erosion of lochan walls. Peatland restoration around these lochans would ensure they remained.

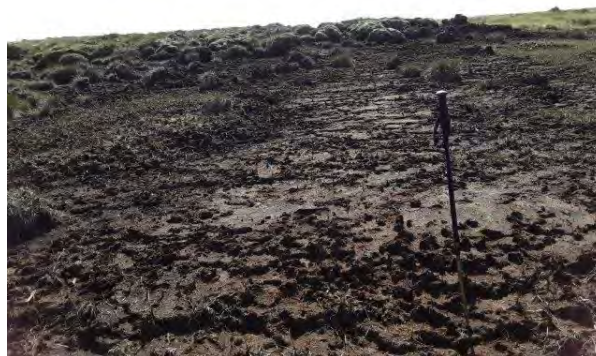
Photo 3.9: A bare peat pan suitable for peatland restoration which forms part of the Monadhliath SAC internationally important blanket bog.

- 3.1.8 Within the internationally important blanket bog of the Monadhliath SAC, there were large expanses of bare peat that were clearly actively eroding. In some areas there was deep peat, demonstrating a large carbon store which is currently being eroded away.

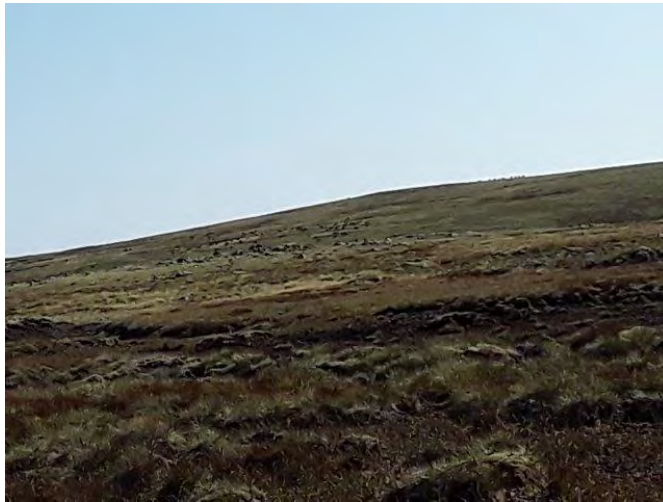
Photo 3.10: c.350 deer on the slopes of Carn Odhar na Criche.

- 3.1.9 There was widespread evidence of deer across the Search Areas. This included hoof marks and deer trails clearly visible in the bare peat. Deer were regularly seen during the site visit including a large, dispersed herd of up to 350 head of red deer seen on the lower slopes of Carn Odhar na Criche within the off-site Search Area. It was considered highly likely that impacts from deer were a significant causal factor of the widespread erosion, particularly within the off-site Search Area. Combined with the cold climate and short growing season associated with the high altitude within the search areas, natural re-colonisation and the ability of the blanket bog to recover from the impacts of deer at these densities is likely to be severely limited.

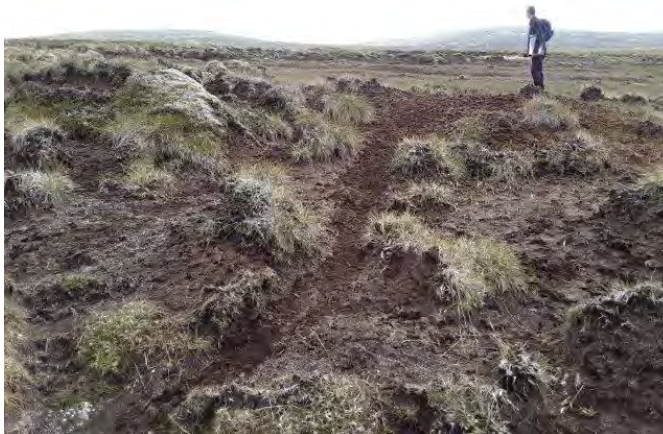
Photo 3.11: A recent deer trail in bare peat between tussocks of hare's-tail cotton-grass.

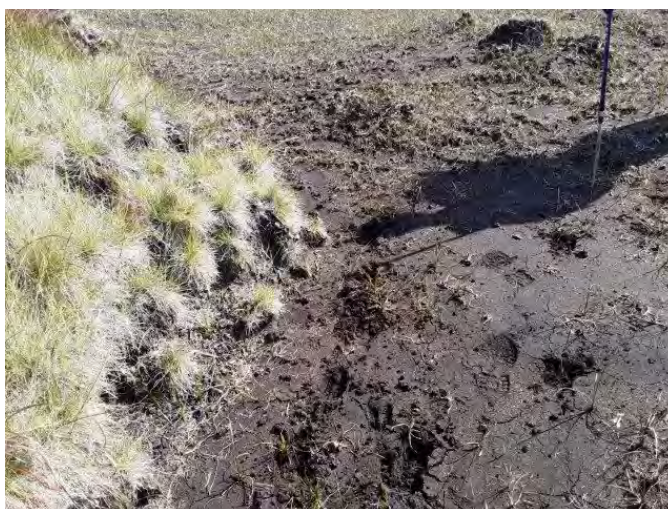
Photo 3.12: Hoof prints clearly visible on bare peat – common across the off-site Search Area.

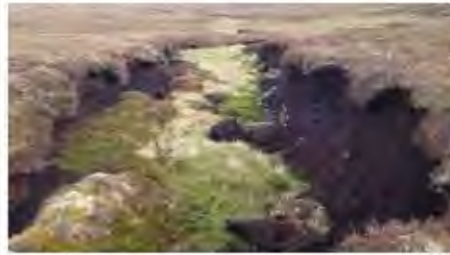
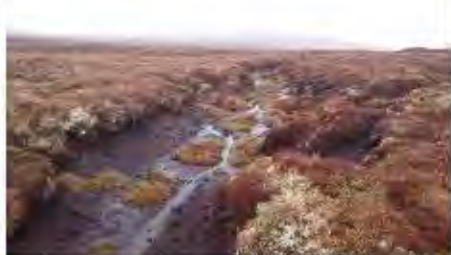
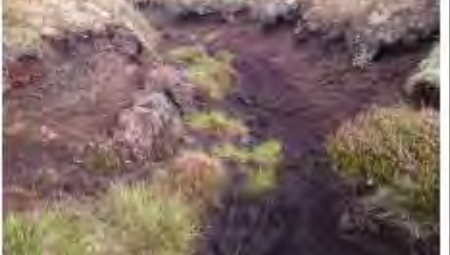
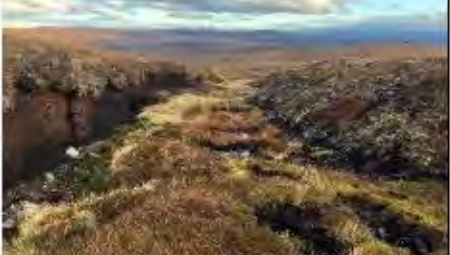
Gully erosion

Carpet re-profiling	Gully channel management	Chequerboard or turf -strip sediment traps	Gully blocking (full or partial height)

Feature	Description	Impact(s) arising pre-treatment	Restoration feature target	Restoration aim(s)	Restoration technique	Equip	Materials	Basics of the technique	Key limitations OR mitigation needed
Linear gullies	Small linear channels caused by severe erosion	Channels continue to deepen and widen, and may join together -> mineral base may start to erode -> side walls will continue to migrate laterally and collapse inwards -> sediment is released during storms -> adjacent peatland surface experiences drought stress and can release CO2 to atmosphere -> runoff down the channels can exacerbate erosion of downstream features (e.g. peat pans) -> reducing extent of active bog vegetation in between gullies	Gully walls	Re-grade banks (as part of gully blocking process) to prevent further gully widening / to reduce sediment supply during storms / to help maintain the integrity of installed peat dams	Undermining re-profiling	Excavator	None	Working from above excavate cubes of peat from the base of the bare gully wall. Work along a short section of wall, then carefully depress the upper gully edge (turf, with peat still attached below it) to achieve a c.45 degree finished slope. Peat won from the excavation to be re-used to form gully blocks, or lift the base of the gully (if there is spare) in between blockages	Peat may be too dry, and bank may collapse when undermining to win peat - if this is the case, revert to standard re-profiling by stripping turf then re-grading bank to win peat for the dams

Medium-large linear channels caused by severe erosion		Gully walls	Re-grade banks to prevent further gully widening and reduce level of collapse (e.g. due to frost heave) / to reduce the mobilisation of sediment from gully walls during storms / to slow rate of runoff into channels during storms / to slow down oxidative losses from bare peat collapse of side walls	Carpet re-profiling	Excavator	Peat and turf	Remove 'nose' of dry turf from gully edge, and place behind machine -> scrape dry bare peat on gully wall off to create a 'bed' to key in donor turves (re-working the peat bank more generally only if needed to reduce its angle (minimise this form of disturbance as far as possible) -> create flat 'bench' at toe of slope in the peat (and otherwise pull up peat/soil from gully base) -> reach behind and strip a large thick turf (e.g. 1.8m by 0.9m; 0.3m+ deep) from the un-eroded surface between gullies -> lay this up and down the prepared slope (lay turves from bottom to top; bottom turf should abut the benching; use gentle compression to seat) -> ideal is to carpet the whole slope (1-3 turves depending on length of angled slope -> use wether turves at base of slope moving to drier types towards top -> use grassier turves in general if available, and avoid heather-lichen dominant turves (higher chance of vegetation die-back) -> ensure installed donor turves are pushed together to minimise open joints -> any surplus peat from the next section down can be deposited in turf borrow holes, capped with the dry 'nose' turf if not used in re-profiling -> tooth over / smooth over borrowed areas to aid their re-colonisation	Large, thick grass-dominated turves are most resistant to being damaged during translocation, and to drought after placement. Heather turves can die back after placement (bucket damage during compression) and often seem to suffer more during droughts. If gullies are close by, there may be too little turf available to carpet slopes and/or the process may leave too much bare peat after the operation. If gully networks are very complex machines may not be able to access all parts of the system. Machine tracks on land in between gullies (especially when coupled to borrowed areas) can initiate new erosion on the land between the gullies.

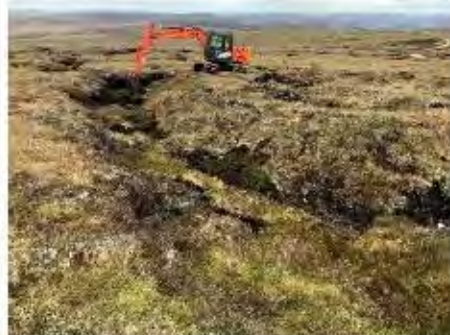
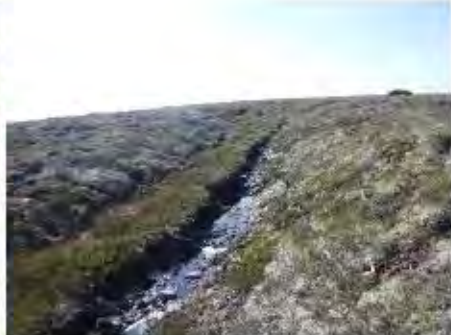
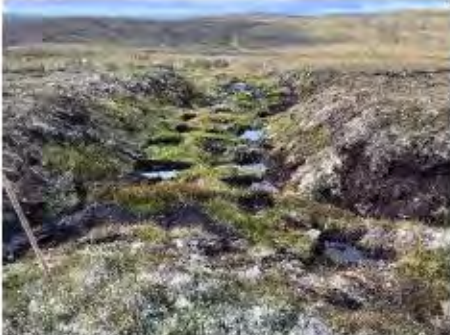
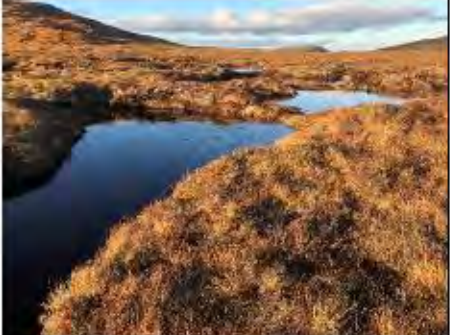
Re-profiling of hagg walls	Leaky dams (stone)	Leaky dams (peat blocks / bog pine stumps)	Leaky dams (peat blocks / bog pine stumps)

Top layer of hagg OR entire structure	As above; also to provide material to build bunds (see below); also, to re-locate dry peat into wetter zone in between bunds (if otherwise it will oxidise over time)	Hagg harvesting	Excavator	Peat and turf	Remove capping vegetation (with good depth of peat attached) and set aside for re-use. Clip off the upper driest zone of peat (upper 1/3 to 1/2) and re-distribute into peat pan 'low points' nearby, or deposit in other nearby excavation zones created when forming bunds (with wetter peat). Replace the vegetation removed earlier to cap the lowered hagg surface. All of the hagg can however be harvested if of use in creating contour bunds in peat pans, with its capping vegetation used to top the bunds for protection	Tends to be used most often if lots of 'dry' haggs present, and lots of bunding needs installed. Careful thought needs to be applied in a pan to which haggs are 'used' and which are 're-profiled' only. Marking should be used to help machine operators know what to do, especially with intermediate forms (i.e. in between wet and dry)

Walls	To slow down runoff from adjacent land into pan / to reduce the sediment supply into pan / to act as receptor & armouring for any bog moss mulch applied to base of slope	Bog pine armouring	Excavator or Labour	Bog pine	Rake up fragments of woody material (or entire root plates if available) from the base of gullies in hagg complexes and spread evenly on the lower slopes of profiled banks or existing banks if angles are shallow. Gently seat this by walking over it or packing with a rake, or using machine bucket pressure.	Care is needed to ensure that any damage done when stumps are removed is made good; stumps should only be removed if they are already well exposed (i.e. don't dig them up) as disturbance to the un-eroded peat mass needs to be minimised
			Gully bases (within hagg complexes)	To slow runoff during storms / to reduce rate of sediment discharge / to help trap sediment and create 'peat dead flats' in void behind each blockage so that specialist plants have better chance to re-colonise	Leaky dams (peat blocks / bog pine stumps)	Excavator or Labour	Peat and turf	Gather up bog pine root plates either by hand or machine as appropriate. Form these into a linear structure across the gully, interlocking these and anchoring them into the peat beneath. Loosely place large turves (with peat attached where possible, for anchoring) on the upstream side of the pine and in spaces between interlocked root plates to form a leaky dam. If no wood is available try to use large cube-shaped turves with a heavy bulk of peat attached and place these in clusters at choke points in the gully. Finished structure typically no more than 0.5m tall and often closer to 0.3m	Seek permission from the land owner that they are happy to use the bog pine available. Be careful not to make the dams overly well-sealed otherwise they will hold a lot of water behind them (if this is an express requirement, there are better structures - see below) to achieve this effect

Gully bases (within hagg complexes)	As above	Leaky dams (stone)	Excavator	Mineral material and stone	Gather up boulders by machine from suitable donor sites or by excavating out from beneath the peat. Form these into a linear structure across the gully, ensuring the material has voids that water can pass through slowly - don't pack these down. Finished structure to be not more than 0.9m but ideally 0.3m-0.5m tall max. Useful in particular on steeper gullies and outflows.	In taking rock from below the peat, you may 'break the seal' (e.g. if iron pans or induration present). This may allow runoff to escape vertically downwards hence meaning bunds may not hold water except in a storm (may not therefore trap sediment). Useful to run some initial trials to test this.
