**Report to: SSE Renewables Developments (UK) Ltd**

**Contract No: J509**

**Freshwater pearl mussel survey at  
Gordonbush Extension Wind Farm**

FWPM survey of Allt a Mhuillinn and Allt Smeorail  
watercourses

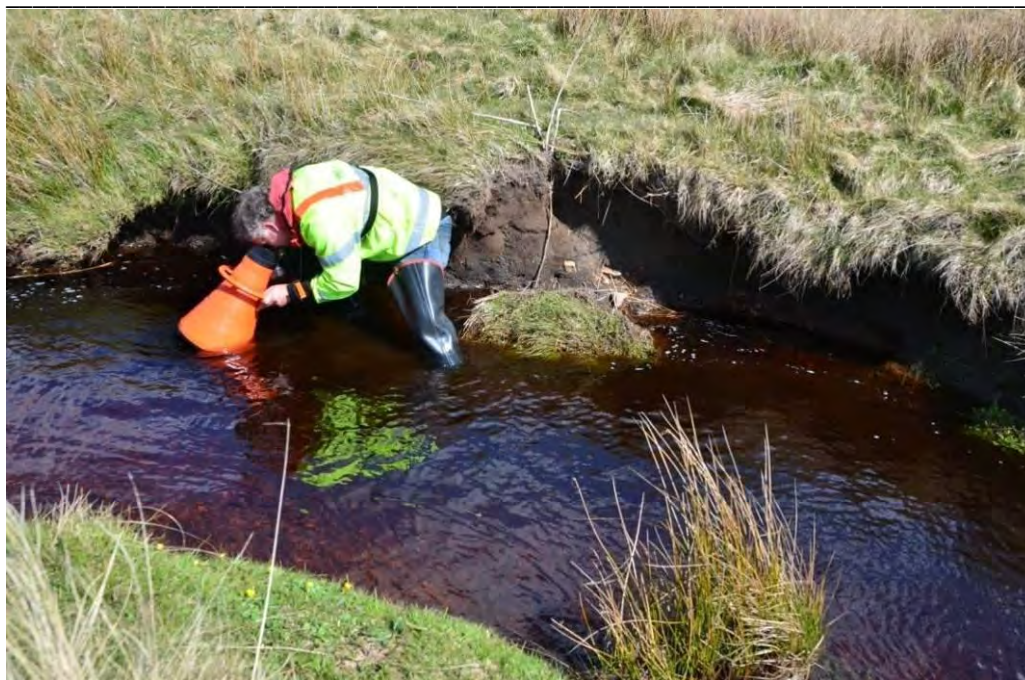
The methodology followed the SNH's "Freshwater mussels survey protocol for use in site-specific projects". This involved conducting a general survey of the river and its substrate types, by walking the banks and/or by wading in the water with the aim of identifying specific areas most likely to harbour mussels. Once suitable habitat was identified then the careful and systematic wading of representative stretches of river was undertaken, using a bathyscope (glass bottomed bucket – see Figure 1) to allow a clear view of the channel while looking for the presence of individuals on the river bed.

**Figure 1 Use of bathyscope to view river bed.**

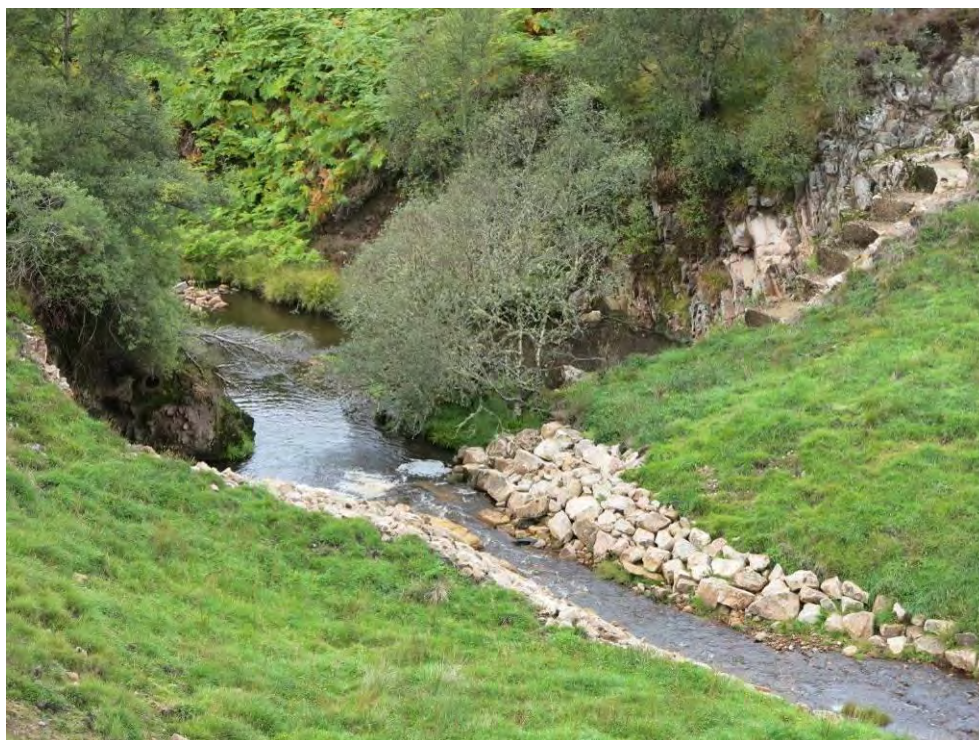
The survey commenced at the site of the old dam structure at GR 2832 9124 (Figure 3). The structure formerly caused a largely impassable obstacle to fish passage, with its removal during 2013 now allowing free passage of fish.

**Figure 3 Site of former dam and start of survey.**

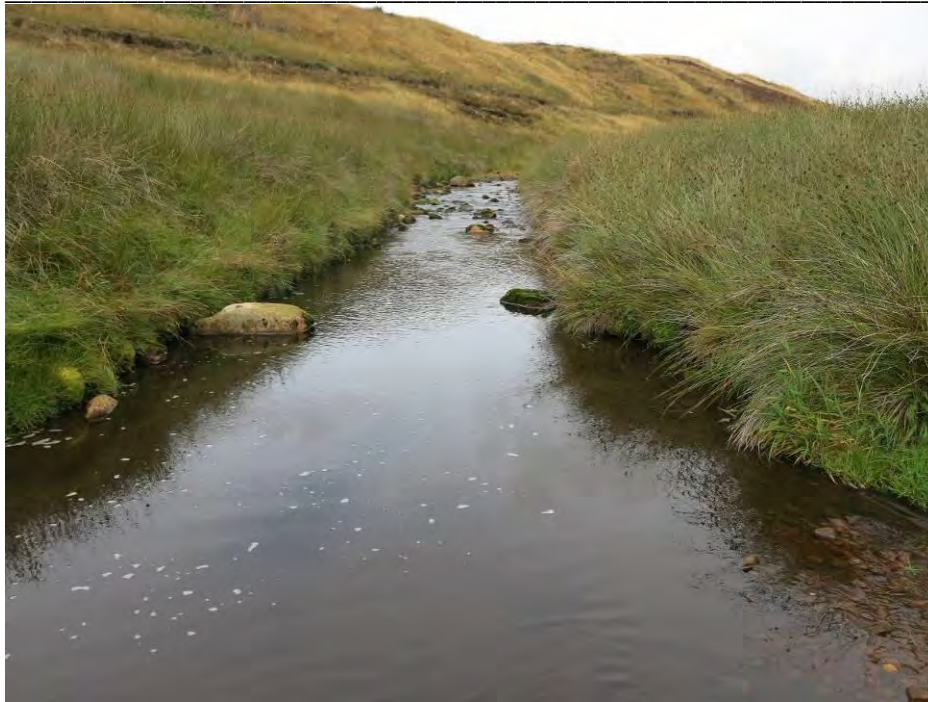
The survey section proceeded with long run sections interspersed with occasional laminar flow glides (Figures 4 and 5). The glides were difficult to survey due to the large amount of suspended algal / diatom material in the water which partially obscured the river bed. The run sections, however, were all possible to survey, although they also had a thick coating of this material. Initially it was suspected the material could be sediment derived, however, microscopic analysis following the survey showed that it was the remains of photosynthetically derived material and not the result of pollution.

**Figure 4 Looking onto run section from glide.**

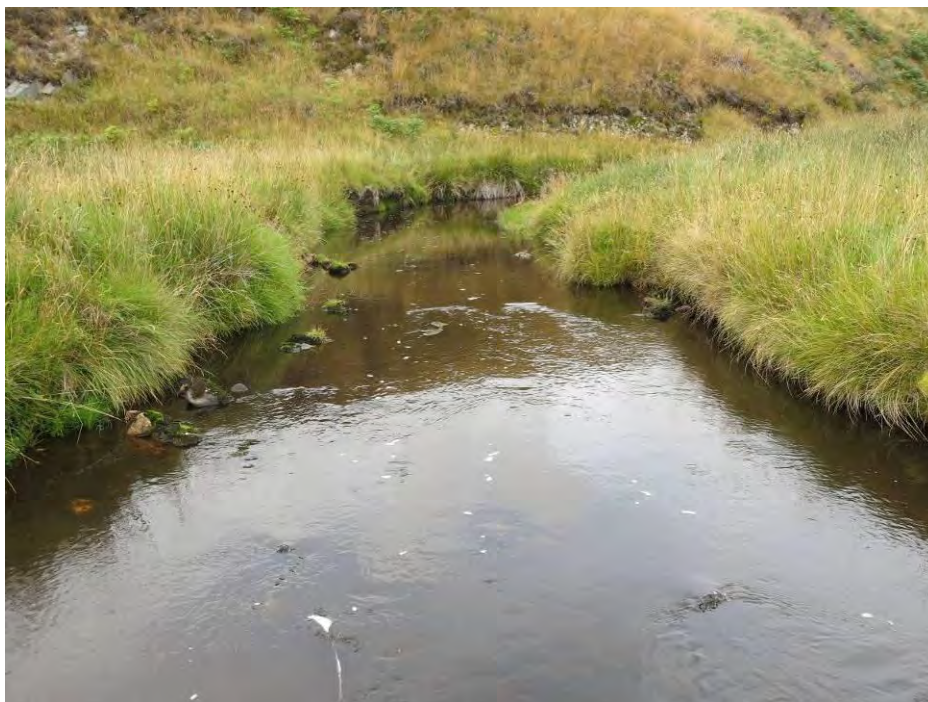
**Figure 5 Slow laminar flow glide section.**

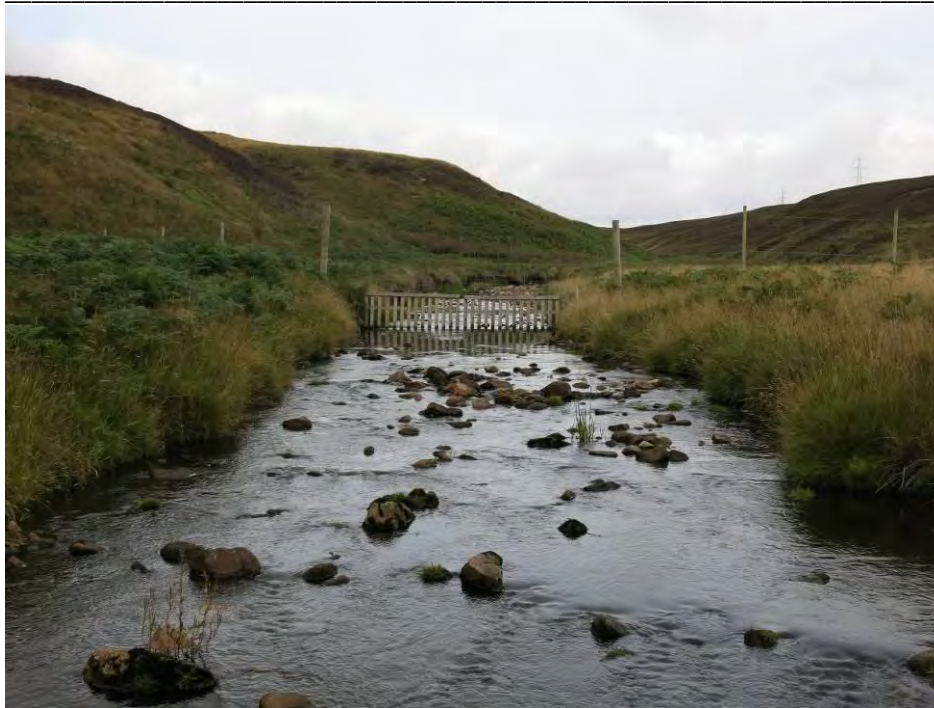
The survey carried on with the river forming long run sections crossed by a recently constructed deer fence with a water gate (Figure 6). Minor evidence of poaching was noted on the river just upstream of this point (Figure 7). No livestock were seen and it was thought this had been caused by deer.

**Figure 6** Run section, crossed by deer fence with water gate.

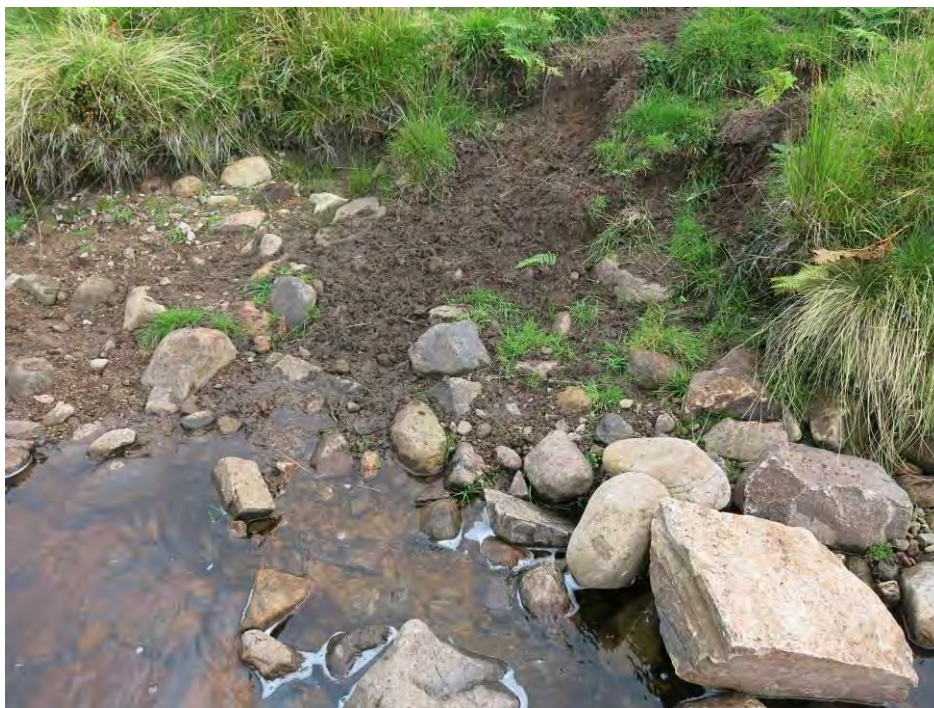
**Figure 7** Minor poaching of bank.

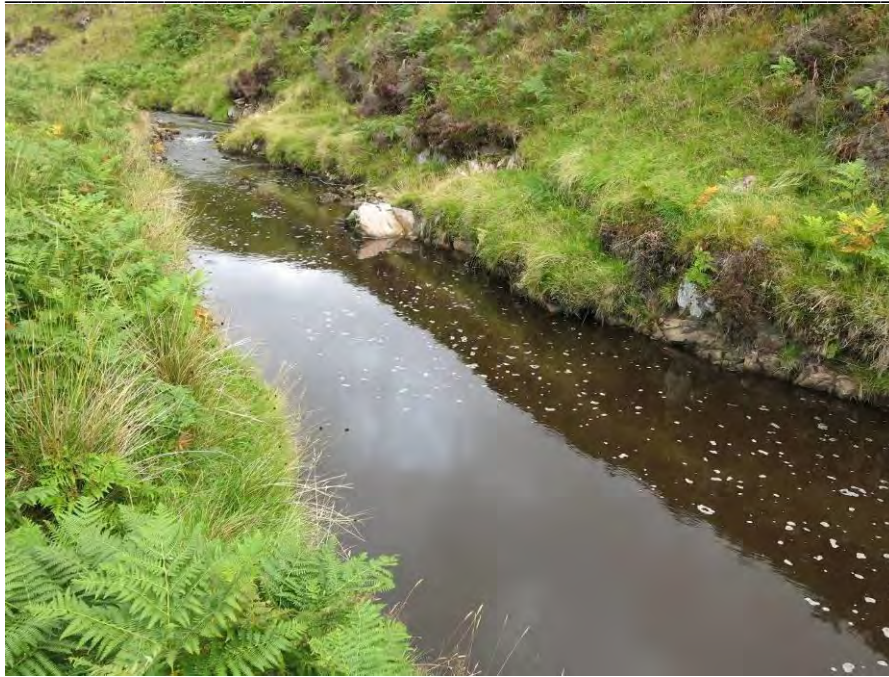
A large pool was noted (Figure 8) containing adult trout. This water was highly discoloured and unable to be surveyed properly. Upstream of this was a large, active point bar (Figure 9) with an actively eroding sandy bank face opposite.

**Figure 8 Large pool – discoloured water**

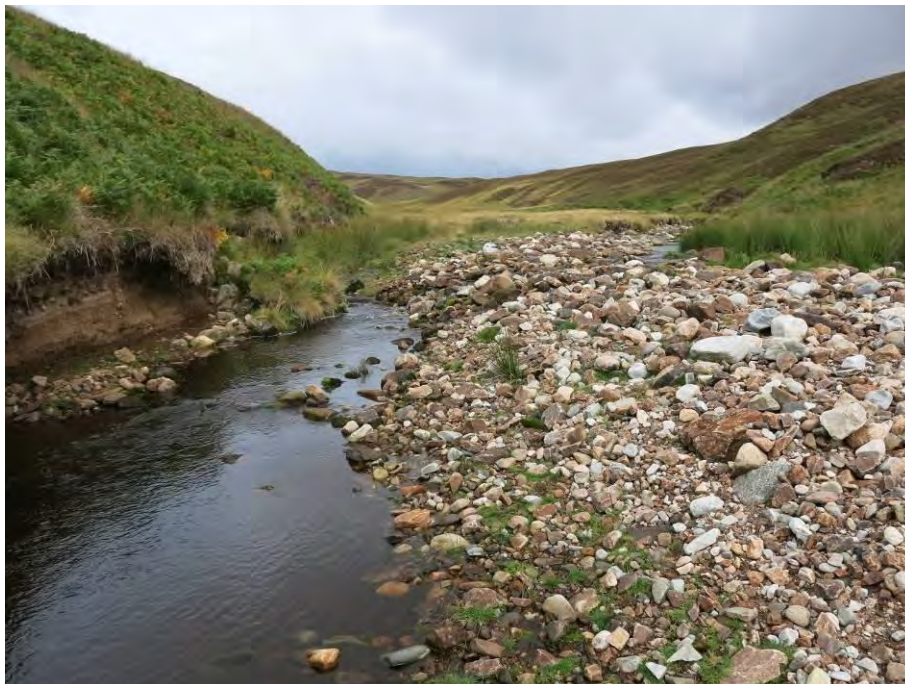
**Figure 9 Large active point bar with actively eroding sandy bank face opposite.**

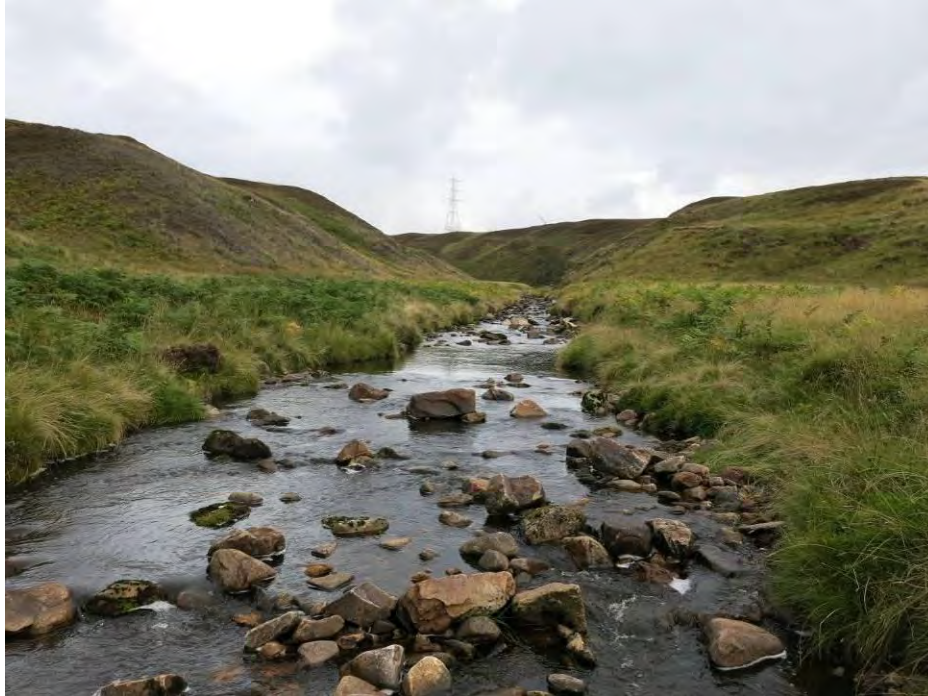
The river continued upstream mainly as run sections with exposed boulders in channel (Figure 10) until it reached the main tributary, the Allt nan Nathraichean (Figure 11). Just above the confluence, the main river narrowed to 2.5m width and averaged 20cm depth. The main tributary flowed near to the existing Gordonbush Wind Farm site, however, there was no difference in levels of discoloration upstream

**Figure 10 Run section – valley becomes more steep-sided.**

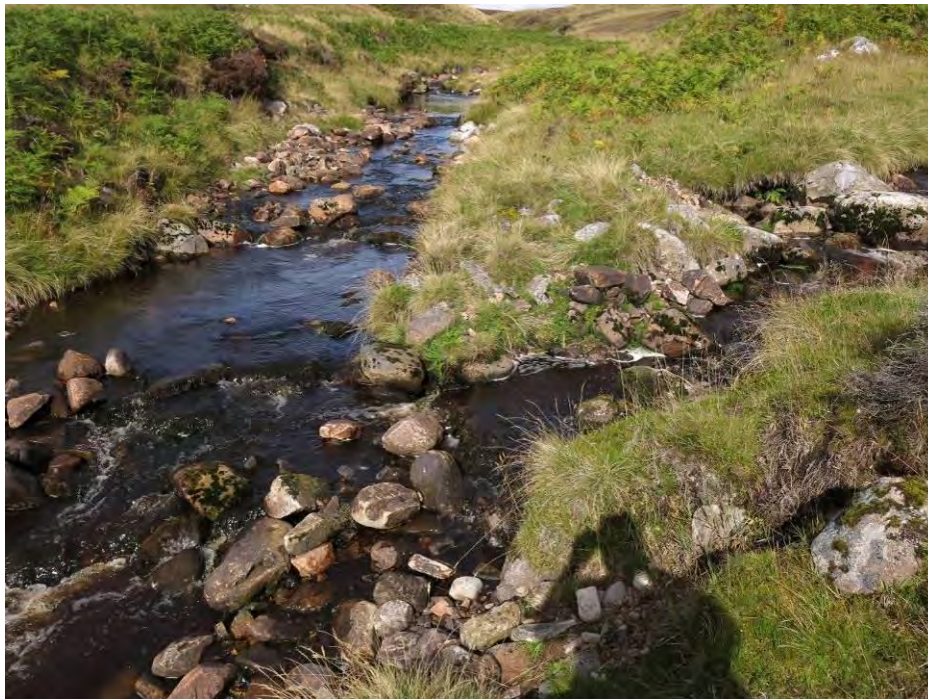
**Figure 11 Main tributary joins the river**

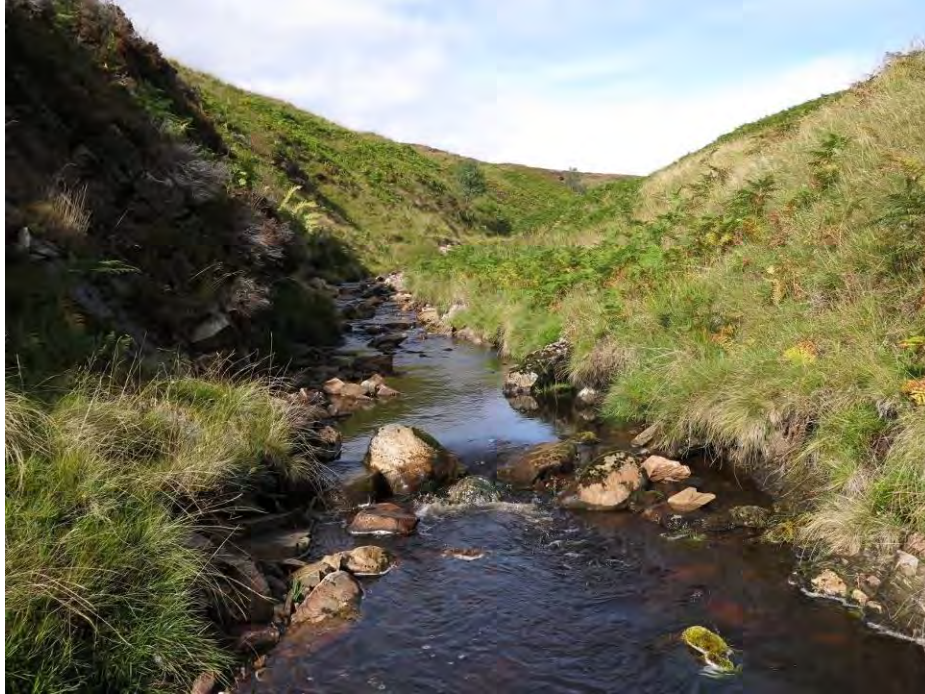
Continuing upstream, the channel continued as a run, with the valley sides becoming steeper (Figure 12), before coming to a large pool directly below a bedrock chute section of approximately 1.5m height (Figure 13) which was considered to still be passable to trout.

**Figure 12 steep sided section, river narrows.**

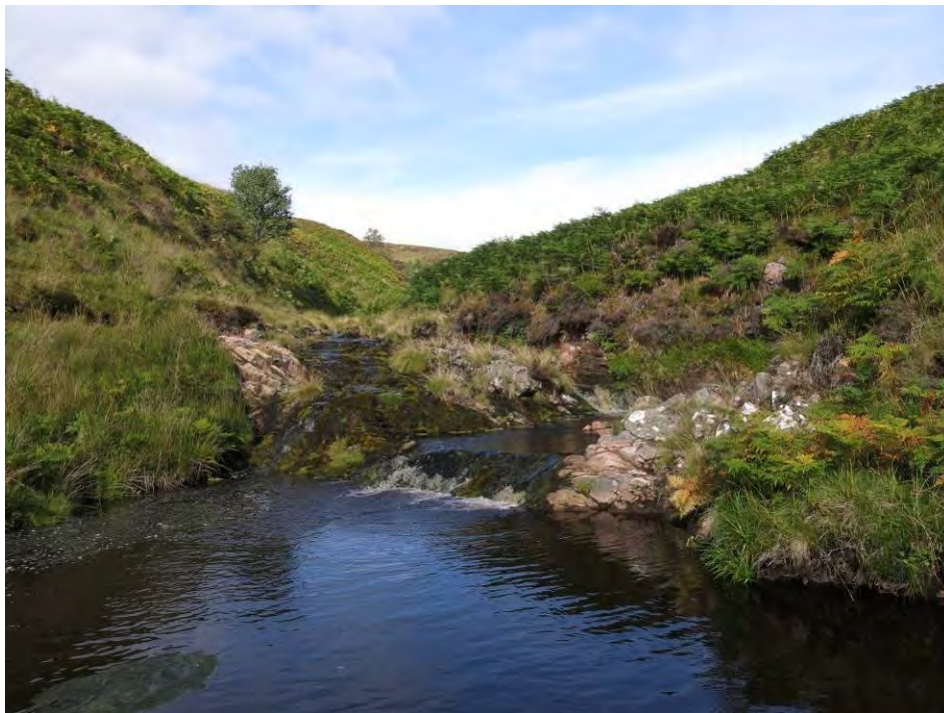
**Figure 13 Bedrock chute section with large pool**

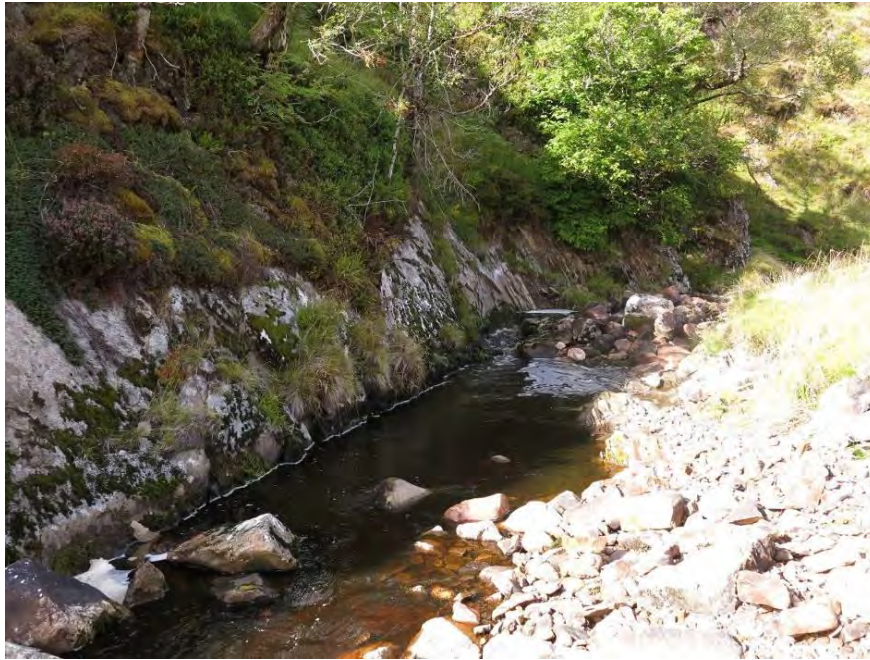
This was followed by a steep sided bedrock channel section which contained some tree cover (Figure 14).

**Figure 14 Steep sided bedrock channel**

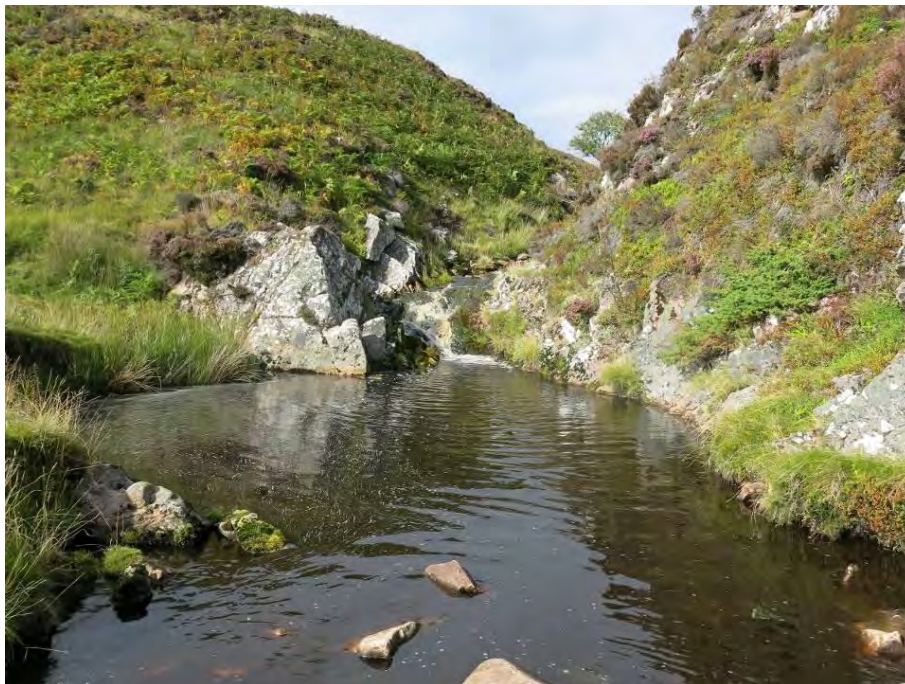
**Figure 15: Pool with minor falls / steep chute above (c. 2m)**

The rest of the survey area upstream and downstream was nearly devoid of bankside tree cover with moorland heath being the main land use. Upstream of this section was a two stage bedrock falls or steep chute with a large pool below (Figure 15). The lower part was around 2m high while the upper part (Figure 16) was around 2.5 high.

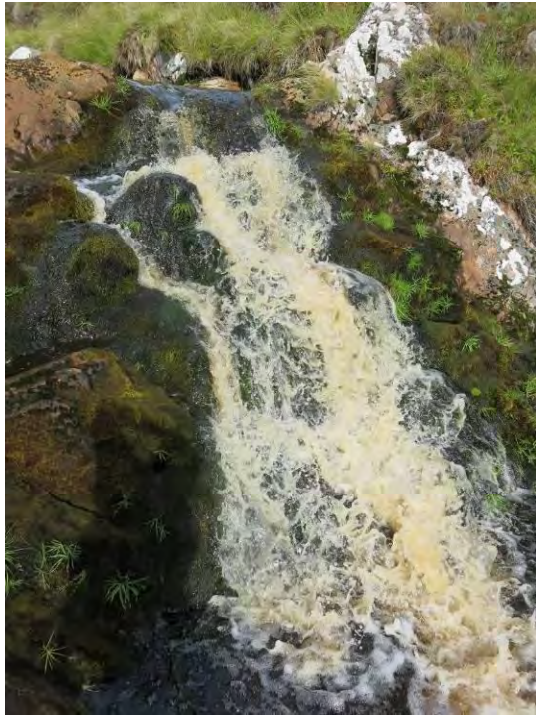
The upper falls/chute will present an obstacle to fish under some, if not all flow conditions.

**Figure 16: 2.5m chute/ falls section**

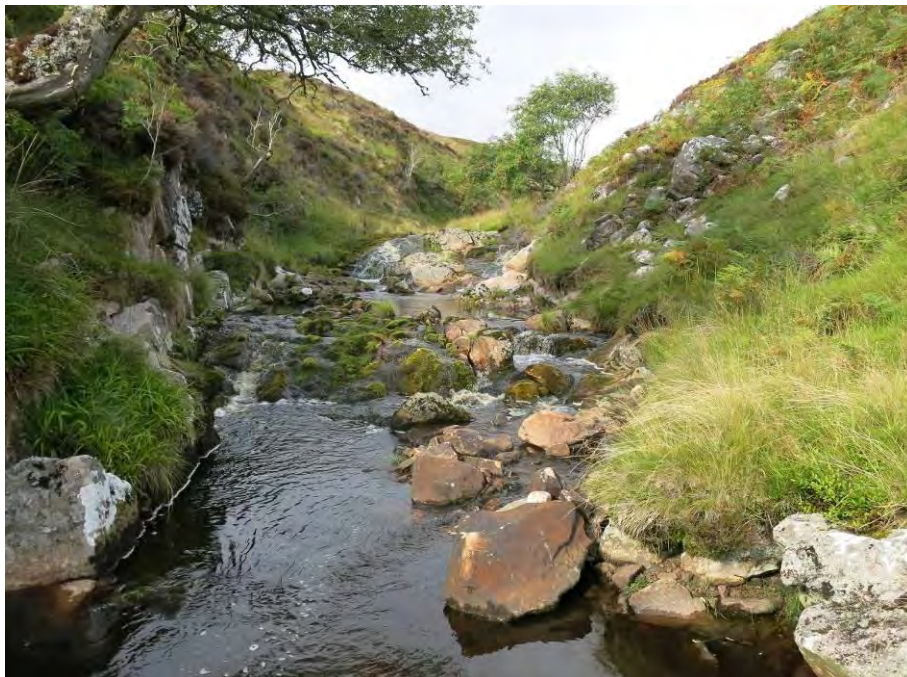
**Figure 17: Run section with further bedrock chutes.**

Upstream of the falls was a further steep sided run section with further smaller bedrock chutes (Figure 17). Upstream of this, the valley opened out with a more

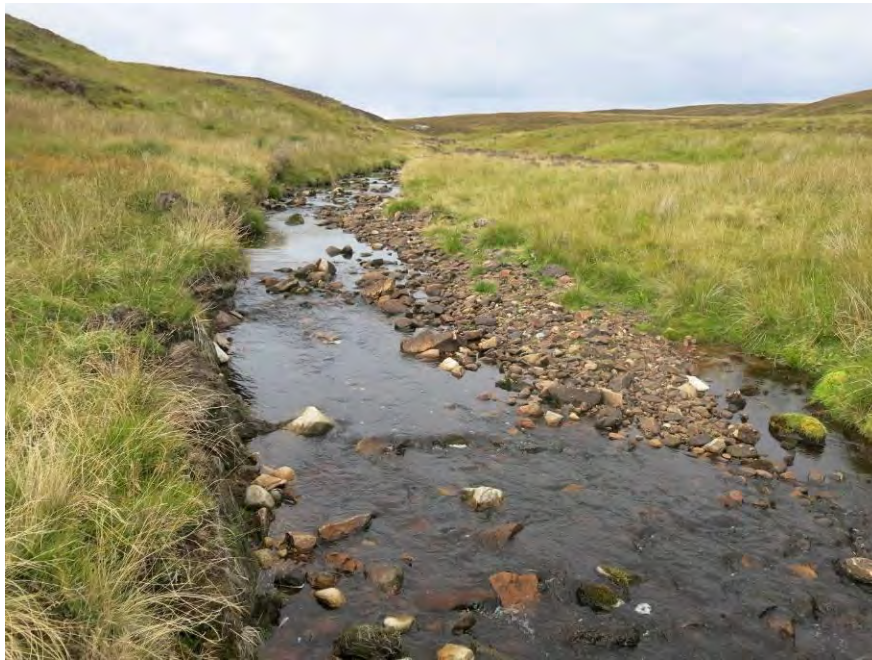
gentle slope and the river became narrow (approx. 1.5m, 10cm deep) with signs of active deposition (Figure 18) until the upstream extent of the survey. The upper tributary had no flowing water and was no more than a wet flush (Figure 19).

**Figure 18: Upstream section of survey – shallow, narrow, active channel.**

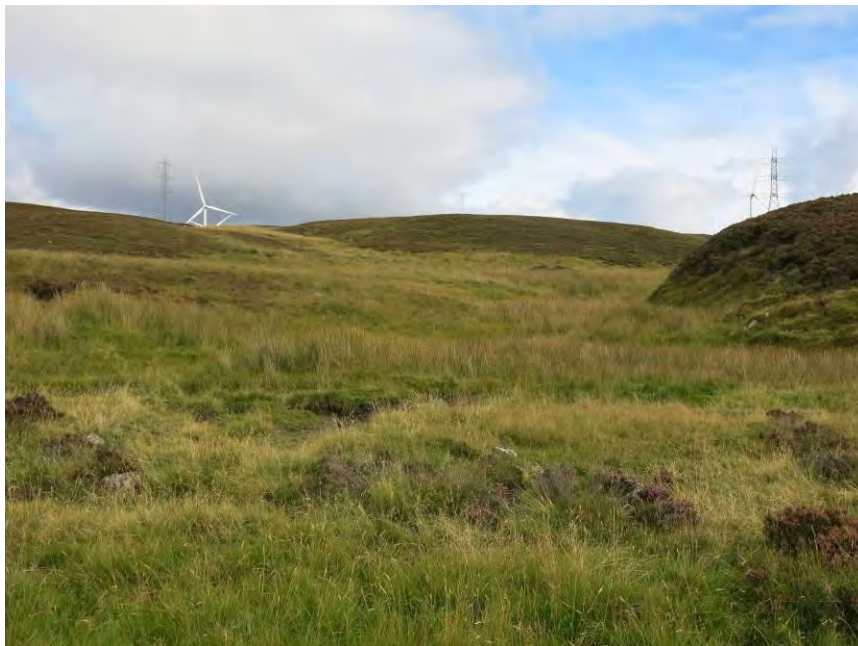
**Figure 19: Upper tributary – no water flowing, wet flush only.**

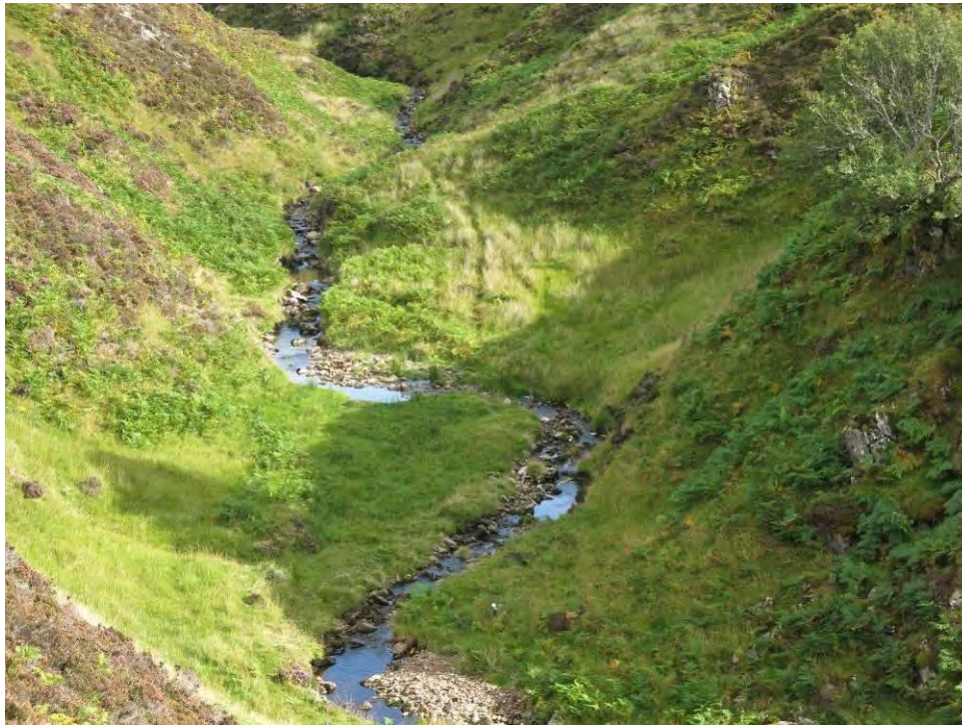
The survey returned downstream and continued with the main tributary, the Allt nan Nathraichean, which flowed in a sinuous, unmodified manner through very steep, near gorge like terrain (Figure 20). The channel was approximately 1.5m wide and 10cm deep showing signs of active sediment deposition along its length (Figure 21).

**Figure 20: Main tributary upstream of power lines, flows within a gorge.**

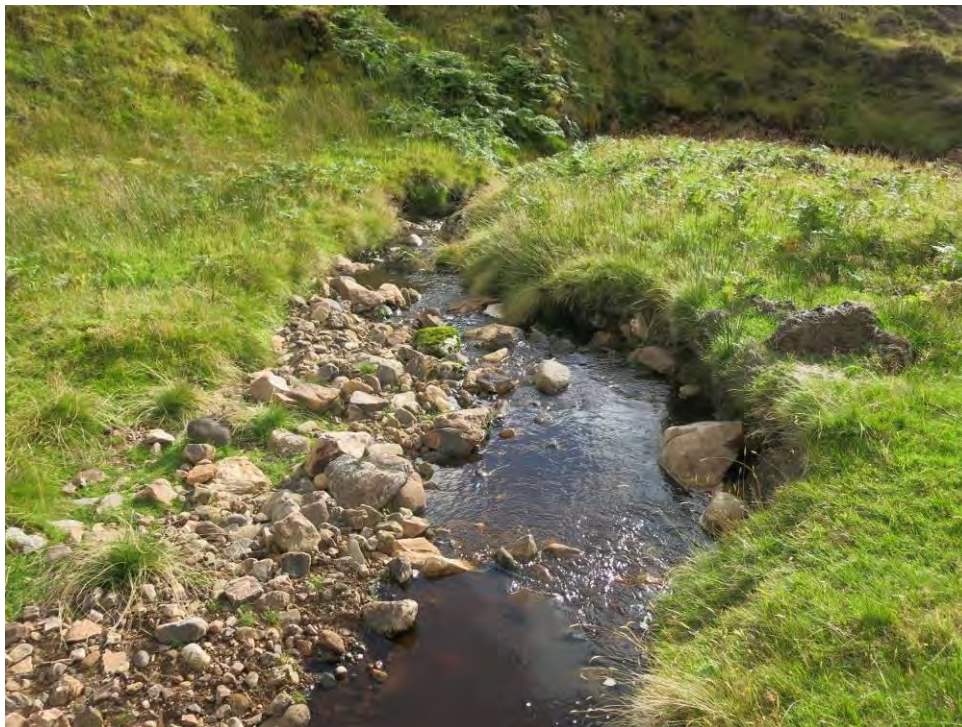
**Figure 21: Showing active channel within main tributary.**

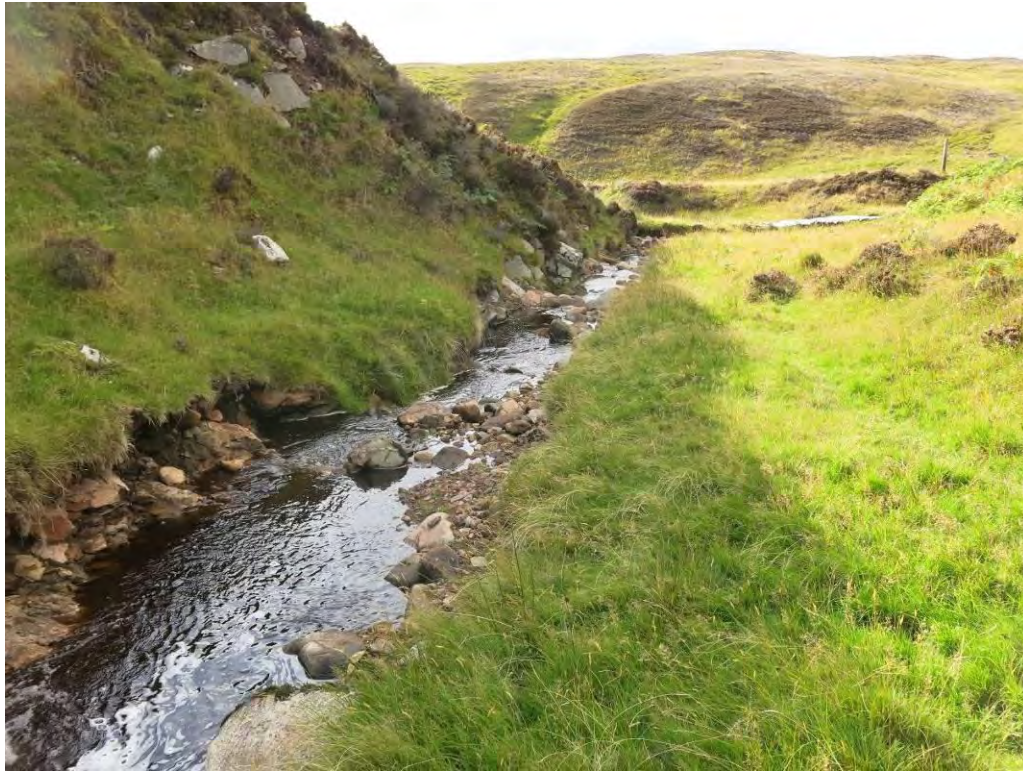
The channel was considered to be highly mobile and less suitable for freshwater pearl mussels than the main Allt a' Mhuilinn. This continued all the way to the confluence (Figure 22), above which was a disused river crossing.

**Figure 22: Looking downstream on main tributary towards Allt a' Mhuilinn.**

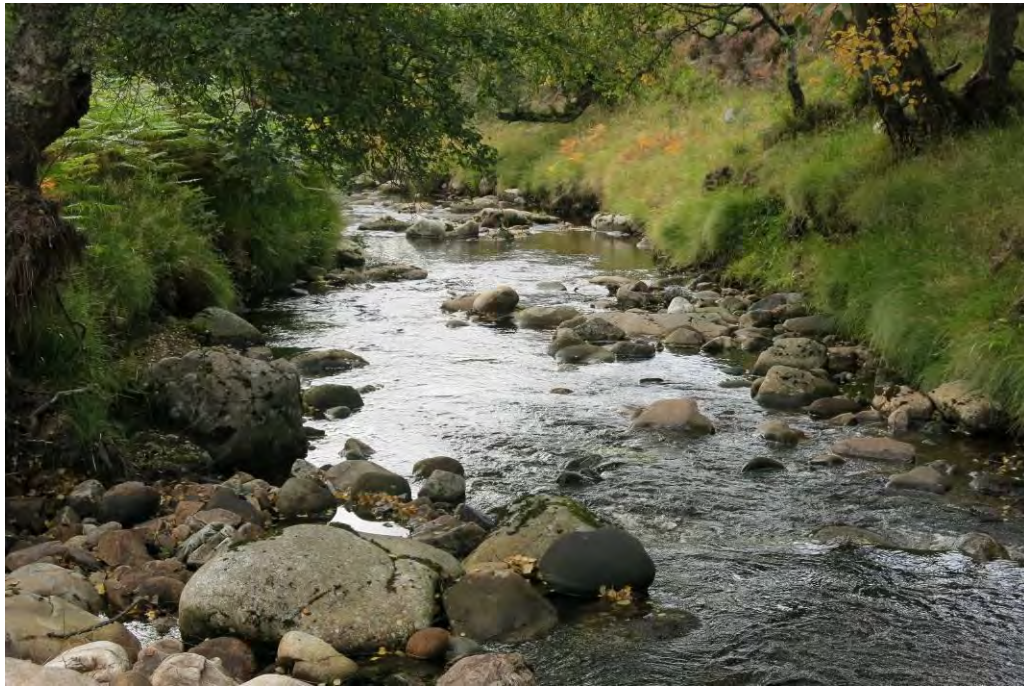
The lower survey section consisted mainly of run sections (Figure 24) within an active channel with evidence of sediment deposition (Figure 25). There was good bank-side tree cover throughout this section. This provides useful channel shading, as well as being a source of large woody debris, which was in evidence in several areas of the lower and middle survey section. The habitat in this lower section was considered to be excellent for freshwater pearl mussels, although none were found.

**Figure 24: Downstream extent of survey, good habitat with good bankside tree cover**

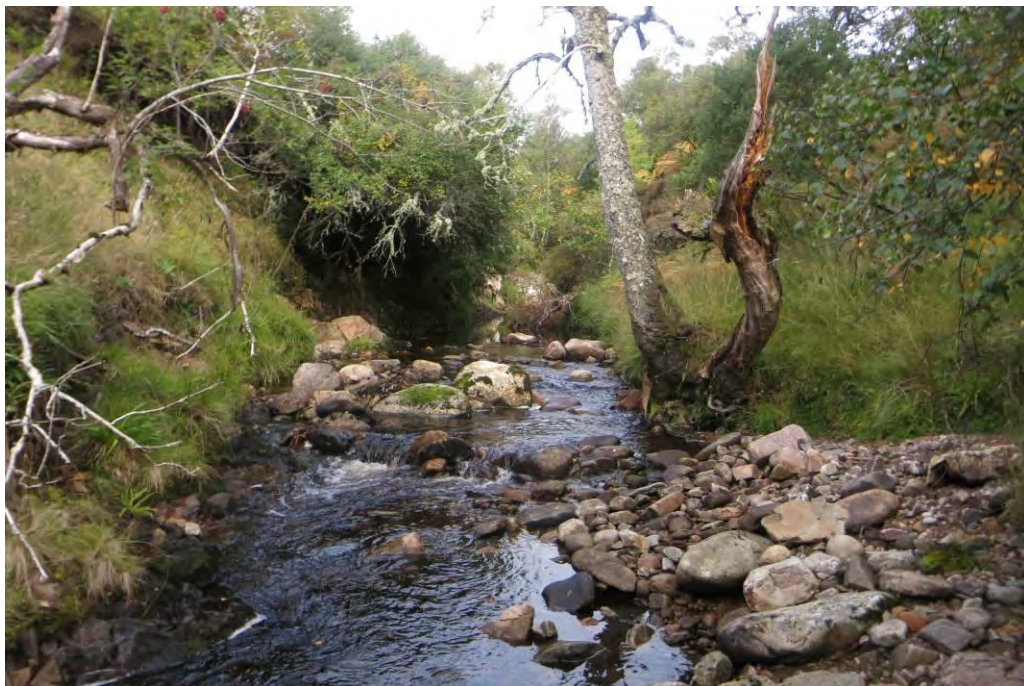
**Figure 25: Run section with small side bar.**

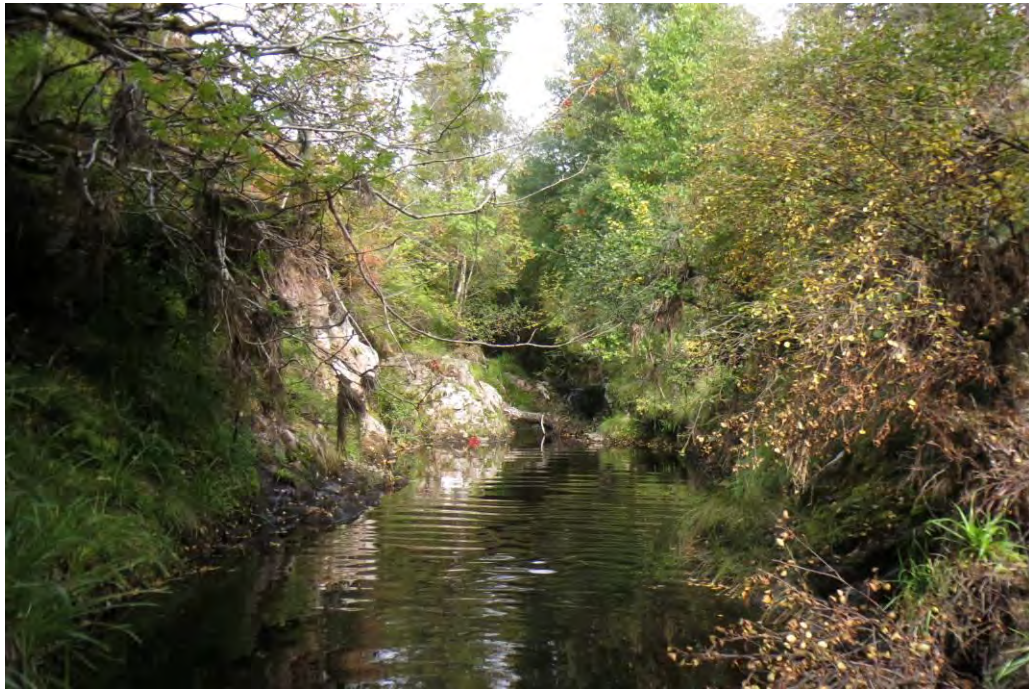
The channel then became bedrock with a large pool and minor 1m high falls, which were considered passable to fish (Figure 26). The channel then returned to a run section with active deposition (Figure 27), containing good freshwater pearl mussel habitat. The river width was fairly uniform throughout the survey area at 4m wide and averaging 25-30cm deep. Some of the pools were in excess of 1m deep. Beyond the riparian tree cover the predominate land use was a mixture of bracken and moorland heath.

**Figure 26: Pool with bedrock channel – minor 1m falls in the distance**

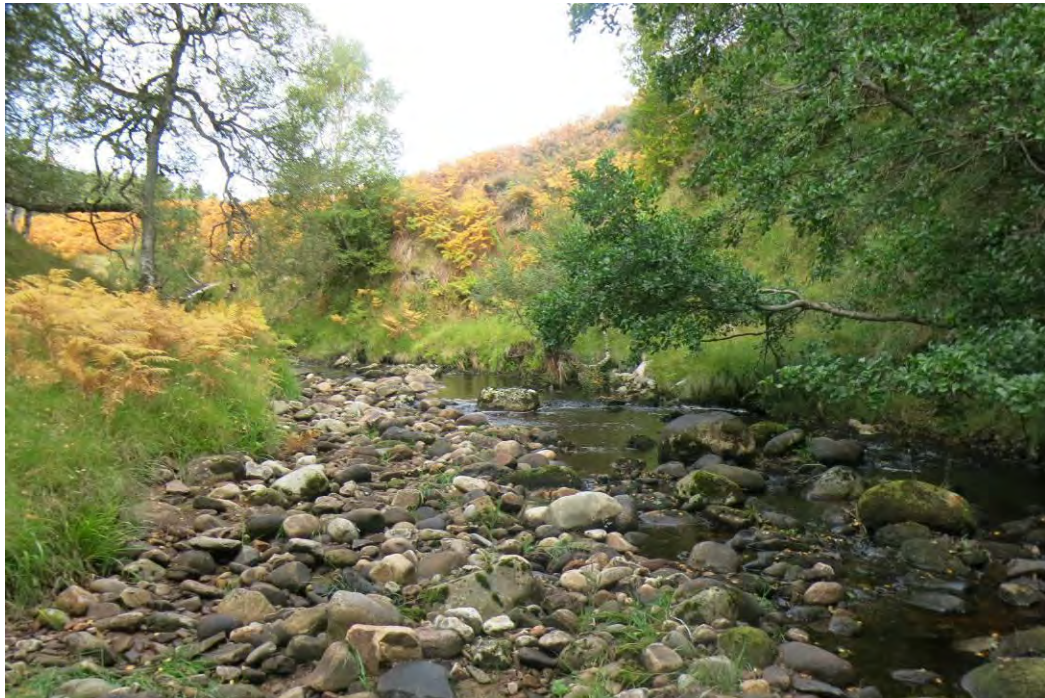
**Figure 27: Run section with extensive deposition (side bar)**

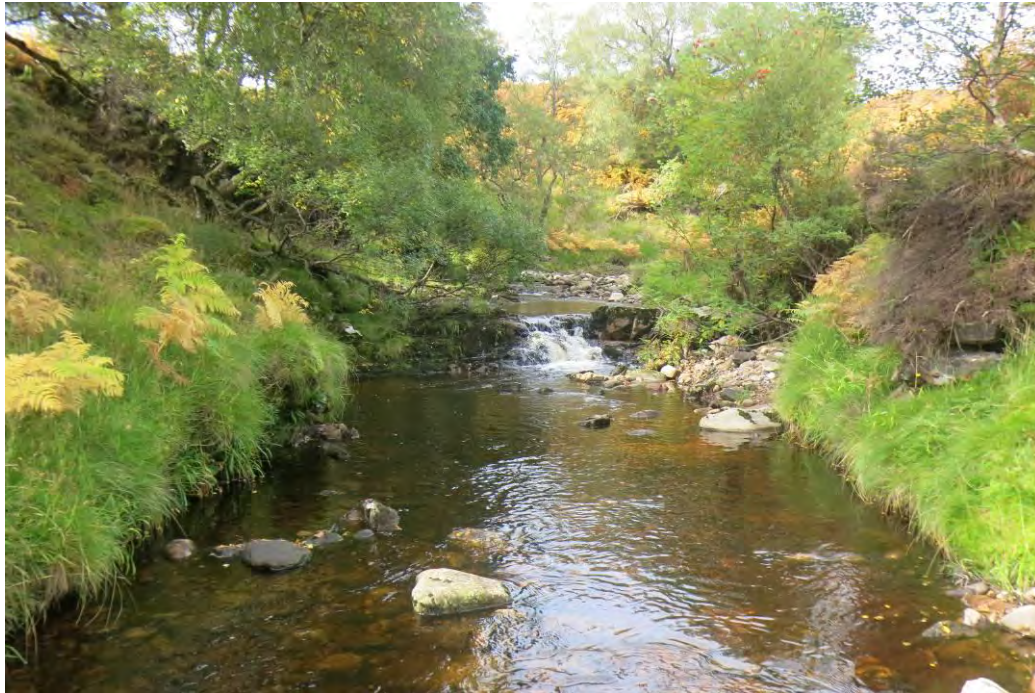
The survey continued upstream with slow flowing glide sections (Figure 28) in between runs and another large pool with a 2m high falls/cascade within a bedrock channel (Figure 29), which was considered passable to fish.

**Figure 28: Glide section, good bank side tree cover**

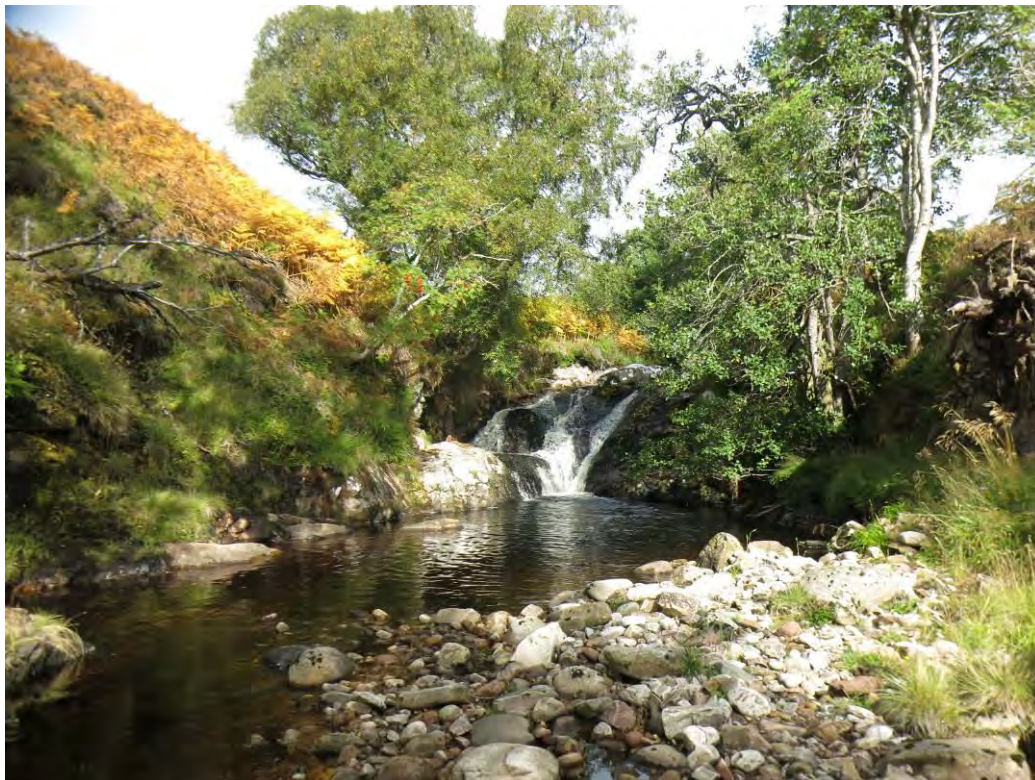
**Figure 29: Pool with 2m falls/cascade within bedrock channel**

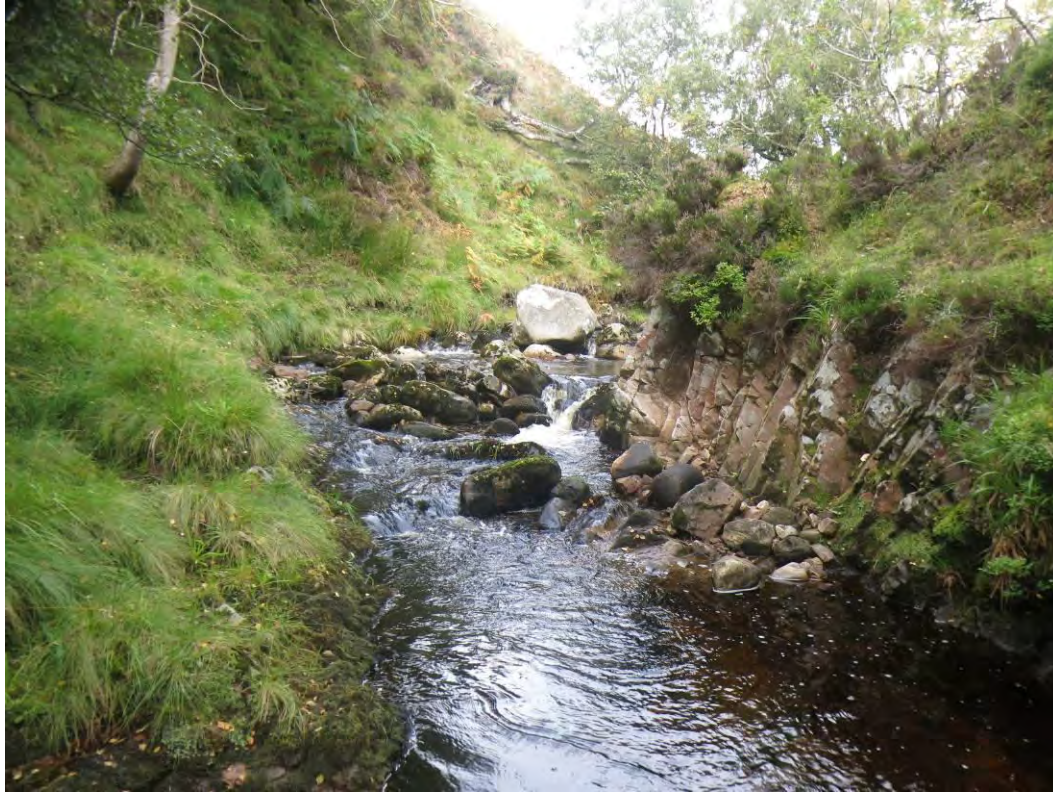
The bedrock channel continued upstream within a steep sided valley form (Figure 30). These bedrock channel sections offer poor freshwater pearl mussel habitat. There were three deer fences crossing the watercourse, which had been recently constructed with water gates which allowed free passage of fish and otters (Figure 31). Within these fenced sections there were at least two areas of bank poaching by deer.

**Figure 30: Typical run section within steep sided bedrock channel**

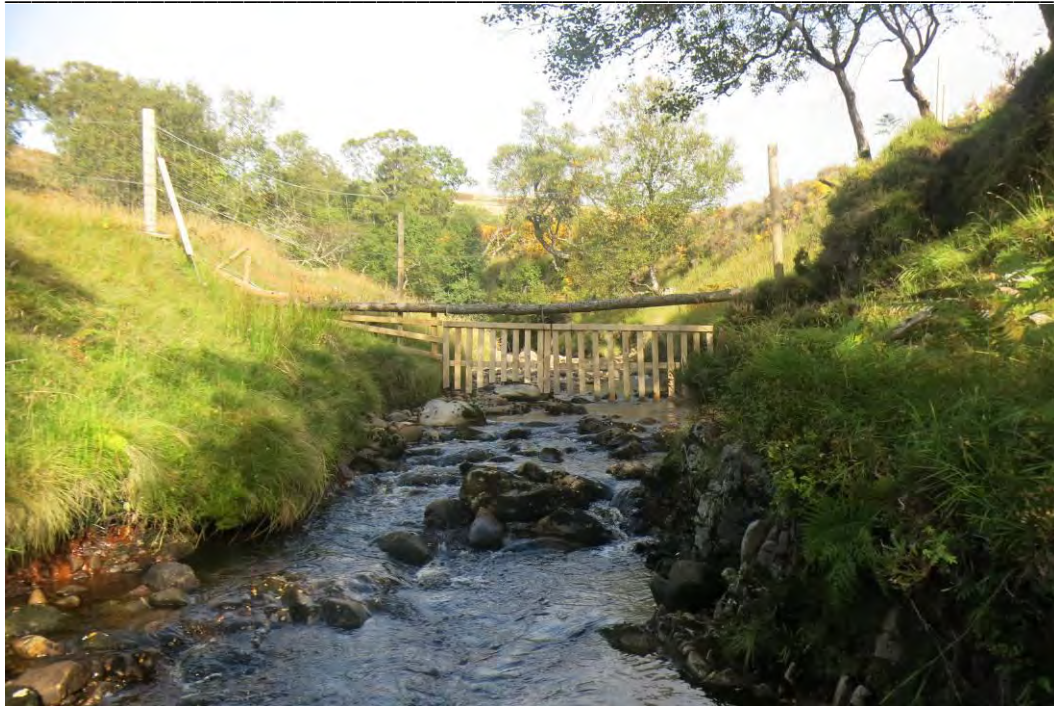
**Figure 31: One of three water gates within channel – fully accessible to fish**

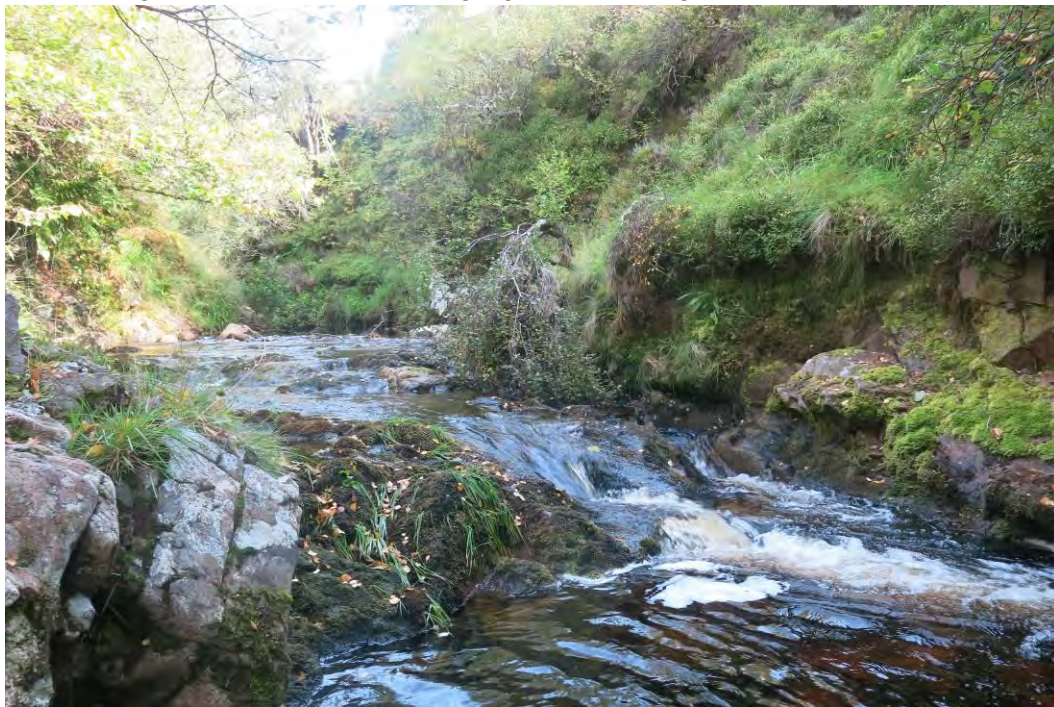
The steep sided bedrock channel dominated the middle survey section (Figure 32) culminating in a short inaccessible gorge section (Figure 33).

**Figure 32: Bedrock channel run in mid section of survey area.**

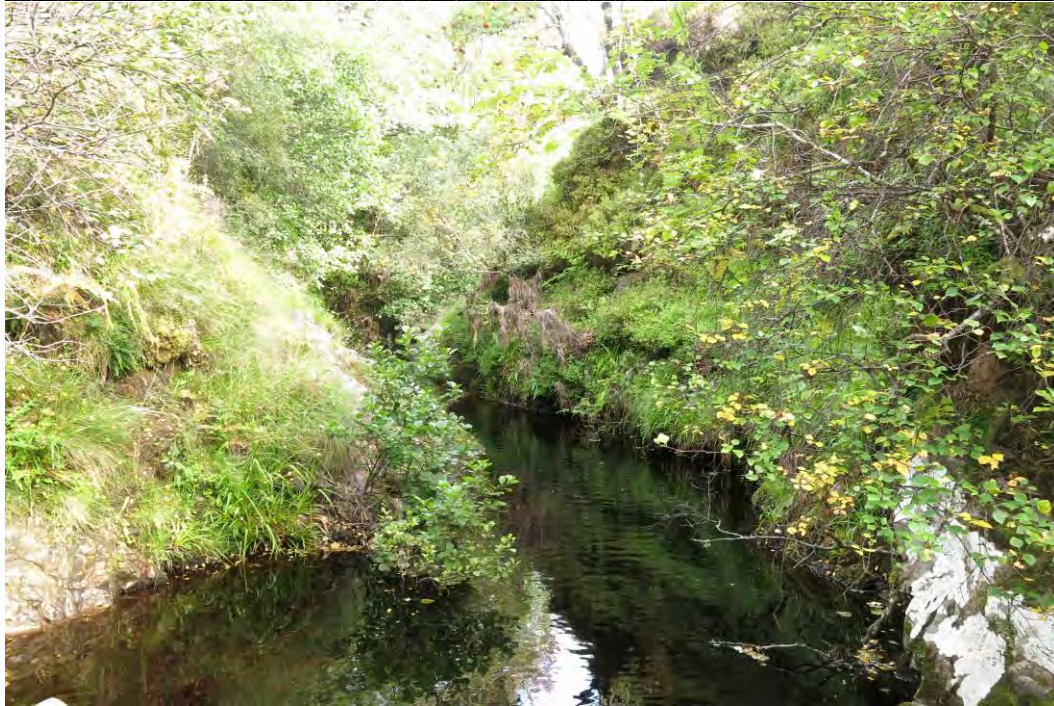
**Figure 33: Inaccessible bedrock gorge section**
