**Report to: SSE Renewables Developments (UK) Ltd**

**Contract No: J509**

**Freshwater pearl mussel survey at  
Gordonbush Extension Wind Farm**

FWPM survey of Allt a Mhuillinn and Allt Smeorail  
watercourses

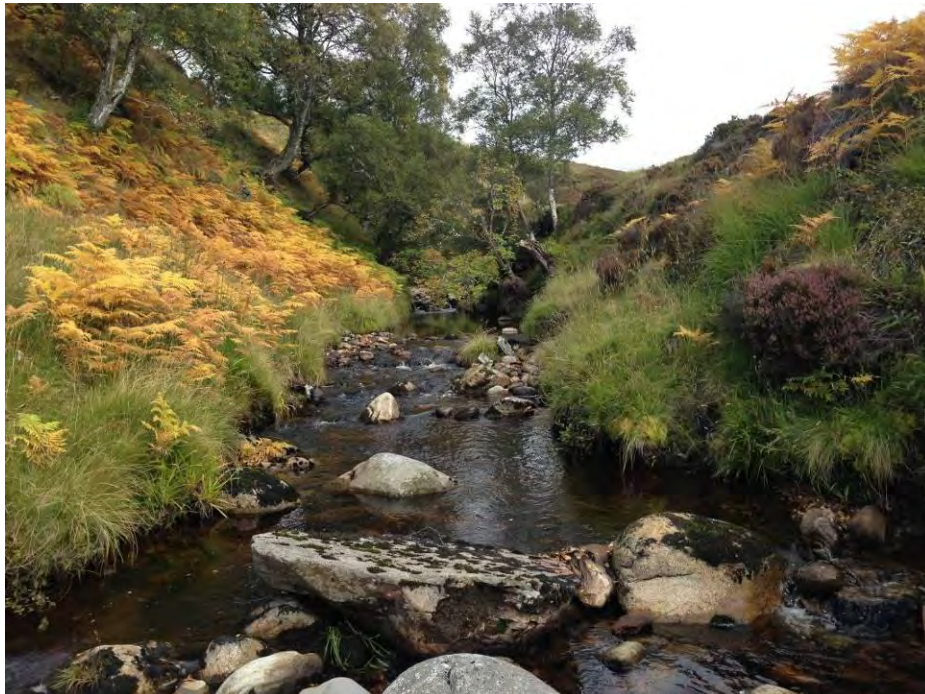
The upper section of the survey area was dominated by runs (Figure 34) with the valley shape gradually become less steep and the extent of tree cover becoming reduced (Figure 35) although there were also still significant areas of bedrock present.

**Figure 34: Typical run within upper section of survey area**

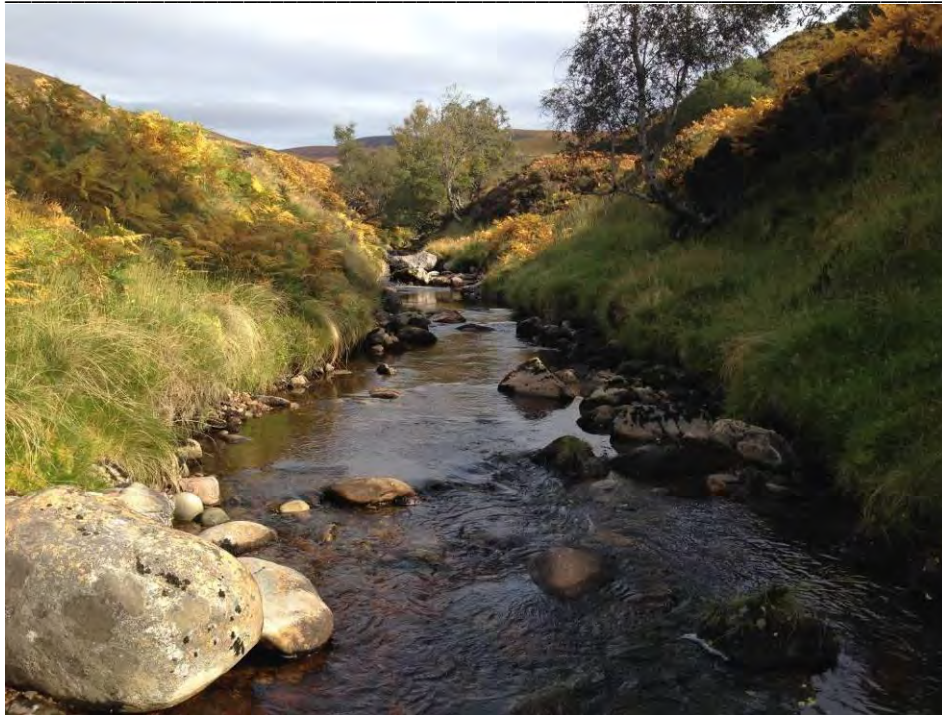
**Figure 35: Run near up end of survey area – valley becomes shallower with less tree cover**

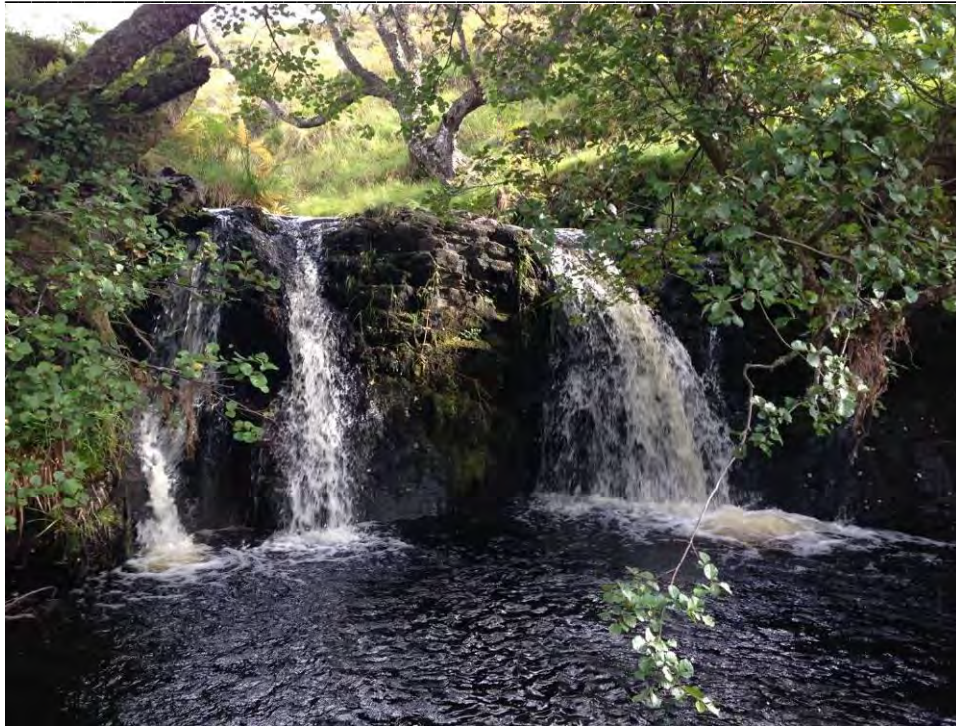
The upper run section culminated in c.3m high falls with a large pool below (Figure 36). This is likely to form a significant barrier to upstream trout migration although might be passable to salmon if present. The survey ended with an open run section flowing into a section with denser bank side tree cover (Figure 37). Over the length of the survey it was considered that the upper and middle section offer generally inferior freshwater pearl mussel habitat due to the predominance of bedrock substrate, while the lower section generally offered excellent habitat.

**Figure 36: Upper falls, 3m**

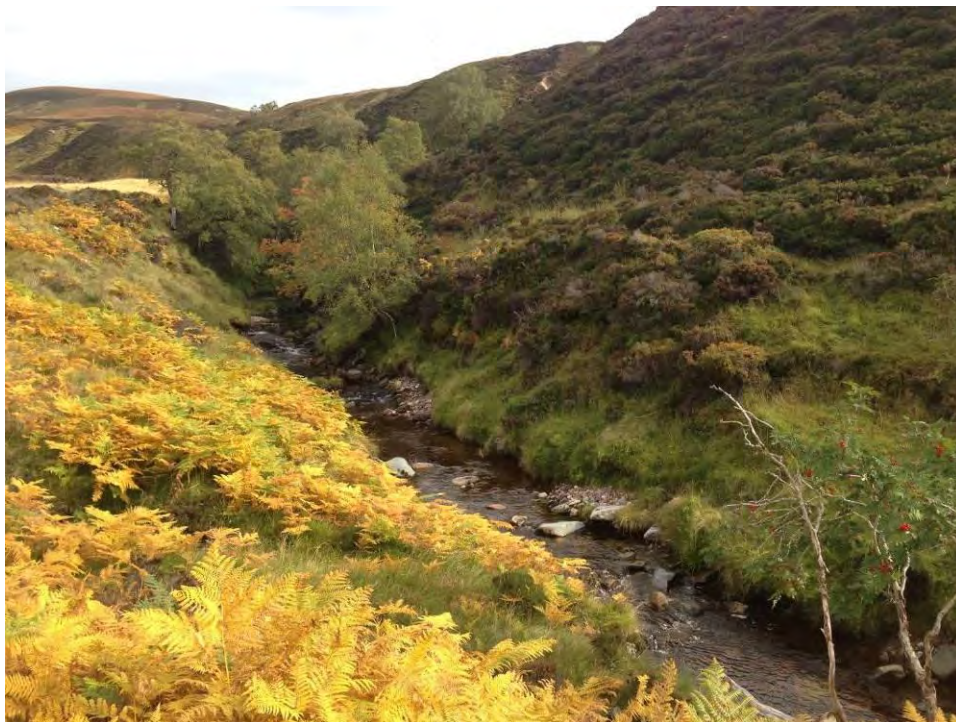
**Figure 37: Upper extent of survey**

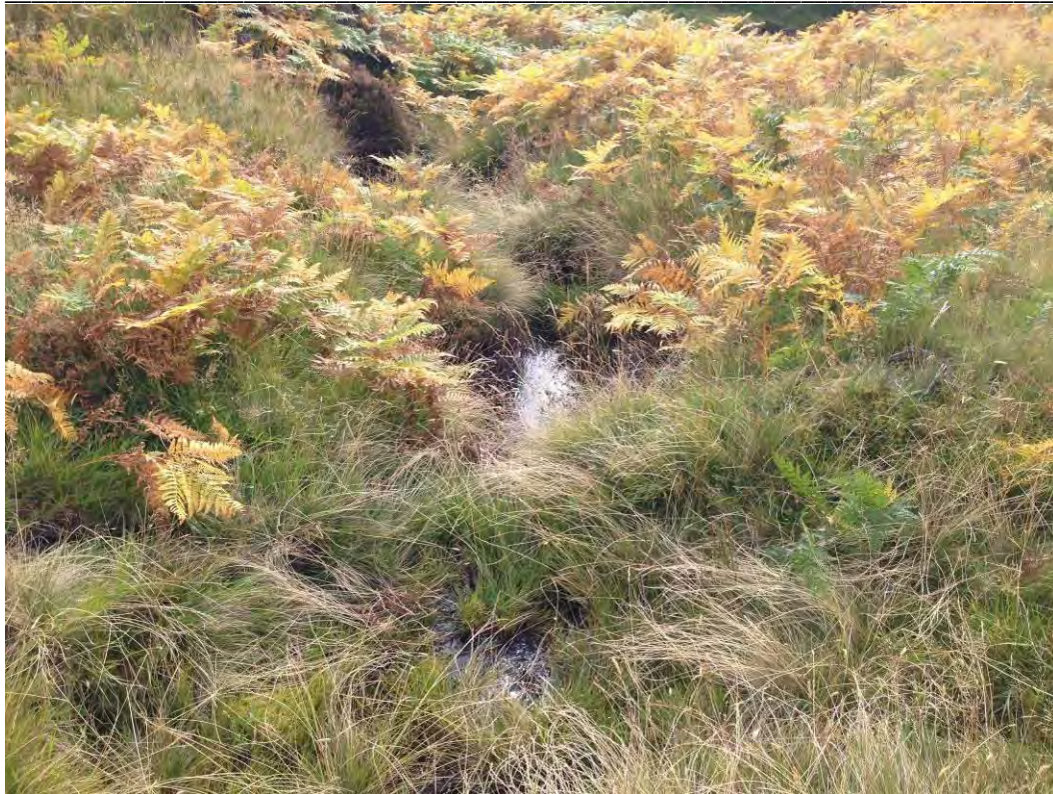
The tributaries of the Allt Smeorail were all very small (c. 0.5m wide, 10cm deep) with poorly defined channel with little or no tree cover (Figure 38) and all offered very poor freshwater pearl mussel habitat

**Figure 38: Upper tributary – poorly defined channel, unsuitable habitat for freshwater pearl mussels**
