3 RESULTS

3.1 Aerial Assessment and Habitat Impacts

Table 2: Target notes from ground truthing survey of the predicted impact zone at the Yellow Bog Access Track

Client SSE Renewables
Project Strathly South Wind Farm Yellow Bog Access Track
Title Site Location Plan

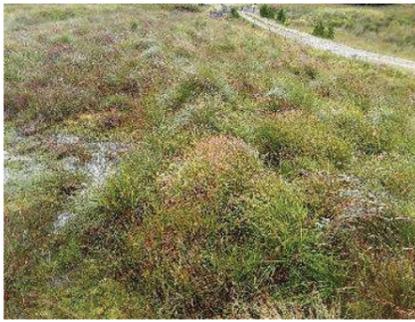
Target notes from ground truthing survey				
Target Note Number	East	North	Note Description	Location Photograph
1	952082	280145	Area dominated by purple moor grass (<i>Molina caerulea</i>) and hare's tail cotton-grass with patches of common cotton-grass, ling heather (<i>Calluna vulgaris</i>) abundant along with cross-leaved heath (<i>Erica tetralix</i>). Hair-cap moss species (<i>Polytrichum</i> spp.) in exposed areas following works and along ditches. In hollows soft rush (<i>Juncus effusus</i>) is abundant. Tormentil (<i>Potentilla erecta</i>) is also abundant throughout the sward. Pleurocarpus moss species are common in the drier areas of the spoil mound from road construction.

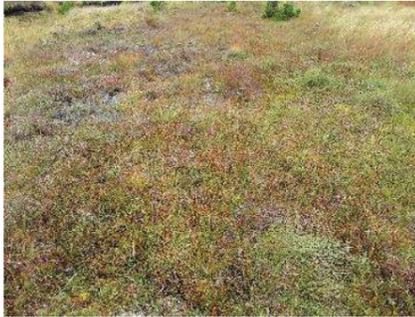
2	952113	280117	M17 mire has developed at this location in the low depression. Ling heather, bog myrtle (<i>Myrica gale</i>) and deer grass (<i>Trichophorum germanicum</i>) abundant. Cross-leaved heath, hare's tail cotton-grass are common throughout the area with a rich sphagnum layer present including large patches of <i>S. capillofolium</i> , <i>S. papillosum</i> and <i>S. cuspidatum</i> .

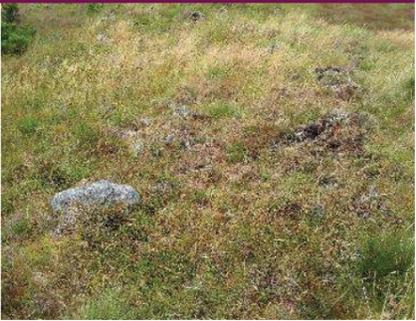
Target notes from ground truthing survey				
3	952129	280114	A drier area on shallow peat/rock substrate dominated by bent grass species (<i>Agrostis</i> spp.). Blanket bog species are beginning to recolonise with cross-leaved heath, ling heather, hare's tail cotton-grass, common cotton-grass and a layer of common bryophytes

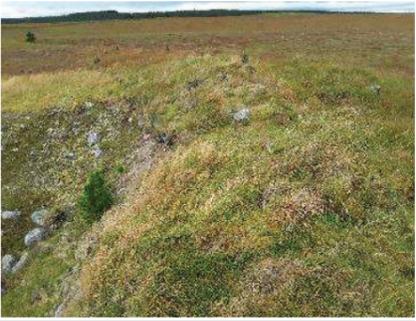
4	952148	280089	Borrow pit present at this location. Vegetation consistent with this drier habitat. Purple moor-grass dominant inter-mixed with bent grass species, ling heather and bell heather (<i>Erica cinerea</i>). Patches of crowberry (<i>Empetrum nigrum</i>) recorded with a bryophytes layer beneath grass / dwarf shrub heath sward. Sparse bryophyte cover present on rocky substrate in borrow pit bottom with some lodgepole pine regeneration.

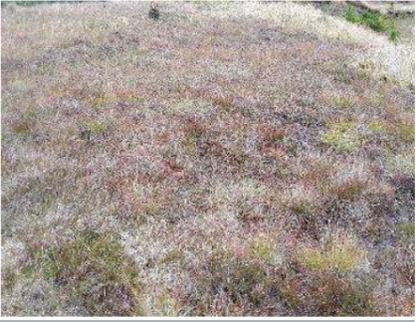
5	952138	280037	Bog myrtle, ling heather, common cotton-grass and deer grass most dominant species. Good layer of <i>S. capillofolium</i> throughout with small patches of <i>S. papillosum</i> .

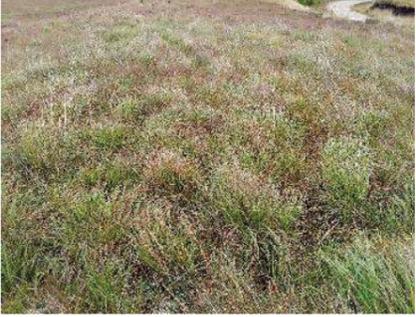
6	952132	280006	Purple moor grass dominated area with common cotton-grass common throughout the sward. Tormentil common beneath the grass sward.

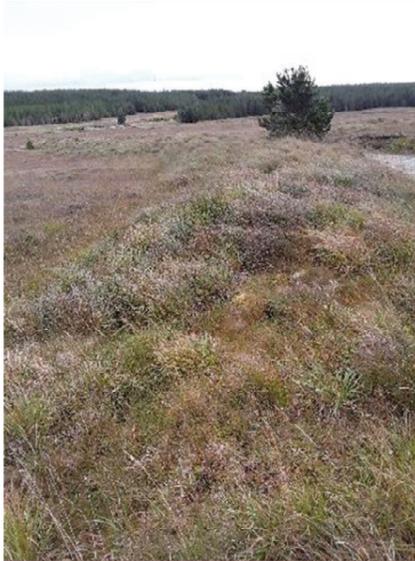
Target notes from ground truthing survey			
7a	952120	279893	<p>Species poor area dominated by purple moor grass with bent grass species present at lower densities. Tormentil common, bog myrtle and common cotton-grass present but sparse. Bell heather and ling heather common in low densities throughout sward. Hair-cap moss species common in patches, along with other pleurocarpus moss species Cladonia lichen species present. Raised area isolated from adjoining bog complex to north; vegetation community of little value</p>

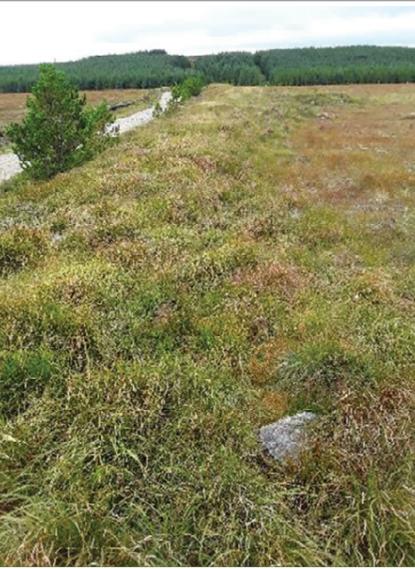
7b	952232	279740	<p>Description as per location 7a.</p>

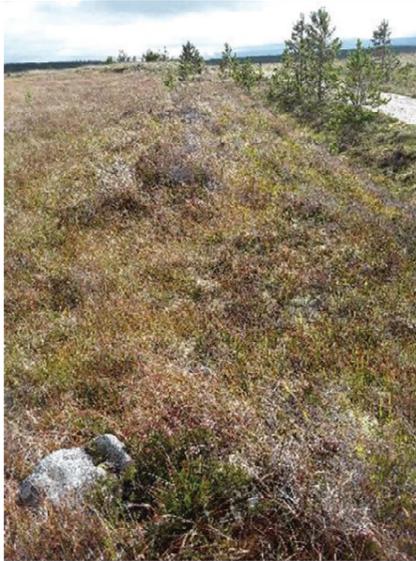
Target notes from ground truthing survey			
9	952279	279550	<p>Vegetation composition much the same as the adjoining blanket bog, hard to differentiate between the two. Shallow peat depth along this section. Soft rush present but sparse, purple moor grass more common closer to the track. Ling heather common and more dominant than in undisturbed ground. Ditch is filled with purple moor grass, bent grass species, and sedges. Bryophytes and ling heather most common towards top of the ditch, along with a carpet of Pleurocarpus mosses. Cladonia lichens common on south facing slope of northern ditch.</p>

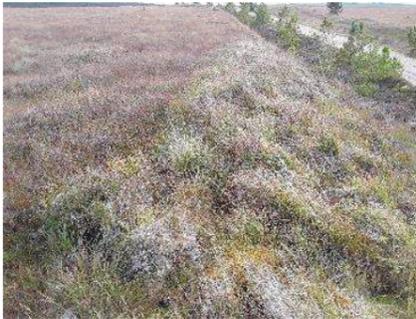
11	952330	279479	<p>Purple moor grass dominant interspersed with sparse tussocks of soft rush. Ling heather and cross-leaved heath common but sparse, bell heather present but uncommon. Tormentil and self-heal (<i>Prunella vulgaris</i>) present sparse throughout the sward. Bog myrtle present and common further west.</p>

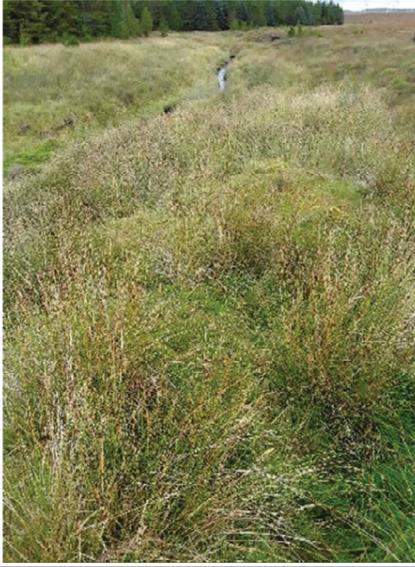
952349	279368	Soft rush dominated area along the burn and up the banking. Bent grass species and heath bedstraw (<i>Galium saxatile</i>) make up the predominant proportion of the vegetation.
13

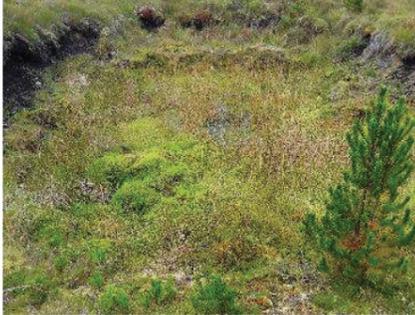
952329	279369	Borrow pit present at this location dominated by soft rush, hair-cap moss species, <i>S. palustre</i> , <i>S. cuspidatum</i> and other sphagnum species.
14

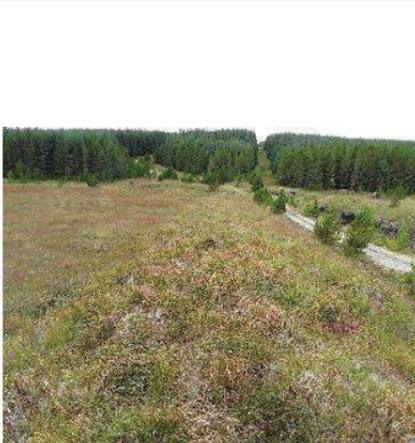
952320	279441	Purple moor grass dominated interspersed with tormentil, ling heather, crowberry, self-heal and cross-leaved heath. Bryophyte layer dominated by hair-cap moss species and woolly fringe moss (<i>Racomitrium lanuginosum</i>) although this is suppressed by the dense grass sward. Cladonia species present throughout. Occasional patches of bell heather present but the compartment is of little conservation value being isolated from the adjoining blanket bog due to raised topography. Dwarf birch is present in dense patches but is heavily grazed further east from waypoint toward the top of the watershed.

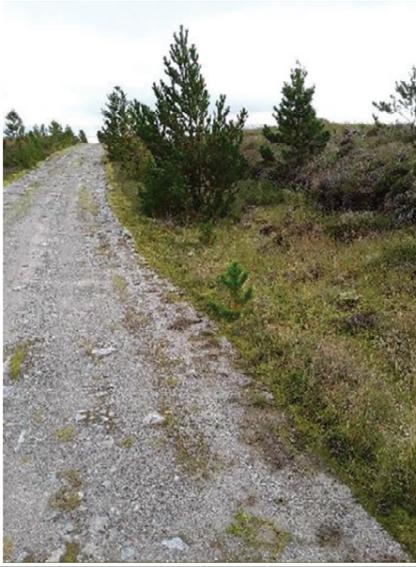
952317	279470	A ditch dominated by bryophytes and woody shrubs. Ling heather and crowberry present and common. Hair-cap moss species and pleurocarpus mosses dominant the ground layer. Purple moor grass and bent grass species common throughout the sward becoming more prevalent further up the ditch banking.
16

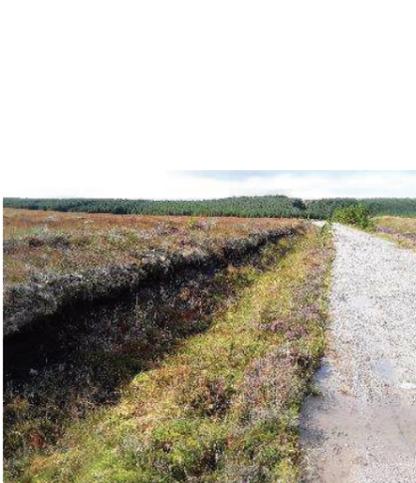
952236	279636	Ditches dominated by bryophytes, ling heather and cross-leaved heath in areas of rocky substrate, and woolly fringe moss in the drier areas. Hair-cap moss species are present in semi-wet areas transitioning into sphagnum species blankets and purple moor grass where some standing water is present. Peat hags forming on the south ditch banking. Effect of the track construction disturbance stops at the edge of the ditch with little impact on the M17 blanket bog adjoining it. There appears to have been some recent subsidence of the ditch banking with peat bags slowly worsening. Recommend reprofiling ditch banking once work has been completed to prevent hags forming.

Erosion features were identified along the length of the track in the form of peat hagg and cracking. Peat hags have formed towards the peripherals of the track's length where peat accumulation is much greater than in the centre. For the most part the peat hags are stable and do not appear to be deteriorating at a rapid rate. However, to the eastern extent of the track there is a peat crack has begun to form ca. 1m behind the peat hag. This will eventually entirely separate from the peat mass and increase the speed at which erosion occurs.

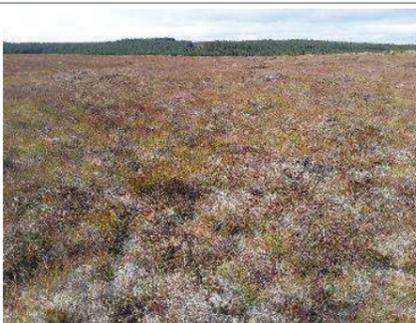
952166	279788	Uniform M17 community to the north and south of the track. Dominated by deer grass, ling heather and to a lesser extent purple moor grass with a carpet of <i>S. capillofolium</i> and Cladonia species. Round sundew (<i>Drosera rotundifolia</i>) and cross-leaved heath also noted.

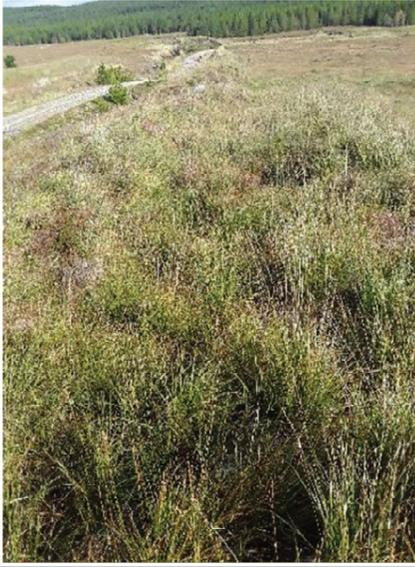
Target notes from ground truthing survey			
18			
	952078	279956	As per description for notes 7 and 14.

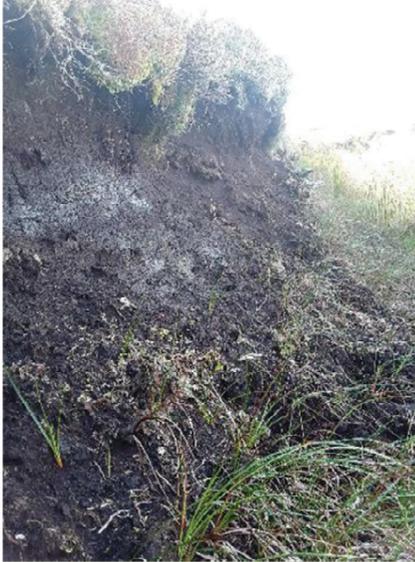
19			
	952106	280023	Road spoil and ditch present at this location. Ditch vegetation is dominated by soft rush and standing water with Sphagnum species common. Common cotton-grass beginning to colonise the bare peat caused by worsening haggling. Hair-cap moss species common on spoil heap along with bent grass species and ling heather. Lodgepole pine regeneration present along the ditch. Bare peat present along length of this section; large cracks forming ca. 1m behind peat hag that will eventually cause subsidence of that peat mass.

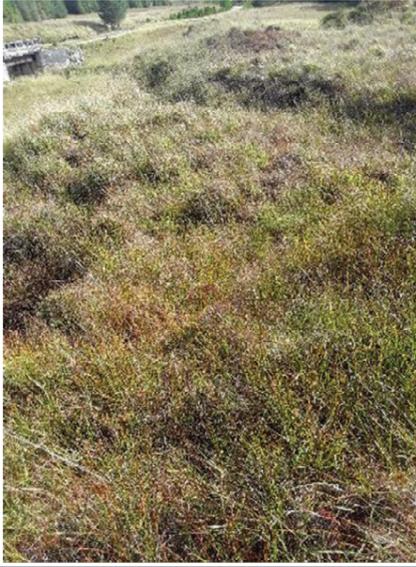
Target notes from ground truthing survey			
20			
	952048	280138	Common cotton- grass, purple moor grass and ling heather dominant the area, with cross-leaved heath and bog myrtle present but sparse. S. capillofolium carpets are present in depressions. The habitat appears to be slowly recovering to M17 blanket mire with deer grass beginning to encroach from adjoining habitat. The compartment currently species poor overall, with few areas of floristic value ecologically. Peat appears to be deep and water table high due to topography.

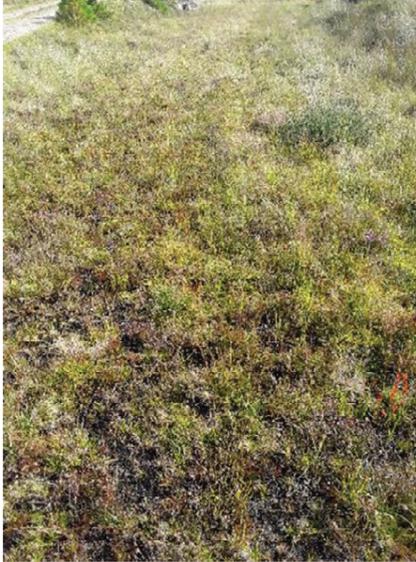
21			
	952050	280159	Rocky substrate with very shallow layer of peat. Ling heather, heath rush (<i>Juncus squarrosus</i>) and purple moor grass the dominant species. Pleurocarpus mosses, hair-cap moss species and sphagnum species form the majority of the bryophyte ground flora. Sphagnum species present only further east closer to stream where ground holds more moisture.

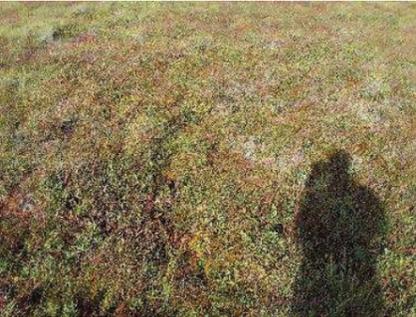
22			
	952174	280059	An area of M17 blanket mire. Deer grass, bog myrtle, common hare-grass and ling heather dominate the field-layer. Sphagnum carpets blanket the ground layer with S. capillofolium the dominant species present. Bog asphodel (<i>Nartheicum ossifragum</i>) present but sparse, hare's-tail cotton- grass tussocks sparsely distributed. Wooley fringe moss hummocks are present. Further west deer grass becomes more dominant and bog myrtle and hare's-tail cotton-grass are no longer present or very uncommon. Habitat generally becoming drier towards the watershed with sphagnum cover

falling. Purple moor grass very sparse and low cover in comparison to its dominance in the disturbed ground either side of the track.
--	--	---
