## Habitat Restoration Opportunities for Cloiche Wind Farm – Site Visit Report

Alba Ecology Ltd.

**September 2021**

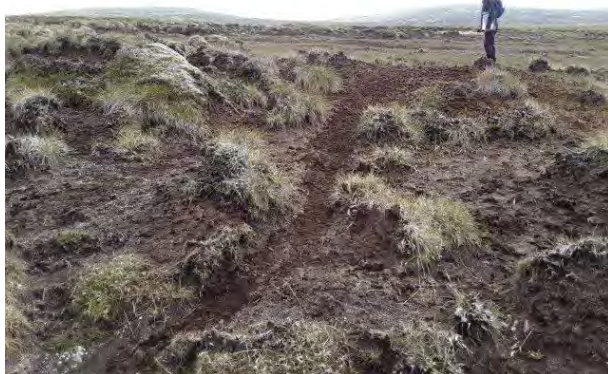
*Photo 10: A recent deer trail in bare peat between tussocks of hare's-tail cottongrass.*

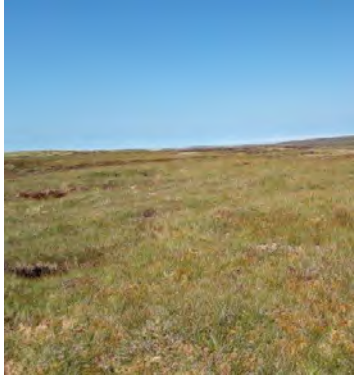
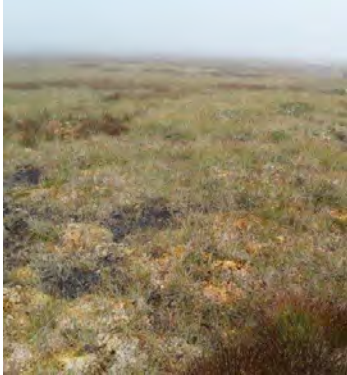
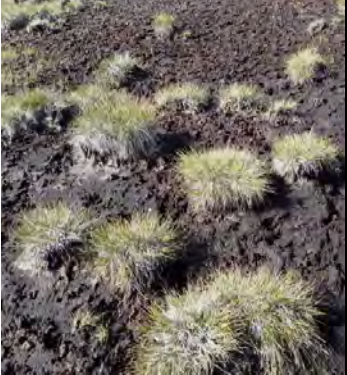
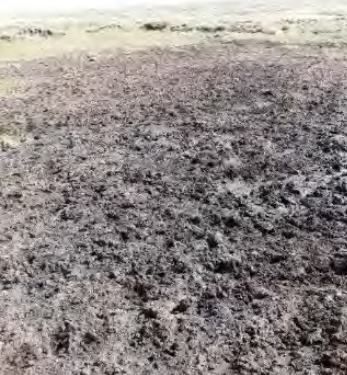
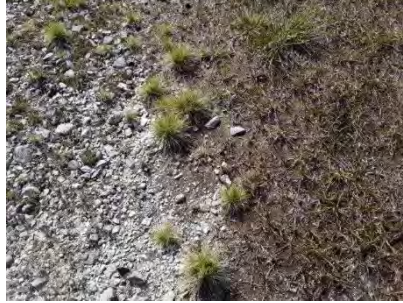
Table 1: Demonstrating the direction of change of the blanket bog habitat within the Search Area from blanket bog habitat to bare peat pans.

Good quality blanket bog vegetation with hummocks and hollows.	Blanket bog vegetation degraded with bare peat patches.	Tussocks of vegetation remaining with actively eroding bare peat surrounding tussocks.	Bare peat actively eroding	Either common cottongrass colonising the bare peat or mineral soil/bedrock exposed.

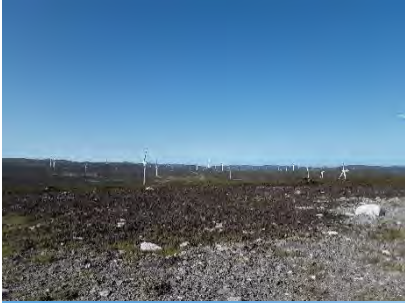
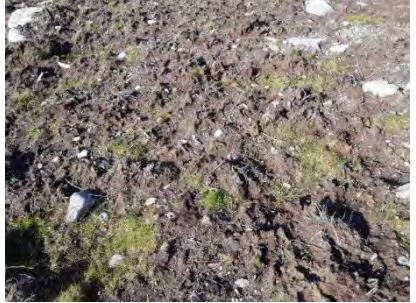
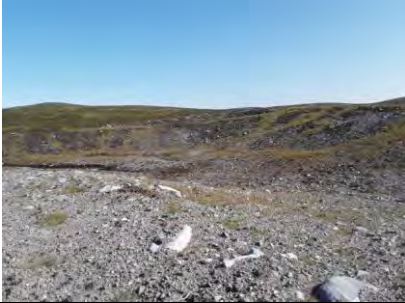
TG	Grid	Note	Comment	Photos
1	NH 56513 03884	View and borrow pit.	View of Stronelaig Wind Farm. There was bare redistributed peat and soil, ca. 50cm deep, around a borrow pit from the construction of Stronelaig Wind Farm. This could be re-seeded. Many detrimental signs of red deer obvious in the bare peat and soil.

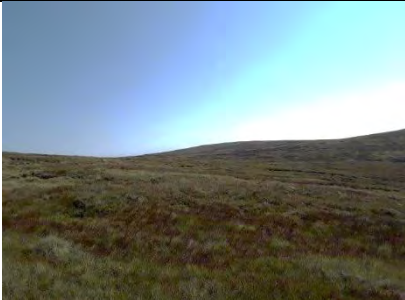
2	NH 58526 03552	Deer.	Ca. 30 deer in the distance on the shoulder of a hill.

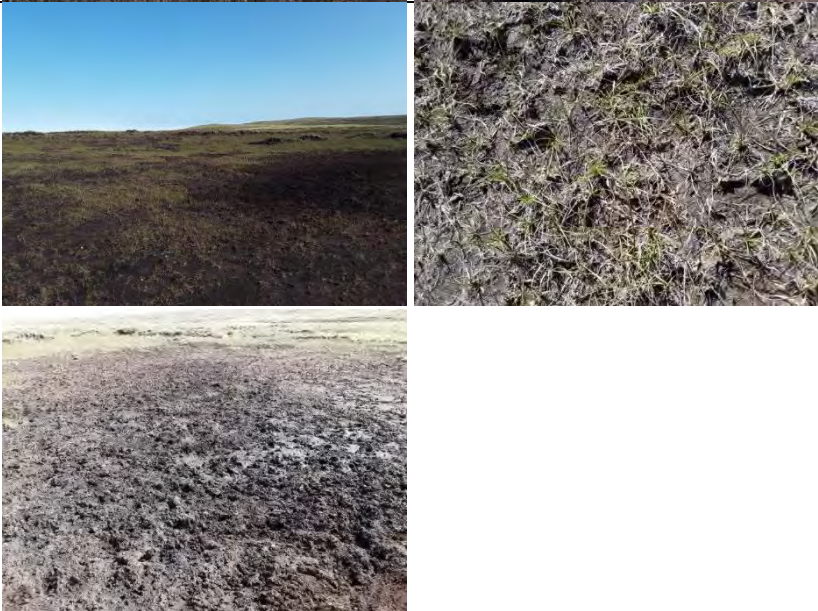
5	NH 58955 03581	Bare peat partly recolonised.	Large bare peat pan ca. 100m x 120m. Some natural re-colonisation (ca. 70% cover) but it was restricted to common cottongrass. The re-colonisation was not uniform, with patches showing clear sign of active erosion. There was ca. >1m of peat below the pan, demonstrating a large resource of peat that was exposed and eroding. Recommend: Reduce grazing pressure hugely. Mulch and re-seeding. Re-profile edges of pan to prevent it further expanding.

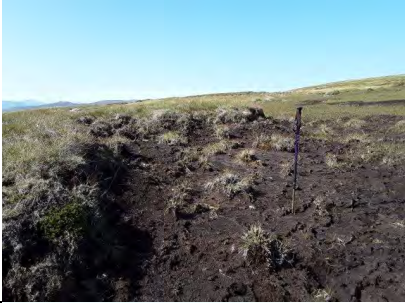
TG	Grid	Note	Comment	Photos
6	NH 58956 03581	Erosion hagg.	Erosion faces around the bare peat pan. This one was less than 1m high. These could be re-profile to prevent further expansion of the bare peat pan.

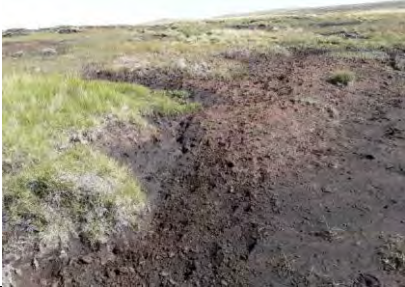
7	NH 58974 03560	Deer prints in bare peat.	Clear evidence of active erosion from deer prints in this bare peat pan which was ca. 10m x 10m in size.

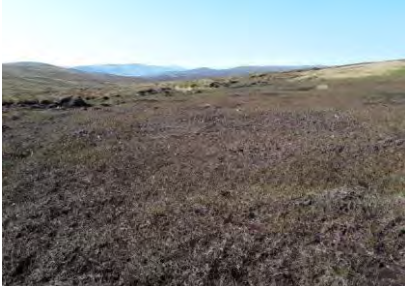
8	NH 58974 03551	Re-colonisation.	This large bare peat pan (ca. 30m x 30m) was colonised by common cottongrass. Deer prints were evident throughout the pan.

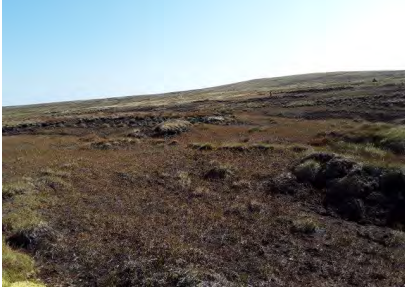
9	NH 59034 03523	Bare peat pan.	Common cottongrass partially re-vegetated over an area of bare peat (ca. 10m x 30m). There was ca. 70% cover of common cottongrass. Rocks showing through in some places but clearly deep peat in other location. Many deer prints evident in the bare peat.

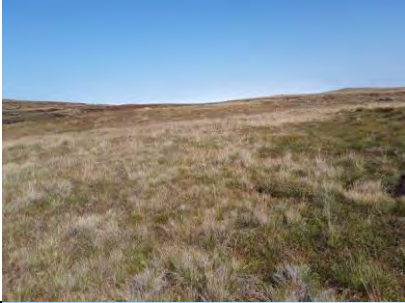
TG	Grid	Note	Comment	Photos
10	NH 59027 03530	Montane grassland.	Montane grassland dominated by mat grass and stiff sedge with lichens (NVC community U7).

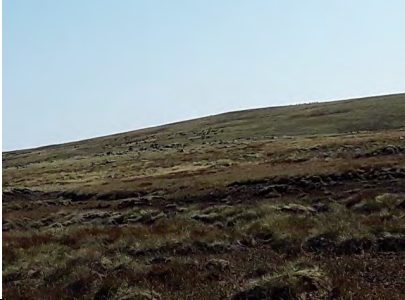
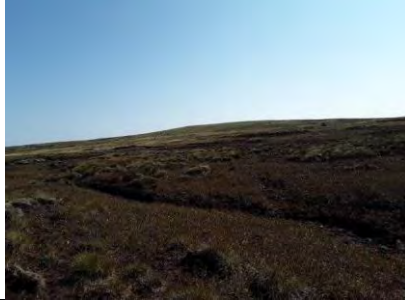
11	NH 59064 03518	Deer.	There were up to 350 red deer visible on hill slope.

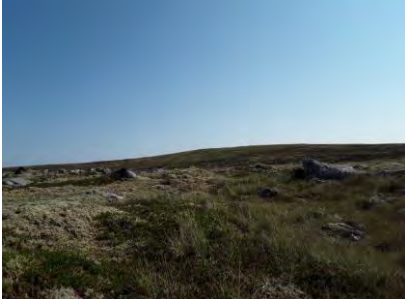
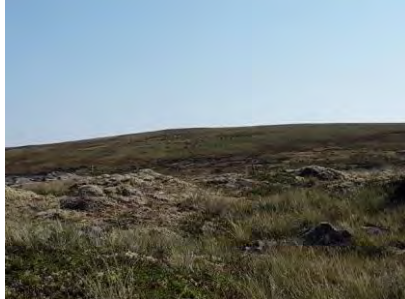
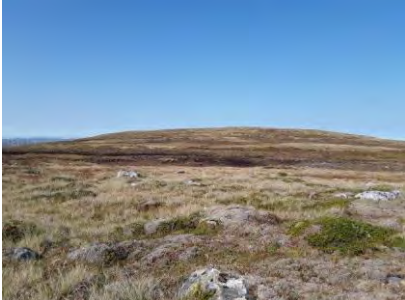
12	NH 59249 03495	Deer.	There were up to 350 deer visible on the hillside. Peatland restoration would only be successful if deer numbers are substantially reduced.

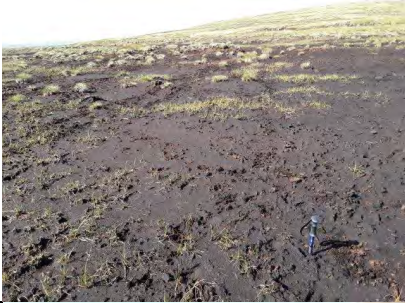
TG	Grid	Note	Comment	Photos
13	NH 59180 03536	Bare peat.	The very large bare peat pan was partially vegetated with common cottongrass, but there were smaller patches within it that were 98% bare peat, with just a little common cottongrass. The bare peat pan was estimated to be over deep peat (>1m deep). Deer prints were frequent across the pan. It was considered to be actively eroding. This area was located within the SAC.

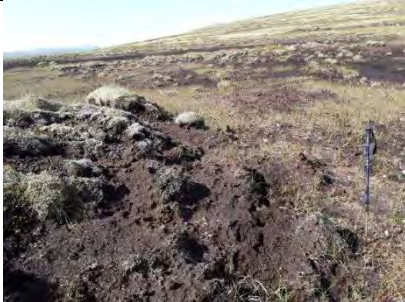
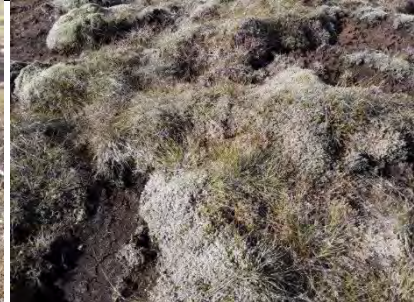
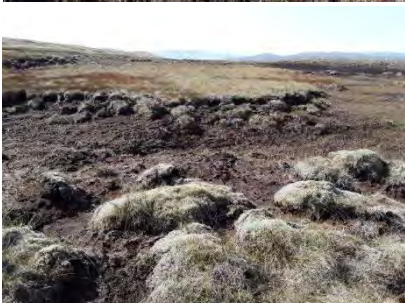
14	NH 59176 03526	Erosion hagg.	Erosion face at the edge of the bare peat pan was ca. 1.5m high. It was an active eroding edge, causing the pan to expand. There were occasional islands of remaining peat in the pan, but they were actively eroding. The vegetation at the top of the erosion features was largely woolly fringe moss with wavy hair-grass, blaeberry and lichens.

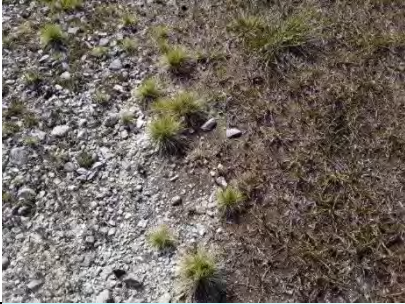
TG	Grid	Note	Comment	Photos
16	NH 59318 03431	Re-colonisation.	On the peat surface, where re-colonisation was seen, it was exclusively common cottongrass. Where there was mineral soil mat grass, stiff sedge, crowberry and mosses such as woolly fringe moss were seen to colonise.

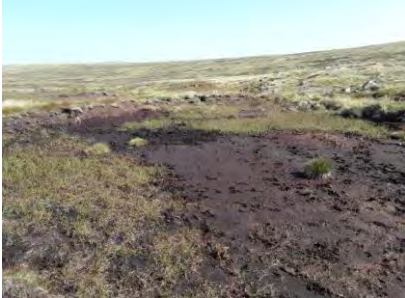
17	NH 59324 03397	Bare peat.	A ca. 20m x 10m of patch of near complete bare peat in a larger bare peat pan with common cottongrass colonising. Clearly actively eroding.

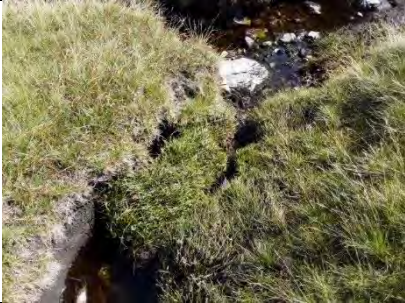
21	NH 59461 03577	Evidence of active erosion.	Large peat particles were deposited on the vegetation around this stream. Clear evidence of active erosion in higher water flows.

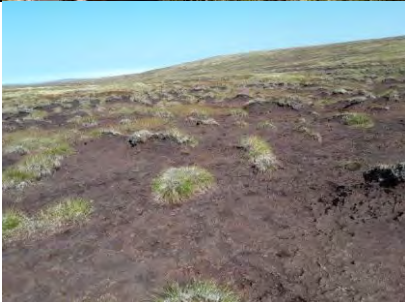
22	NH 59478 03611	Evidence of active erosion.	Tussocks of deergrass and hare's-tail cottongrass surrounded by bare peat. Active erosion. It was estimated this was on deep peat (>1m).

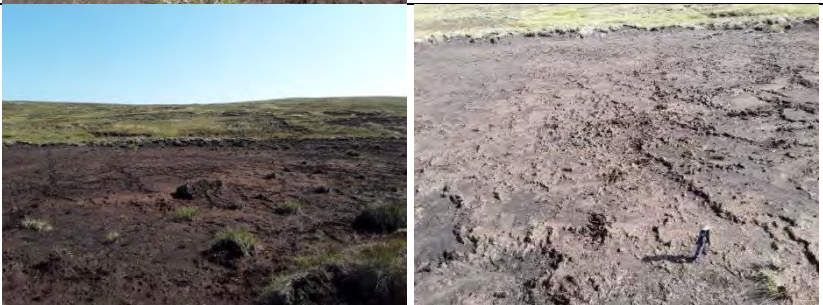
23	NH 59571 03760	Large bare peat pan.	There was a large bare peat pan ca. 50m x 100m. There were deer prints frequently across it. There was little to no re-colonisation. It was estimated this was on deep peat (>1m). Active erosion.

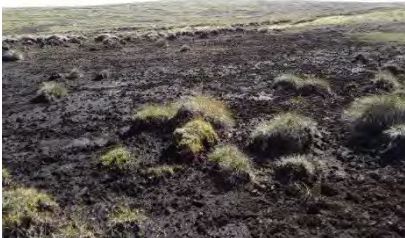
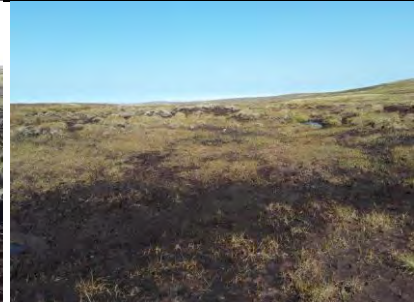
26	NH 59408 04175	Vast bare peat pan.	Bare peat pan ca. 450m x 150m, with a little common cottongrass. Large tracks with hare's-tail cottongrass hummocks with bare peat around them. The scale of degradation is extensive.

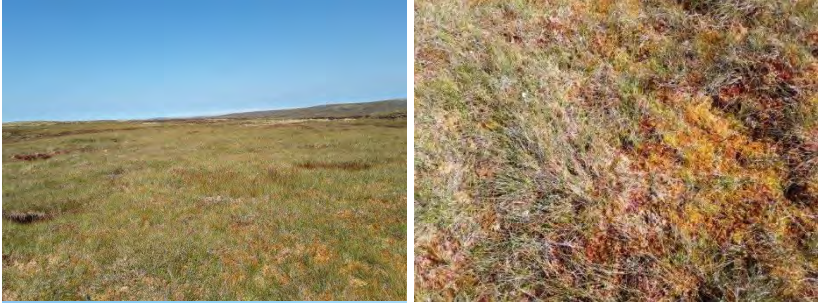
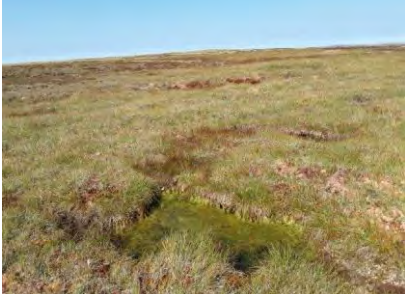
TG	Grid	Note	Comment	Photos
28	NH 59260 04415	M17a with M2 pools.	An area ca. 50m x 100m where bog-moss cover was good forming a near carpet. There were two M2 bog pools with feathery bog-moss. The vegetation was NVC community M17a with mostly deergrass, hare's-tail cottongrass, red bog-moss, papillose bog-moss and crowberry growing through it. There was also cowberry and little heather. This was a fragment or remnant of blanket bog in good condition.

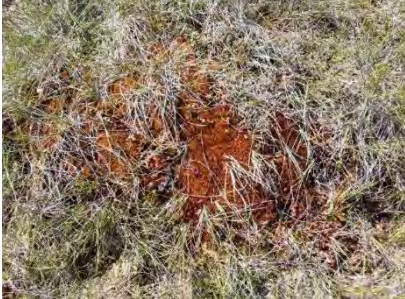
29	NH 59260 04415	Rusty bog- moss.	Rusty bog-moss was in a hummock that was ca.60cm wide and 15cm deep. Cloudberry, woolly fringe moss and blaeberry were within the hummock. The hummock was within the M17a community.

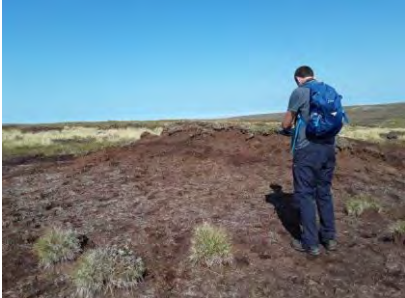
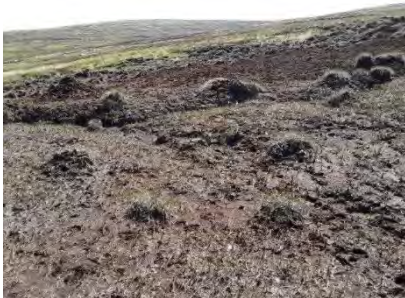
32	NH 59307 04580	Remnant peat island.	There was a ca. 1.5m high peat island in a large bare peat pan. There was a little re-colonisation by common cottongrass.

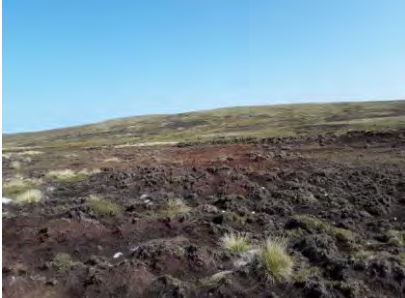
33	NH 59225 04593	View.	A view of a typical large peat pan.

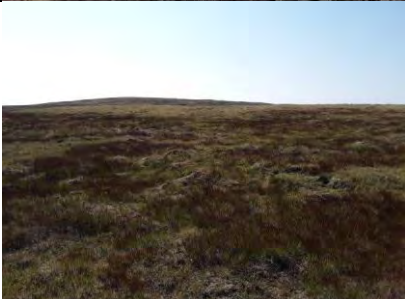
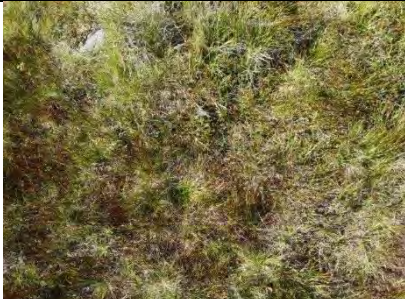
34	NH 59235 04663	Montane grasslands.	The grassland had abundant deergrass with tormentil, mat grass, heath rush, alpine bearberry, cowberry and crowberry. Woolly fringe moss was abundant (NVC community U5e).

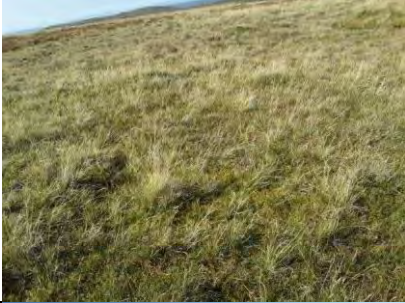
TG	Grid	Note	Comment	Photos
35	NH 59238 04701	Montane grasslands.	Mat grass dominant with heath rush and stiff sedge. The ground flora included little shaggy moss, red-stemmed feather-moss and woolly fringe moss (NVC community U7a).

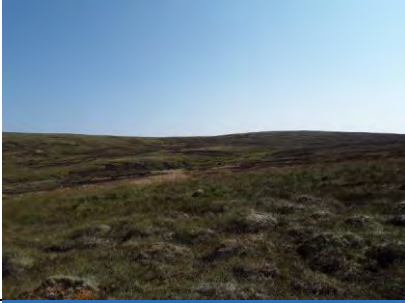
36	NH 59326 04746	View.	View looking southeast showing extensive erosion.

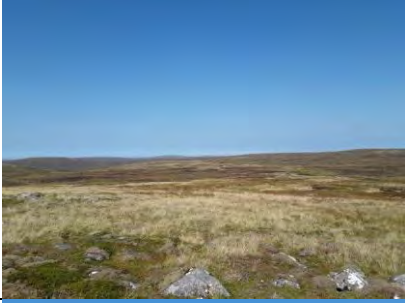
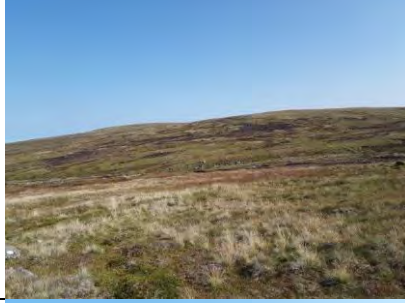
37	NH 59327 04753	Views.	View looking north showing extensive erosion (1 <sup>st</sup> photo). View looking east showing extensive erosion (2 <sup>nd</sup> photo).

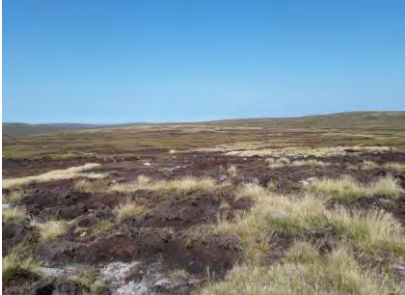
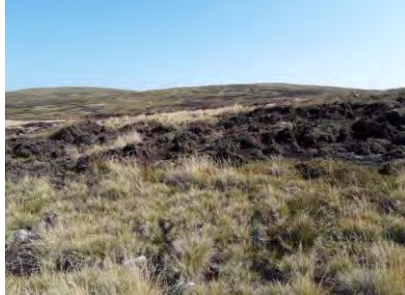
38	NH 59330 04968	Vast bare peat pan.	Erosion exposed the bedrock/substrate below. There were erosion faces at the edge of the pan, demonstrating expansion of a bare peat pan.

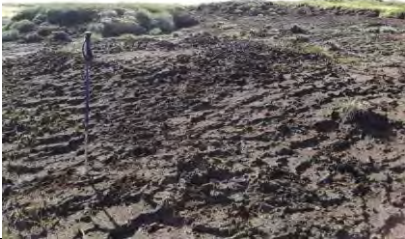
40	NH 59330 04787	Evidence of active erosion.	The ripples in the bare peat (>1m deep) demonstrate active wind erosion.

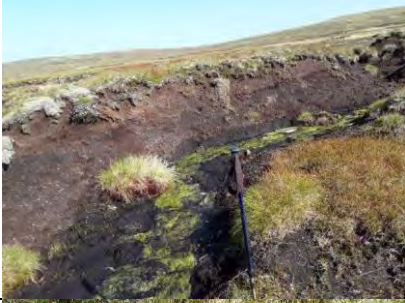
41	NH 59321 05106	Hagg erosion face.	There was a ca. 2m high erosion hagg which could be re-profiled to prevent further erosion. There was deergrass and woolly fringe moss on top of the erosion hagg.

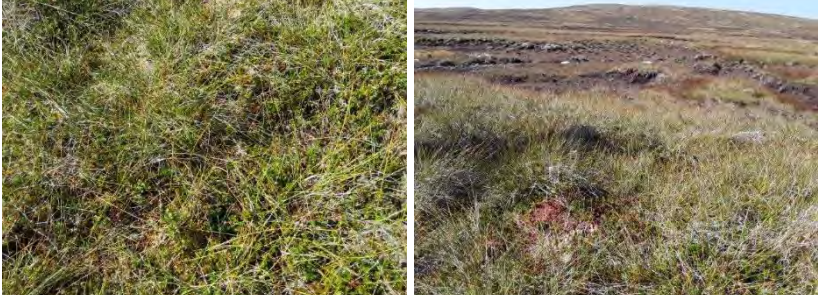
42	NH 59301 05119	Blanket bog vegetation.	Hare's-tail cottongrass was abundant growing through a mixture of low dwarf shrubs including crowberry, blaeberry and alpine bearberry. There was a layer of lichens over red bog-moss and woolly fringe moss (NVC community M20b).

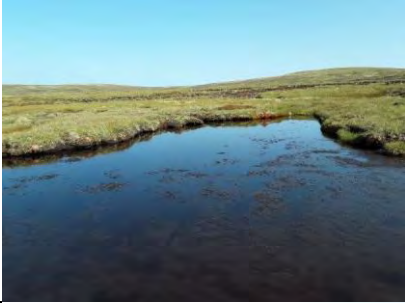
TG	Grid	Note	Comment	Photos
43	NH 59231 05168	Pool.	There was a large pool (ca. 10m x 10m). The bog vegetation surrounding the pool was dry. The water in the pool was ca. 50cm below the surface of the surrounding bog. The pool was murky with algae and a little feathery bog-moss.

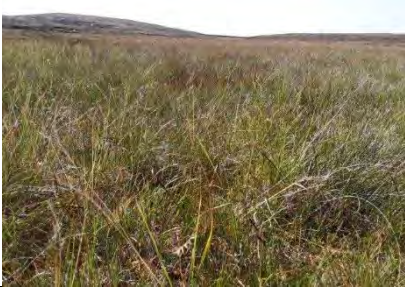
44	NH 59217 05200	Bottle sedge.	This area was in a topographically low and may once have been a fen. Bottle sedge was poking through the blanket bog vegetation which included red bog-moss and papillose bog-moss. There was hare's-tail cottongrass, common cottongrass, deergrass, mat grass and heath rush with a little sub-shrubs (NVC community M17c).

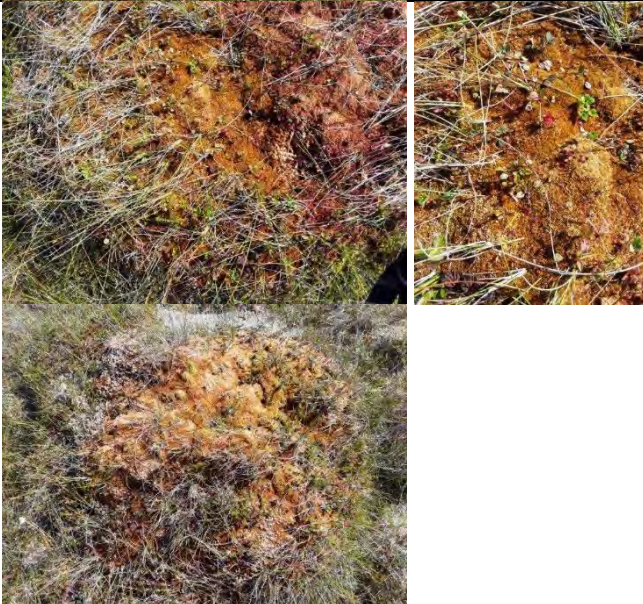
45	NH 59221 05240	Rusty bog-moss.	Two hummocks of rusty bog-moss. One was ca. 70cm wide 20cm high the second was ca. 1m wide and 50cm high. There was red bog-moss mixed in with the rusty bog-moss.

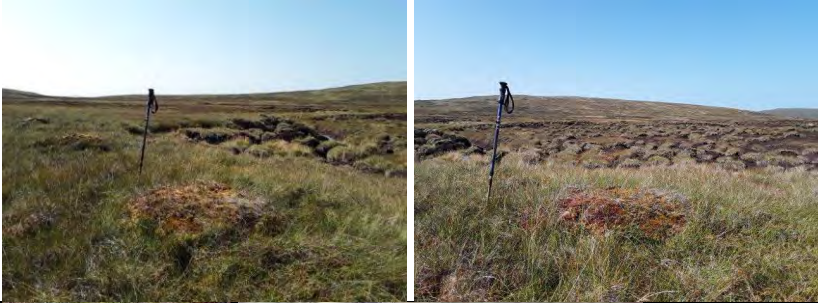
TG	Grid	Note	Comment	Photos
46	NH 59219 05240	Rusty bog-moss beside hagg system.	The rusty bog-moss hummock at this location was within 2m of an extensive erosion feature. It is a relic, in a fragment of blanket bog.

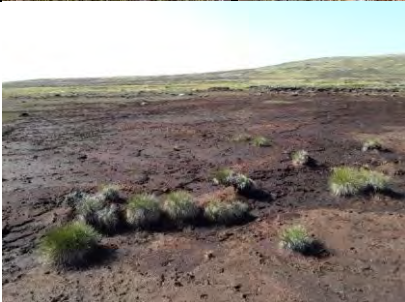
48	NH 59106 05221	Bare peat pan.	Very large area of bare peat. There was some common cottongrass colonisation but large areas were actively eroding.

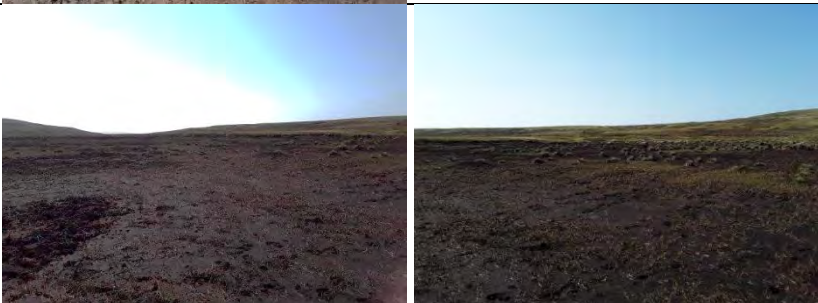
49	NH 58755 05139	Bare peat pan.	There was ca. 100m x 100m of bare eroding peat. There was ca. 10% common cottongrass but the area appeared to be expanding.

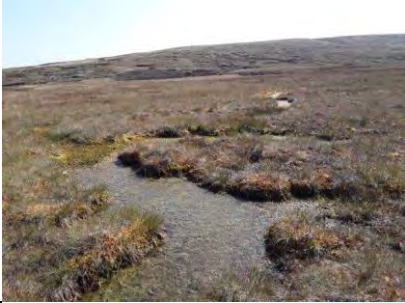
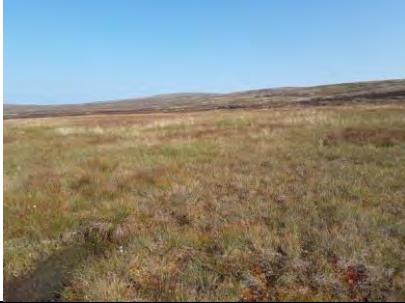
TG	Grid	Note	Comment	Photos
50	NH 58597 05101	M2 pool in open blanket bog.	There was an M2 pool with feathery bog-moss in open bog, with hare's-tail cottongrass and deer grass. There was a good cover of bog-moss (NVC community M17a). There was also occasional bottle sedge. There was little or no heather in this patch and in the whole of the Option Area.

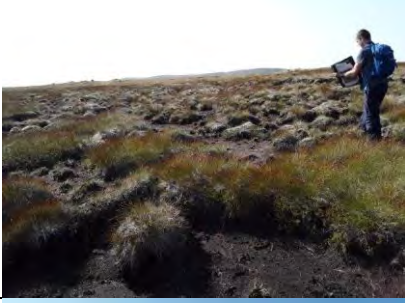
51	NH 58272 05299	Bare peat around tussocks.	The peat appeared deep (>1m). The area was not yet a bare peat pan, but tussocks of hare's-tail cottongrass and deergrass with woolly fringe moss were present between the bare peat.

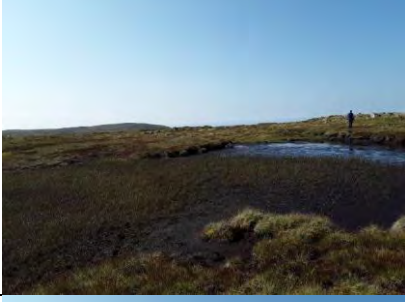
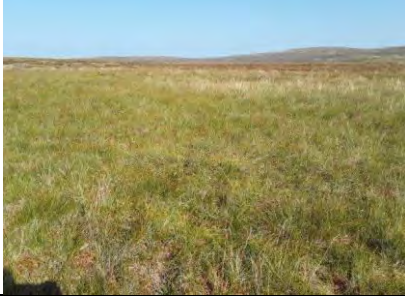
52	NH 58202 05282	Pools.	There was a species poor pool system (M3). There were no bog-mosses present. The area was surrounding by a species poor M17a blanket bog with bog-moss and bottle sedge.

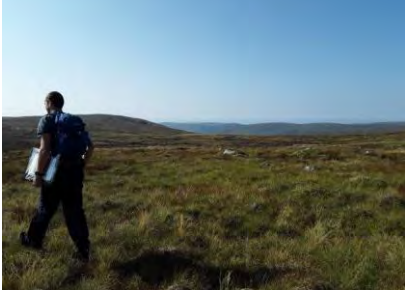
53	NH 58111 05293	View of deer.	There were ca. 40 deer seen on the hill slope in the distance.

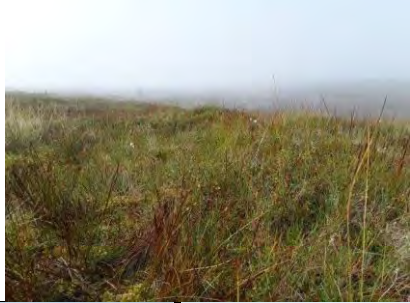
TG	Grid	Note	Comment	Photos
54	NH 57341 05518	Dwarf birch.	Dwarf birch was present in a transition point from montane heath to small patch of blanket bog, then into modified bog. The dwarf birch was amongst woolly fringe moss, hare's-tail cottongrass, crowberry, red bog-moss and deergrass. There was a hummock of rusty bog-moss.

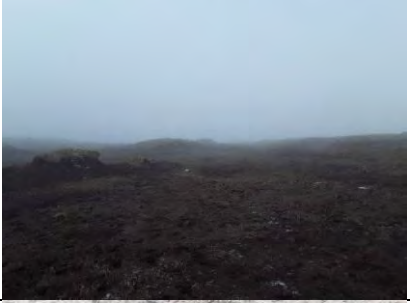
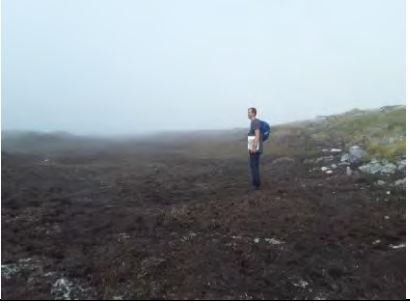
55	NH 58250 05514	Bare peat pan.	Very large bare peat pan ca. 100m x 150m. The erosion faces were ca. 1.5m high. There were occasional remnant islands ca. 1m high. To the east the pan had eroded to a rocky substrate. To the west the peat surface was actively eroding.

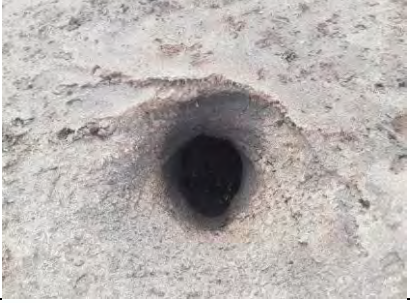
56	NH 58255 05503	Hole in peat.	There were several ca. 50cm diameter holes in the peat to underground pipes. The holes were ca. >1m deep with water flowing underneath.

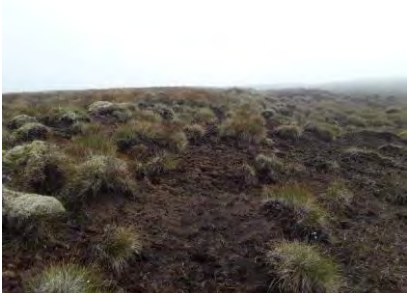
57	NH 58298 05382	Bog being lost.	Where blanket bog vegetation was actively being lost, there was often tussocks of hare's-tail cottongrass or deergrass, the roots holding the vegetation in place, but bare peat around the tussocks. These areas were located at the edge of peat pans, where they met intact fragments of bog habitat. It demonstrates that blanket bog vegetation is currently being lost and bare peat areas are expanding.

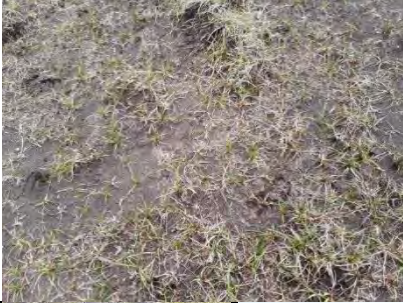
TG	Grid	Note	Comment	Photos
58	NH 58377 05381	Common cottongrass colonisation.	Common cottongrass was colonising bare peat surface. In some areas colonisation was quite extensive, in others it was very occasional.

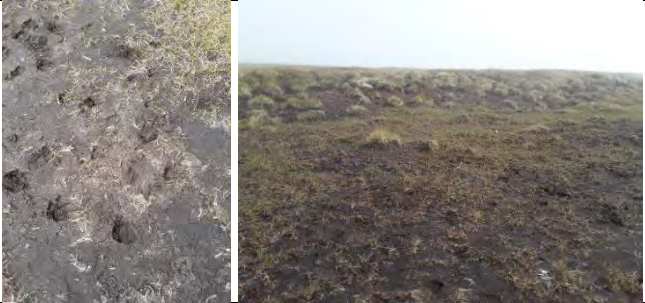
59	NH 58374 05379	Evidence of active eroding peat.	Bare peat was actively eroding, exacerbated by numerous deer prints. Areas with colonisation, areas of active erosion, and erosion of blanket bog vegetation can be in close proximity to each other. All three were within 20m at this location.

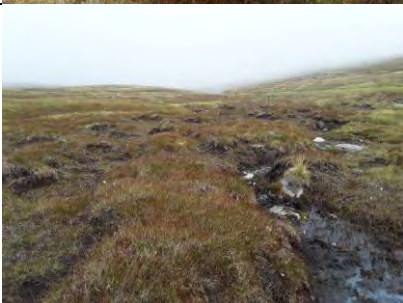
61	NH 58971 05766	Erosion gullies.	There were multiple erosion gullies (ca. 1m depth) within modified blanket bog, with woolly fringe moss as the edges of the erosion features. These gullies could be blocked to raise the water table and prevent further erosion.

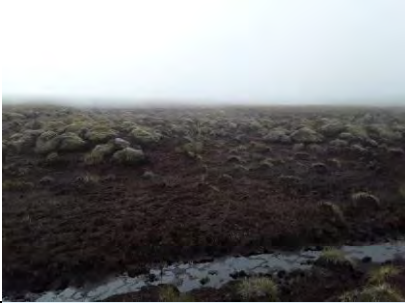
TG	Grid	Note	Comment	Photos
62	NH 59852 05947	Bare peat pan and tussocks of hare's-tail cottongrass.	There was deep peat (>1m deep) with a bare surface and some remaining tussocks of hare's-tail cottongrass. All this peat will be lost if there is no management intervention.

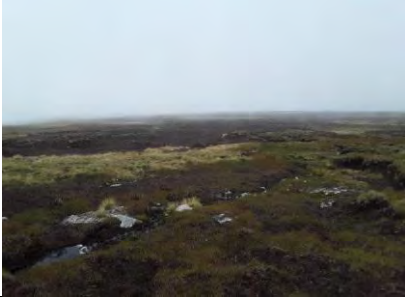
63	NH 60260 06570	Vast bare peat pan.	Ca. 250m wide and extensive bare peat pan. It was mainly bare peat with some colonising of common cottongrass and mat grass in places.

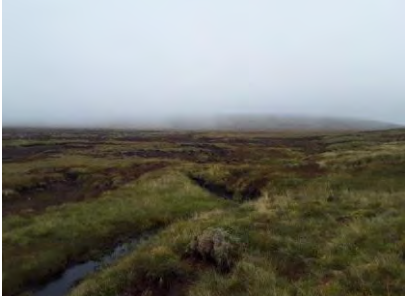
64	NH 60274 06691	View.	View of extensive bare peat pan. Slopes have all eroded with very little remaining bog as just small stripes. There were occasional patches in the centre of the bare peat pan which were deergrass and common cottongrass dominated.

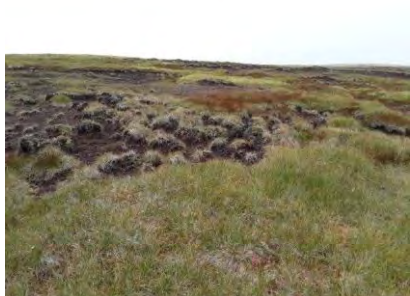
65	NH 60266 06720	Remnant bog.	Remains of blanket bog habitat. The patches were ca. 30m x 10m in size. They included red bog-moss, papillose bog-moss, hare's-tail cottongrass, crowberry, bilberry, alpine bearberry and deergrass. At the edges it breaks up into tussocks surrounded by bare peat, then it goes into the bare peat surface.

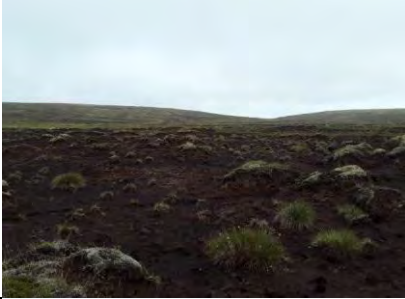
TG	Grid	Note	Comment	Photos
66	NH 60224 07046	Flat bare peat pan.	Given the conditions this whole area would revert to blanket bog, due to the deep peat below and the topography of a wide, flat area with slopes rising around it.

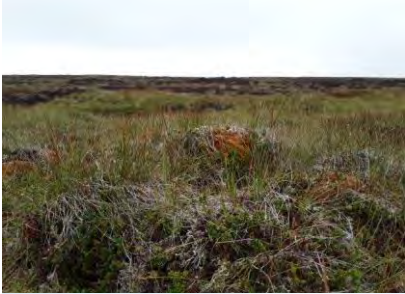
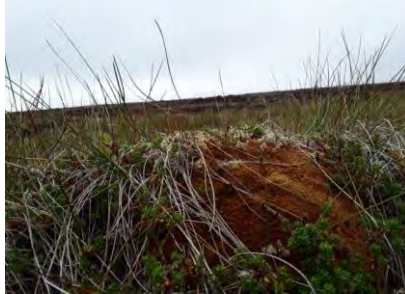
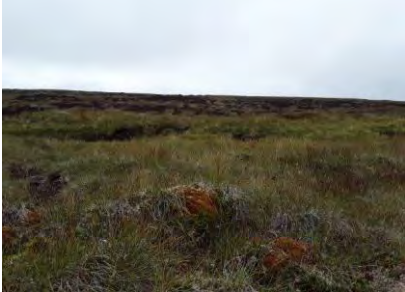
67	NH 60351 07125	Rusty bog-moss and bare peat.	There was a tiny patch of blanket bog habitat in a vast expanse of bare peat. The fragment of remnant bog was ca. 10m x 10m. Rusty bog-moss was present in several hummock.

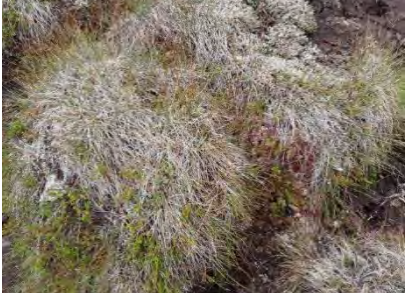
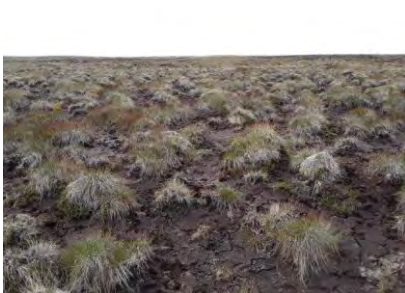
68	NH 60412 07086	Tussocks surrounded by bare peat.	Tussocks with woolly fringe moss, deergrass, crowberry, alpine bearberry, and red bog-moss.

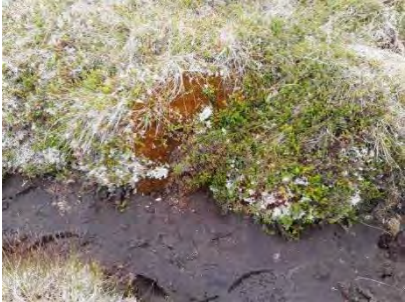
TG	Grid	Note	Comment	Photos
69	NH 60406 07029	Rusty bog-moss.	Rusty bog-moss beside bare peat.

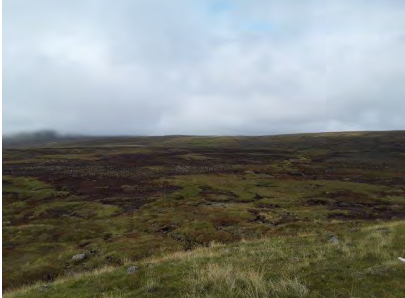
70	NH 60397 06695	View.	View of extensive area of bare peat, with some remnant bog.

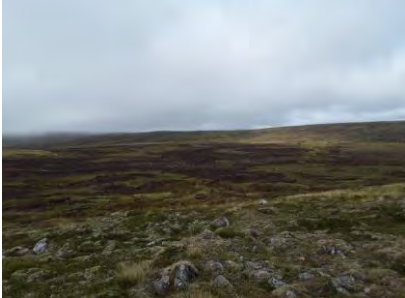
71	NH 60364 06630	View.	View of an area in north of Option Area. It is a large flat area suitable for restoration. The light area is the tussocks surrounded by bare peat. The orange areas are remnant bog with deergrass. Large areas of exposed deep peat are seen as the dark brown colour in this and other photos..

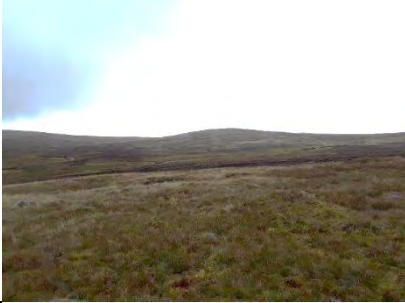
TG	Grid	Note	Comment	Photos
76	NH 59543 05685	View.	Extensive area of bare peat in the background.

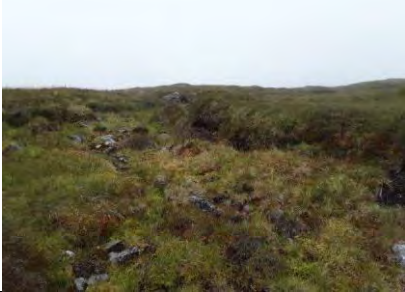
77	NH 57578 05727	Example of an erosion gully with vegetation.	Example of a revegetating gully. It was outside the Option Area. No revegetating gullies were seen within the Option Area. This gully was ca. 1.2m deep and was vegetated with wet heath vegetation including deergrass and heather.

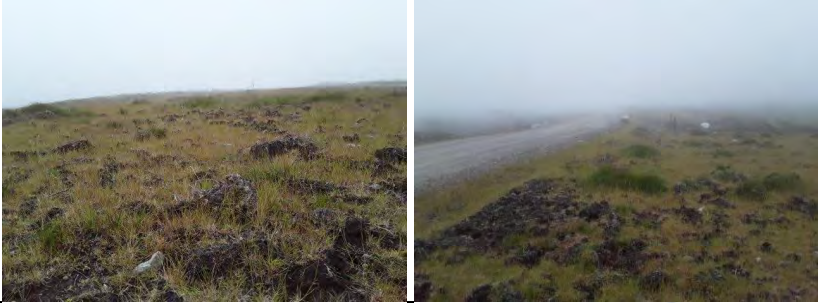
TG	Grid	Note	Comment	Photos
80	NH 56137 03848	Stronelairg re-instatement.	There was ca. 80% to 90% cover of vegetation on this redistributed peat beside the Stronelairg Wind Farm track. There were some patches of common cottongrass, heather and bog-mosses developing. Deergrass and crowberry were also present. It was establishing and the bare peat surface was largely covered with the nurse crop (including bent grasses, mat grass and wavy hair-grass). The re-instatement of vegetation was working better in some places than others.

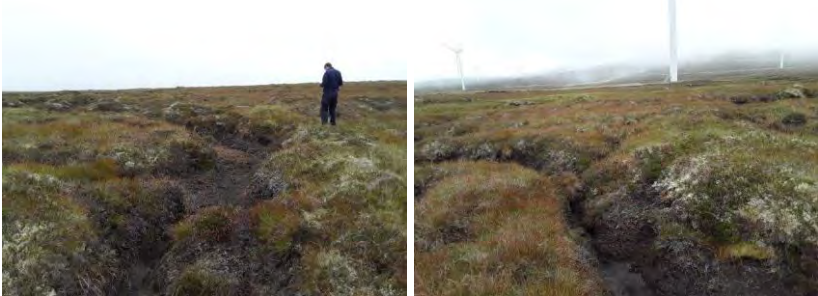
81	NH 48361 04356	Erosion gullies.	West of T4 of Stronelairg Wind Farm there were numerous erosion gullies. This one had a bare peat base. It was ca. 1m deep and 1-2m wide. The bog habitat was on a gentle slope. Blocking the erosion gullies would reduce erosion and raise the water table.

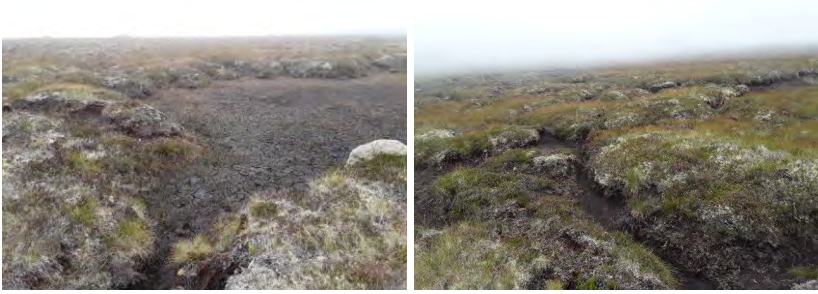
82	NH 48159 04507	Erosion gullies.	There was a network of small erosion gullies. They were ca. 1m deep and 50cm to 1m wide. The tops of this area had a high cover of lichens. These erosion gullies could be blocked.

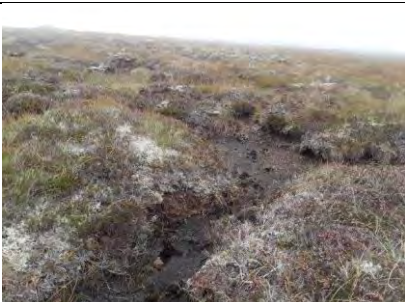
83	NH 48146 04515	Deer prints.	Detrimental deer impacts were evident. There were deer tracks on the bare peat within the erosion gullies exacerbating them.

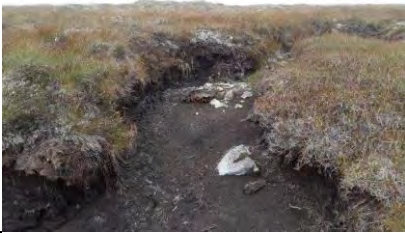
TG	Grid	Note	Comment	Photos
84	NH 48066 04616	Erosion gullies.	This erosion gully was ca. 1m wide and 1m deep. The blanket bog habitat was characterised by woolly fringe moss and lichens.

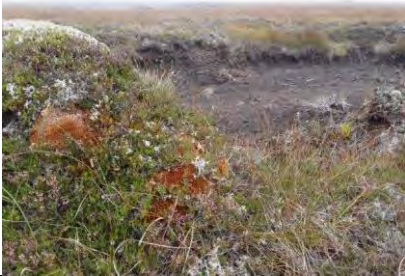
85	NH 48060 04621	Rusty bog-moss.	Rusty bog-moss was present with woolly fringe moss on edge of an erosion hagg.

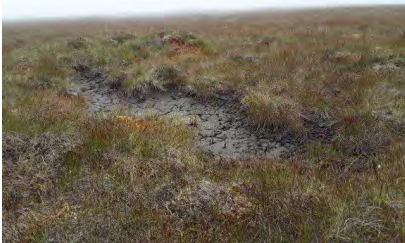
86	NH 48042 04638	Pools.	There were some dried out pools. If the water table was raised these pools would likely restore. They were present in some species poor M17a blanket bog with rusty bog-moss hummocks present.

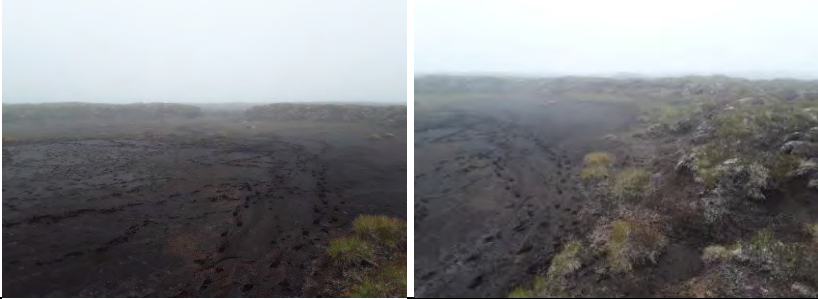
TG	Grid	Note	Comment	Photos
88	NH 47906 04673	Lost lochan.	Large bare peat area which is recorded on the OS map as a lochan. It was ca. 80m x 40m in size. There was a surrounding wall of peat around the lost lochan ca. 1.5m high. There was a clear breach in the wall and a section which was eroded. There were deer tracks within the bare peat.

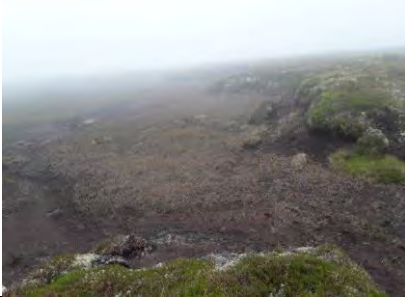
89	NH 47876 04690	Lost lochan.	The breach point of the lost lochan was ca. 3m wide. If it was blocked, then the lochan would likely refill with water.

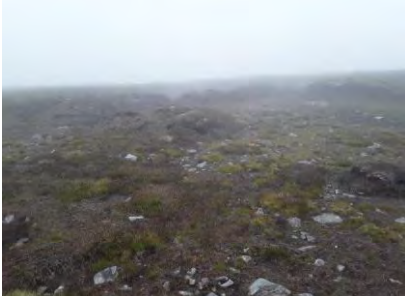
90	NH 47879 04693	Bare peat.	On the far side of the lost lochan there was an area eroded to bedrock.

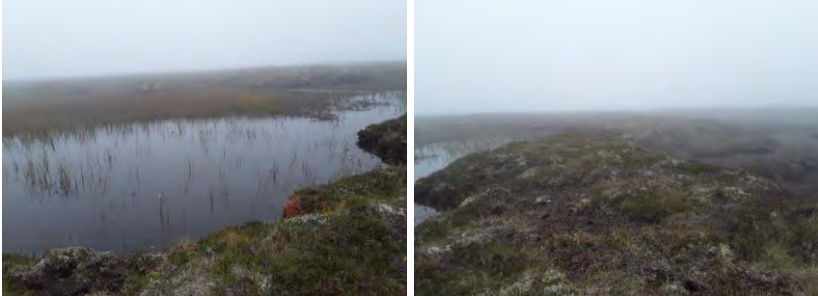
91	NH 47936 04581	Lochan.	There was a lochan with water and common cottongrass beside the lost lochan. However, the barrier wall was eroding. It was ca. 2m wide. This lochan could also be lost if action is not taken.
