# **TECHNICAL APPENDIX 10 – SOIL AND WATER**

SSE Generation Ltd Strathy South Wind Farm Peat Landslide and Hazard Risk Assessment

**Technical Appendix 10.1** Peat Landslide Hazard and Risk Assessment Prepared for: SSE Generation Ltd

SLR Ref: 428.00660.00070 Technical Appendix: 10.1 Version No: Rev 1 August 2020

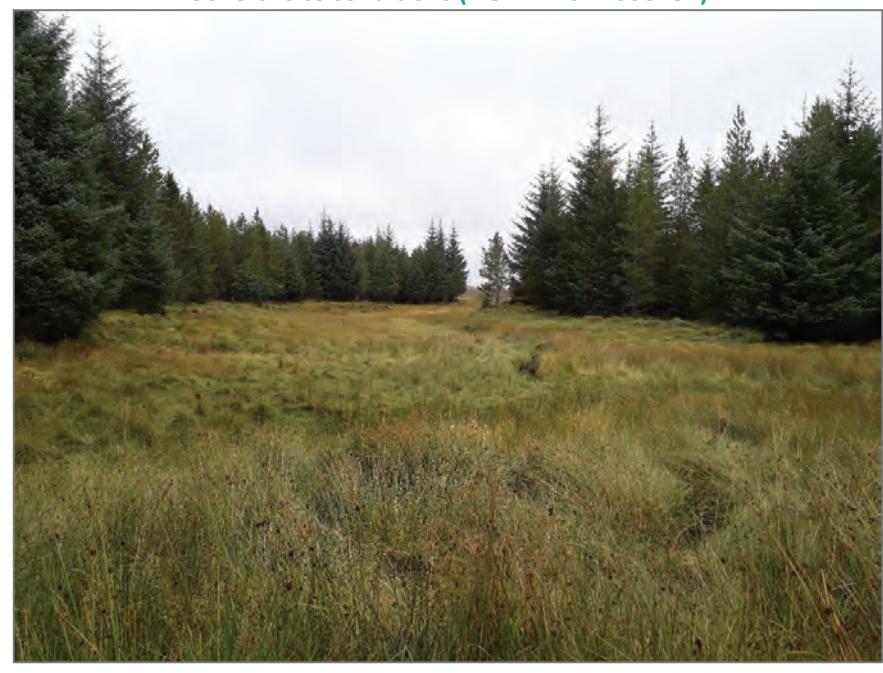
Photo 1-4 General site conditions (NGR 277617 953131)

Peaty soil and peat deposits cover most of the site and overlie glacially derived soils such as Glacial Till comprising, sand and gravels and in places bedrock. There are limited exposures of bedrock, where exposed it is observed to be metasedimentary rocks over the entire site.

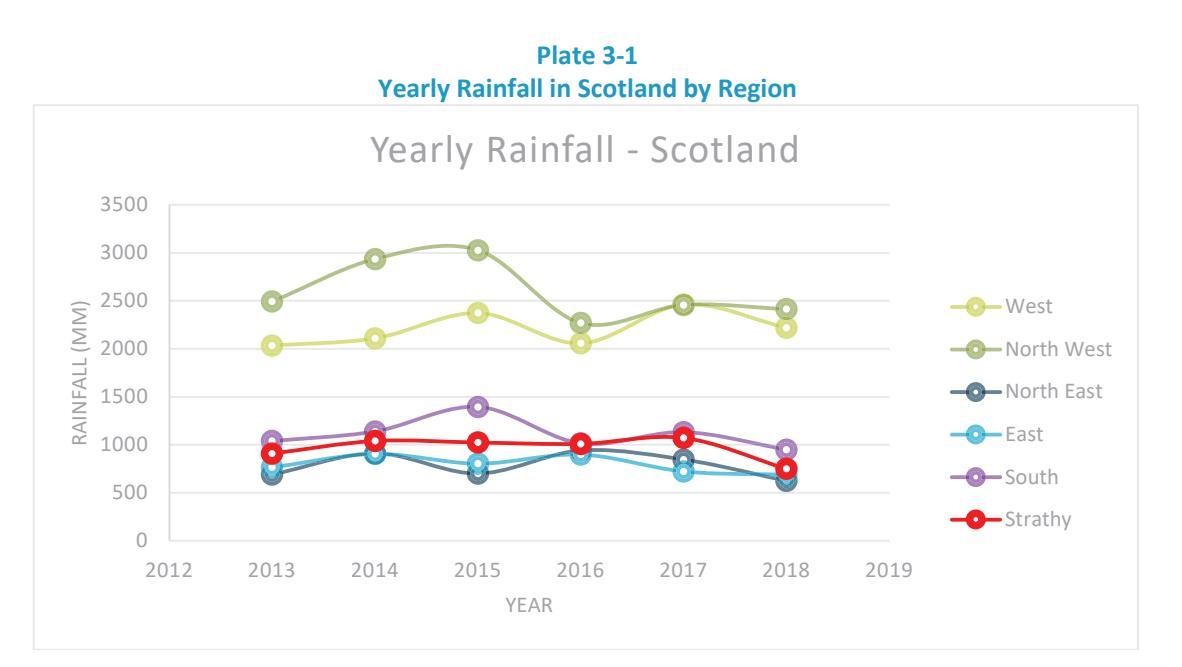
Periods of intense, heavy rainfall are often seen as a trigger for instability events. SEPA Rainfall data sourced from the Strathy Bridge weather station<sup>21</sup>, approximately 12 km north of the site, shows that the average annual rainfall in the region (2013-2018) is 967 mm per annum, as detailed in Plate 3-1. This is compared with less than 800 mm in the east and northeast of Scotland, greater than 1,100 mm in the south of Scotland and in excess of 2,000 mm in the west and northwest of Scotland.

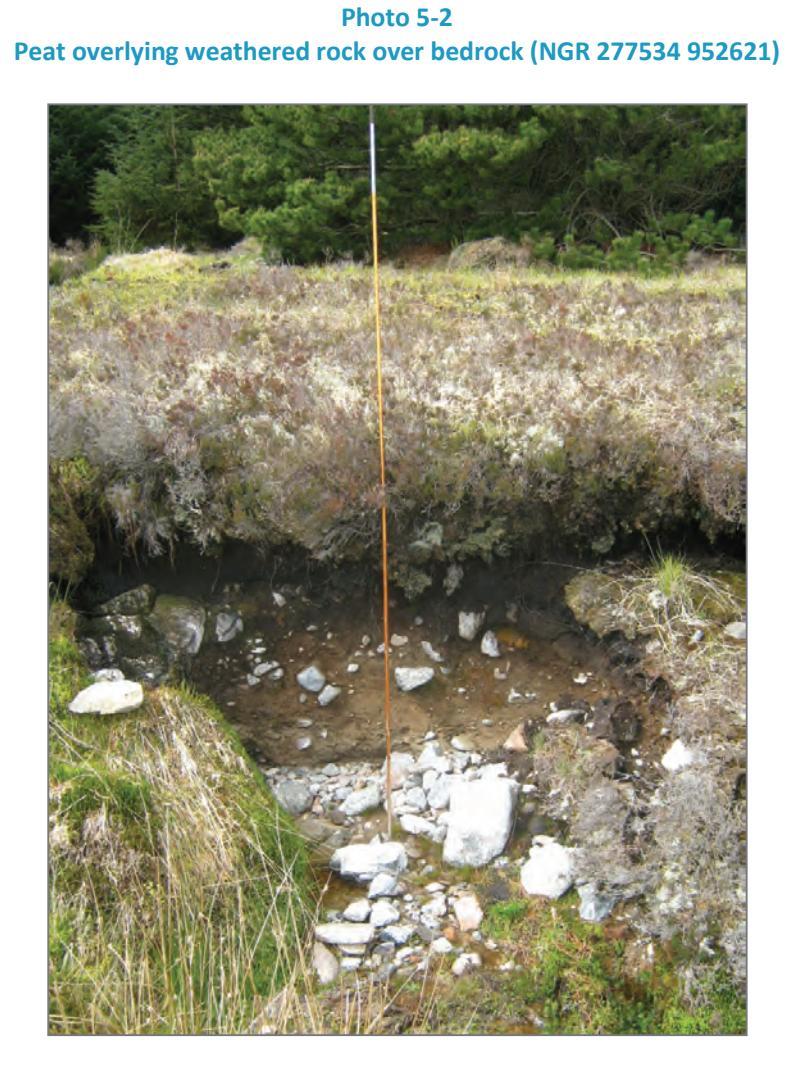
> Photo 5-3 Outcropping bedrock (NGR 280699 950347)

- Granular (sand and/or gravel/weathered rock), of glacial origin and occasionally interbedded with silty sands;
- Rock no rock samples were recovered from the probe locations although where exposed, the rock was • foundations; and
- No clay horizons were encountered and evidence from SLR site walkovers did not encounter cohesive clay materials on-site.

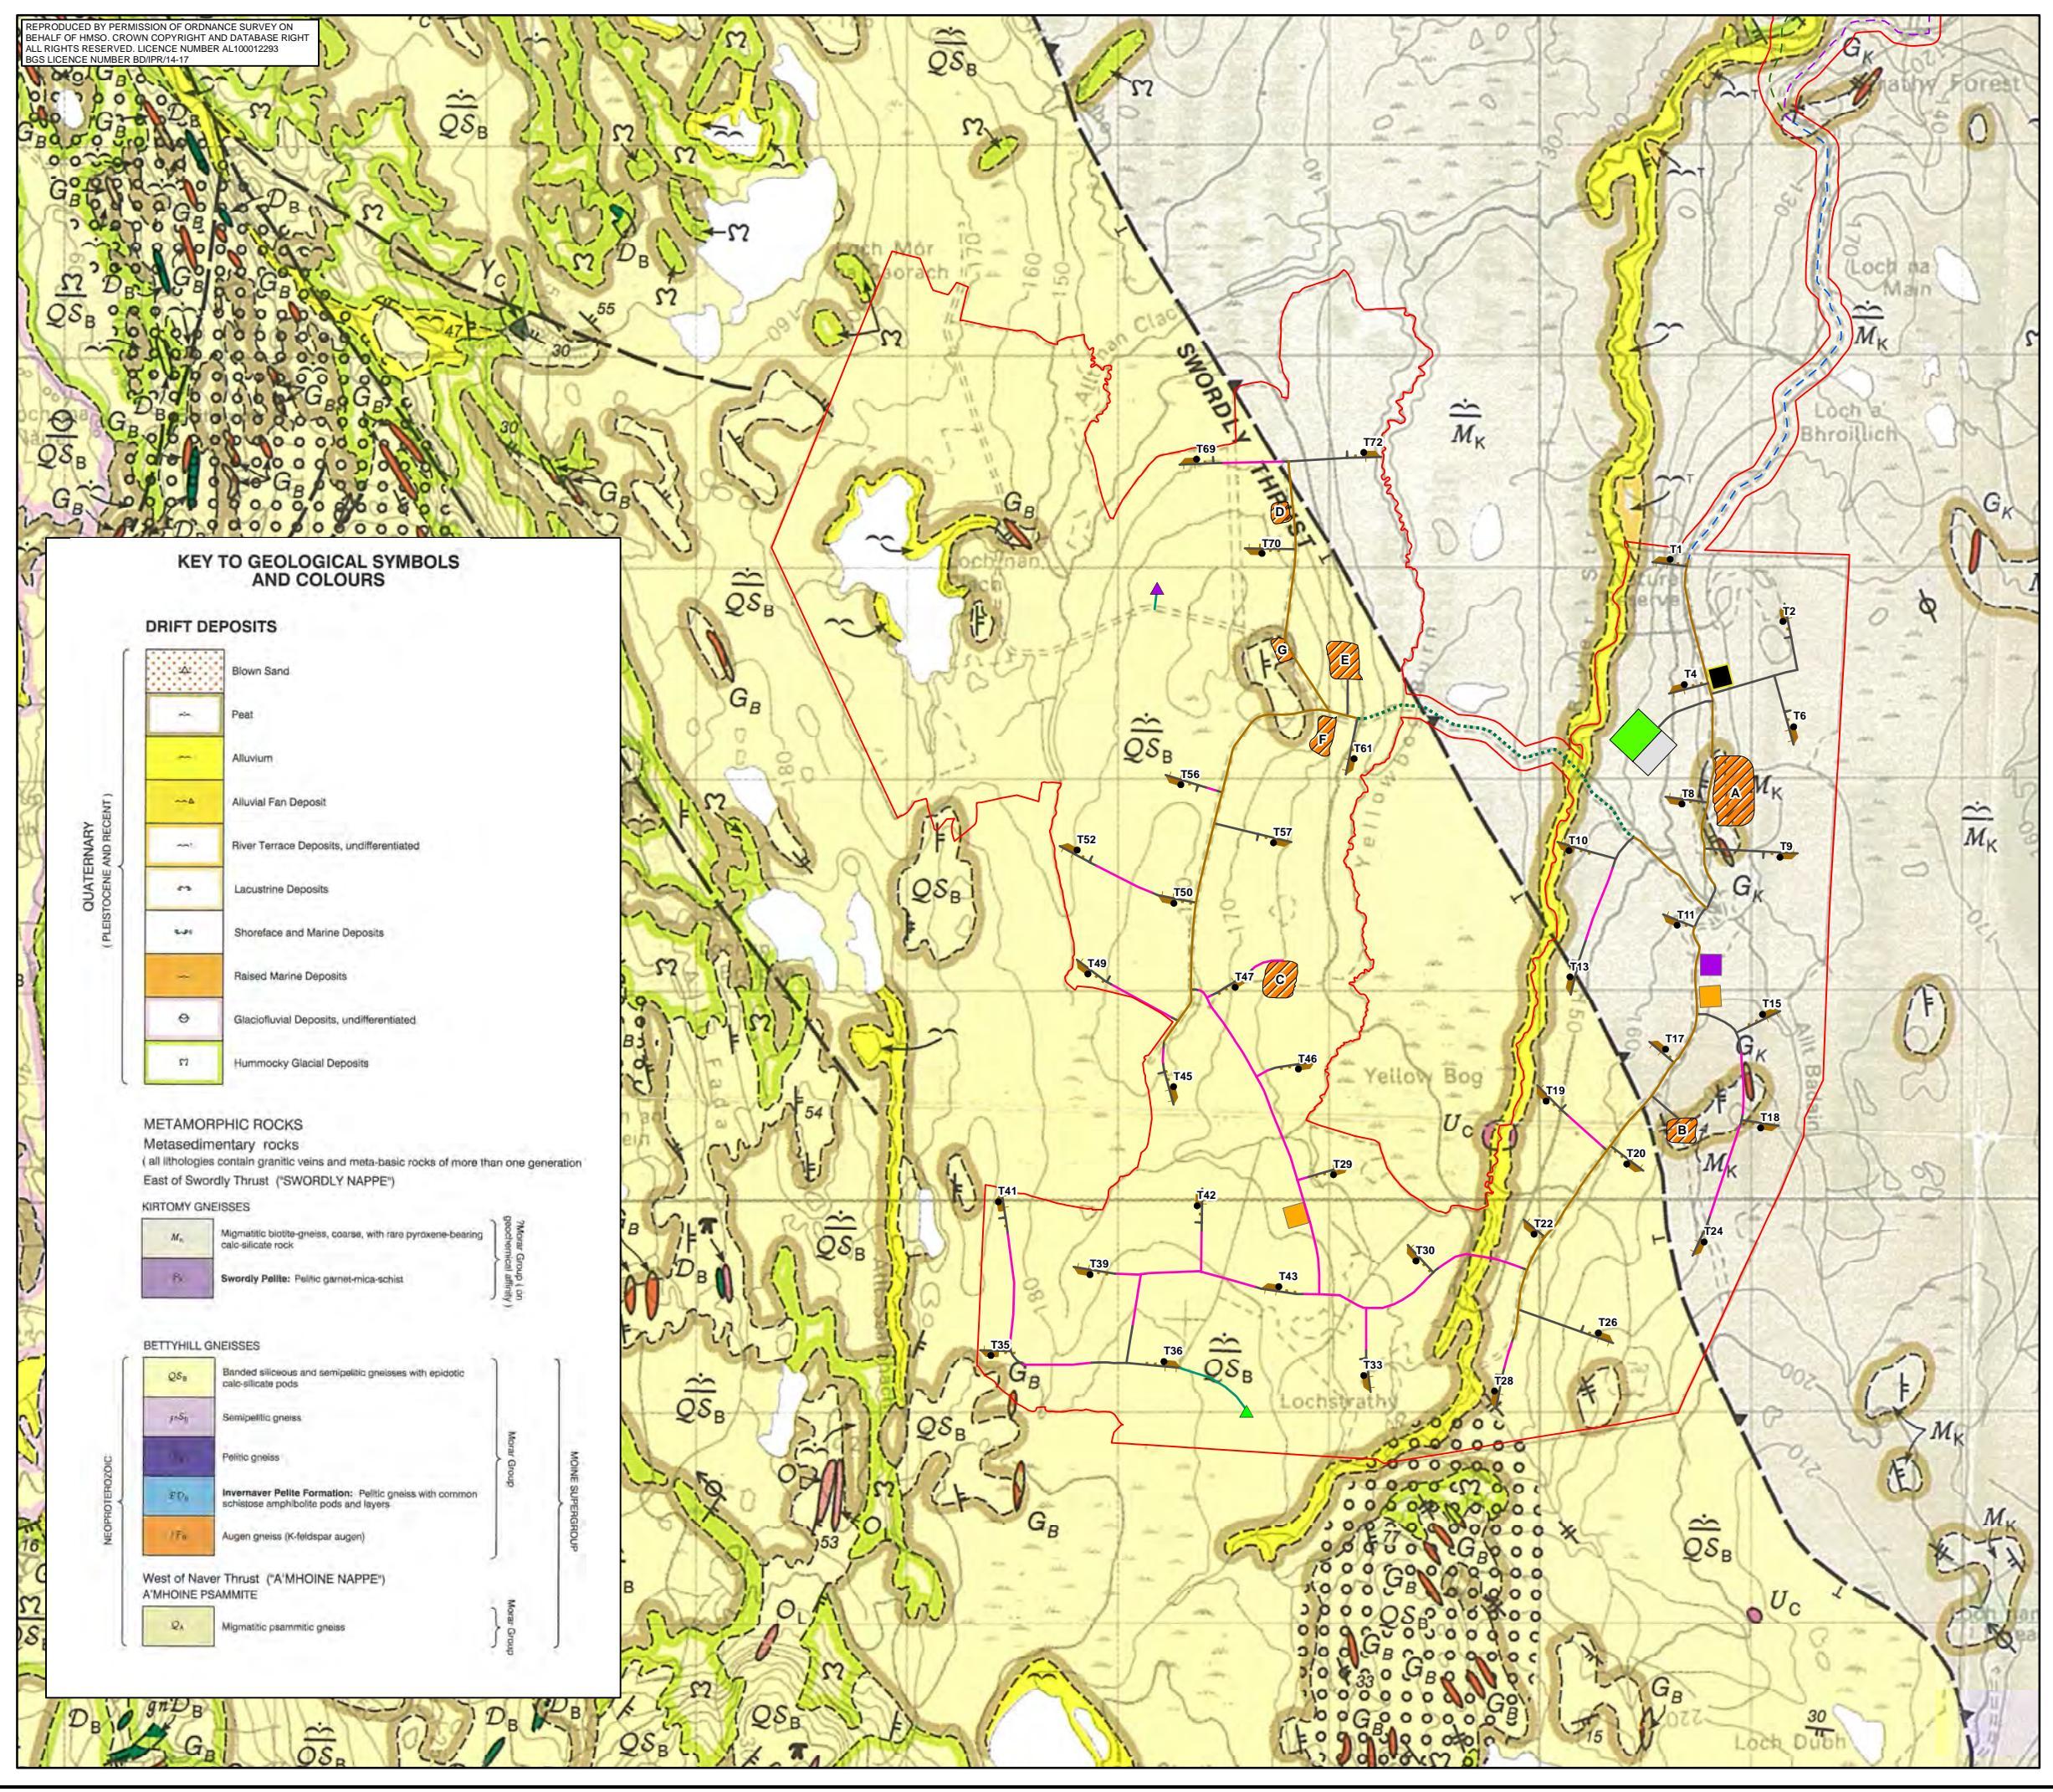
# **FIGURE 10.1.3**

# Superficial and Bedrock Geology

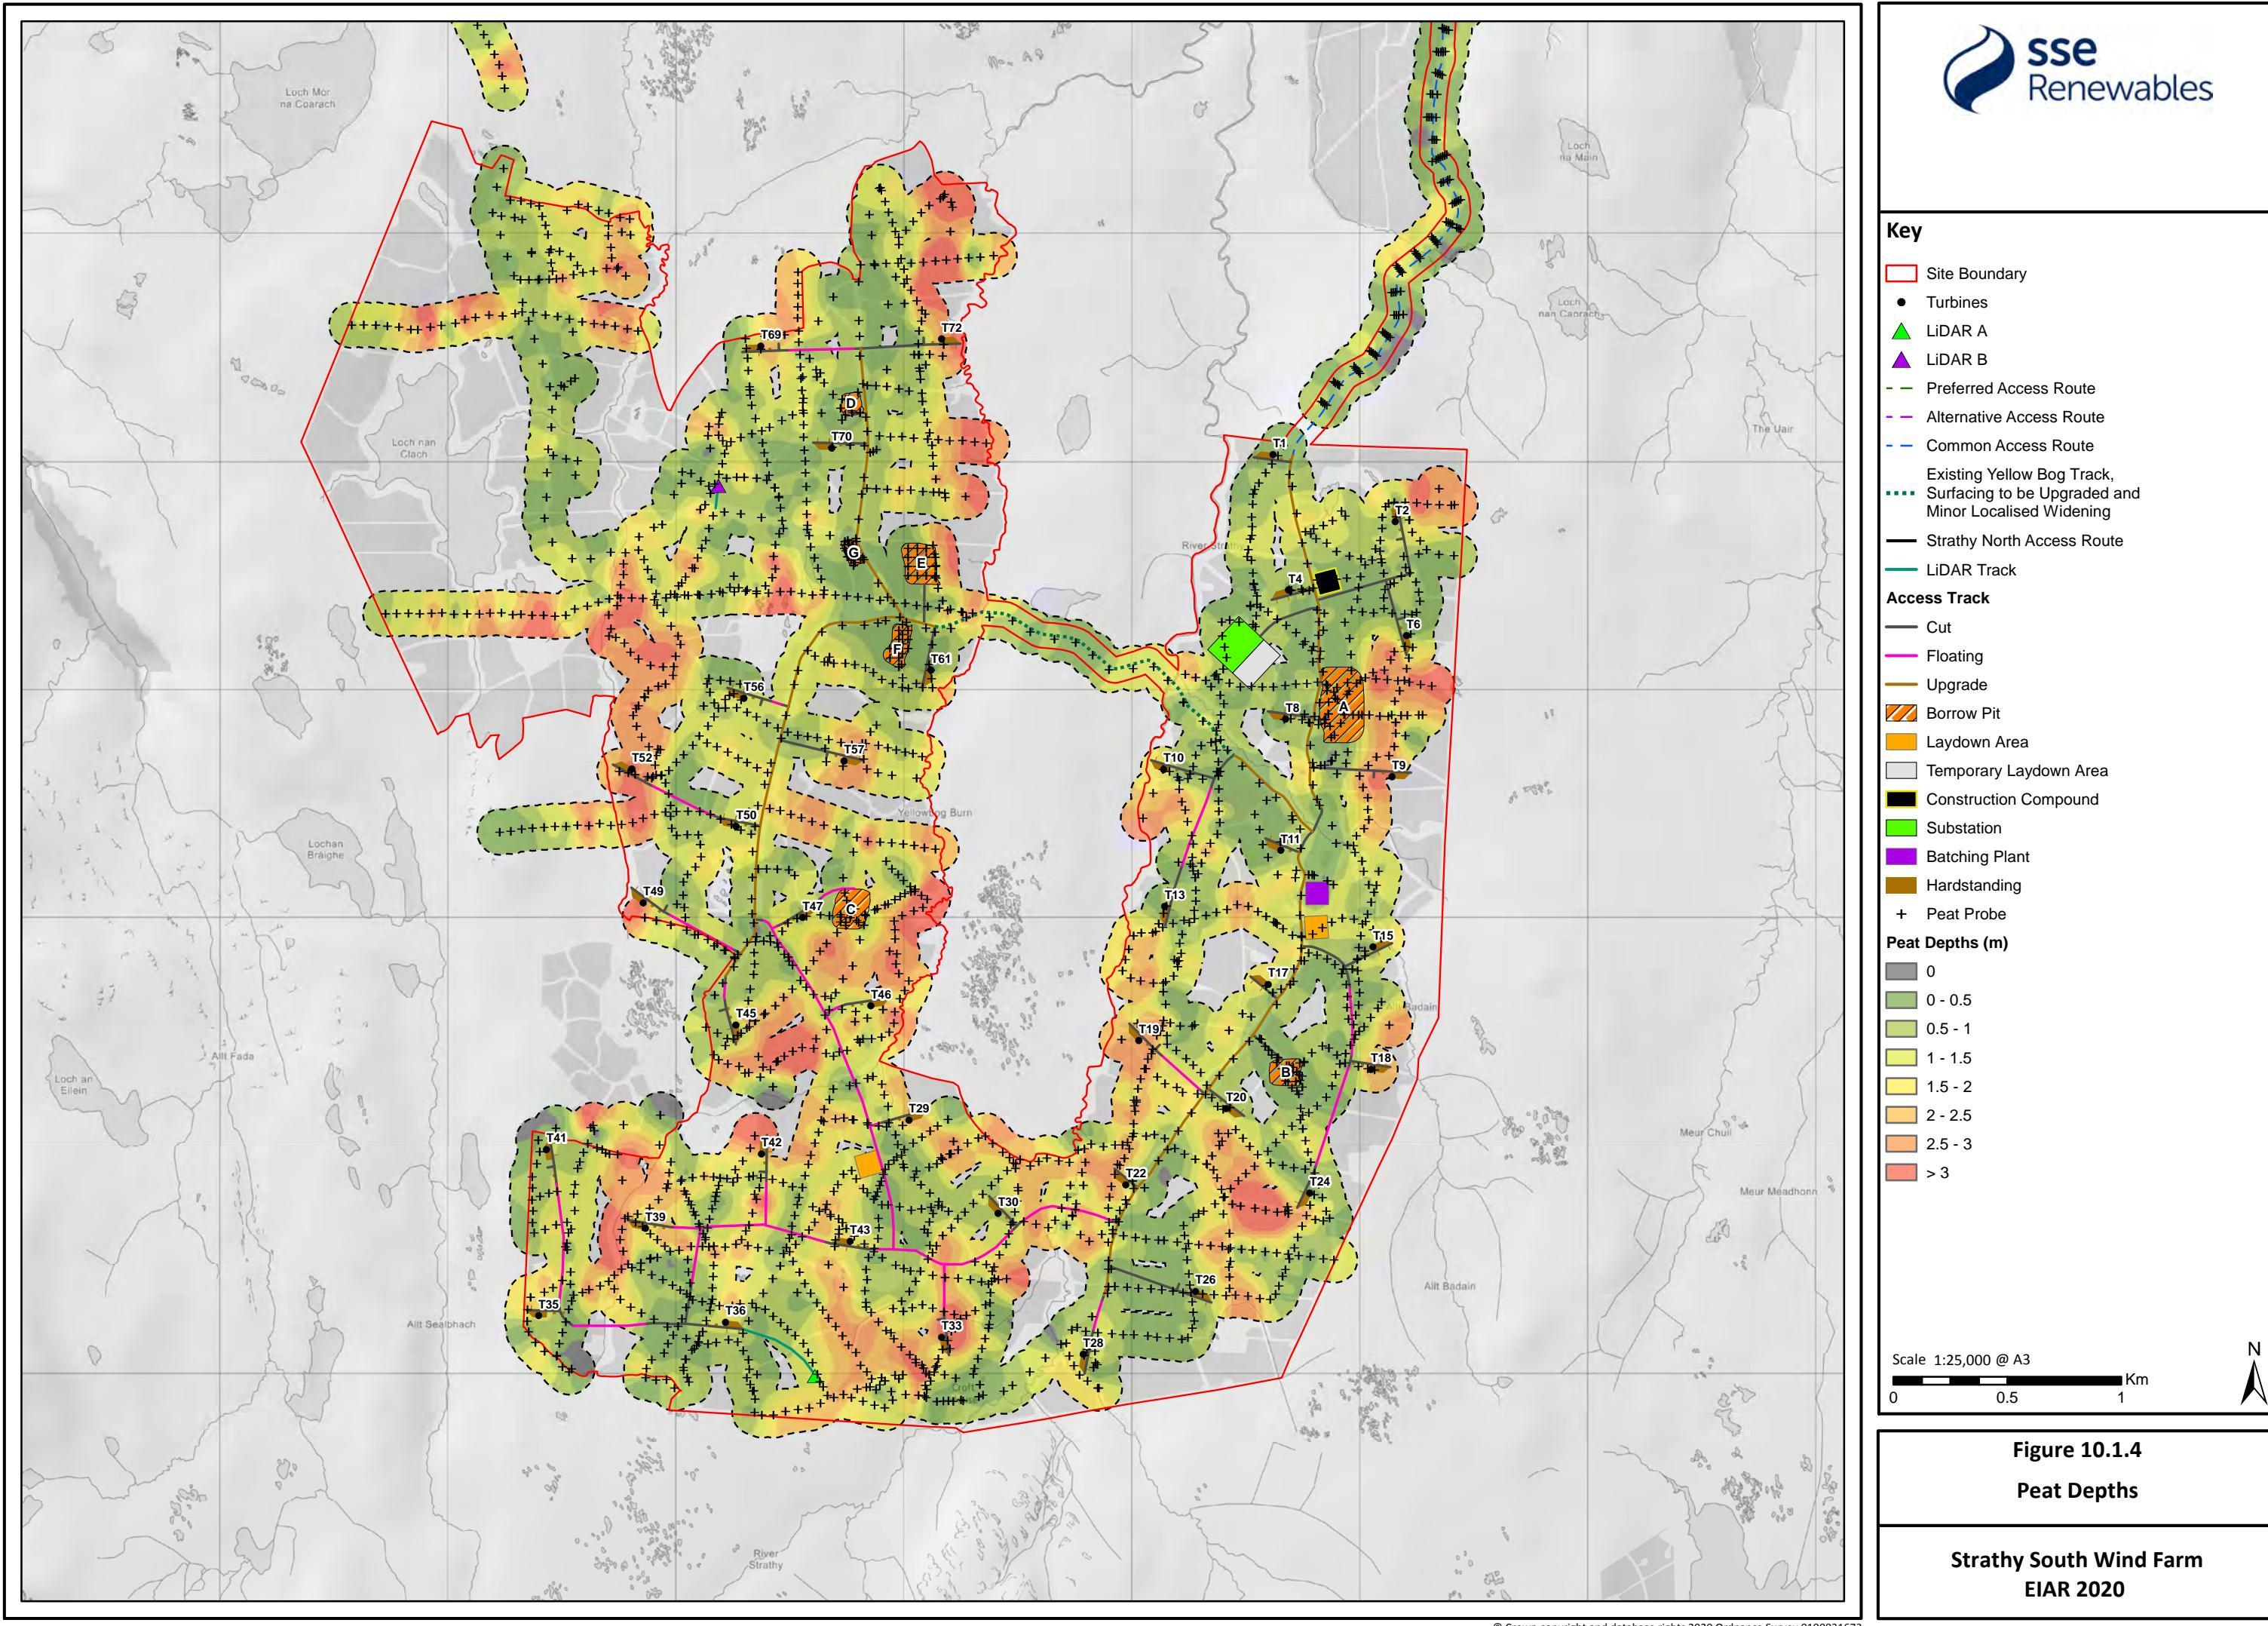
# FIGURE 10.1.4

# Peat Depth

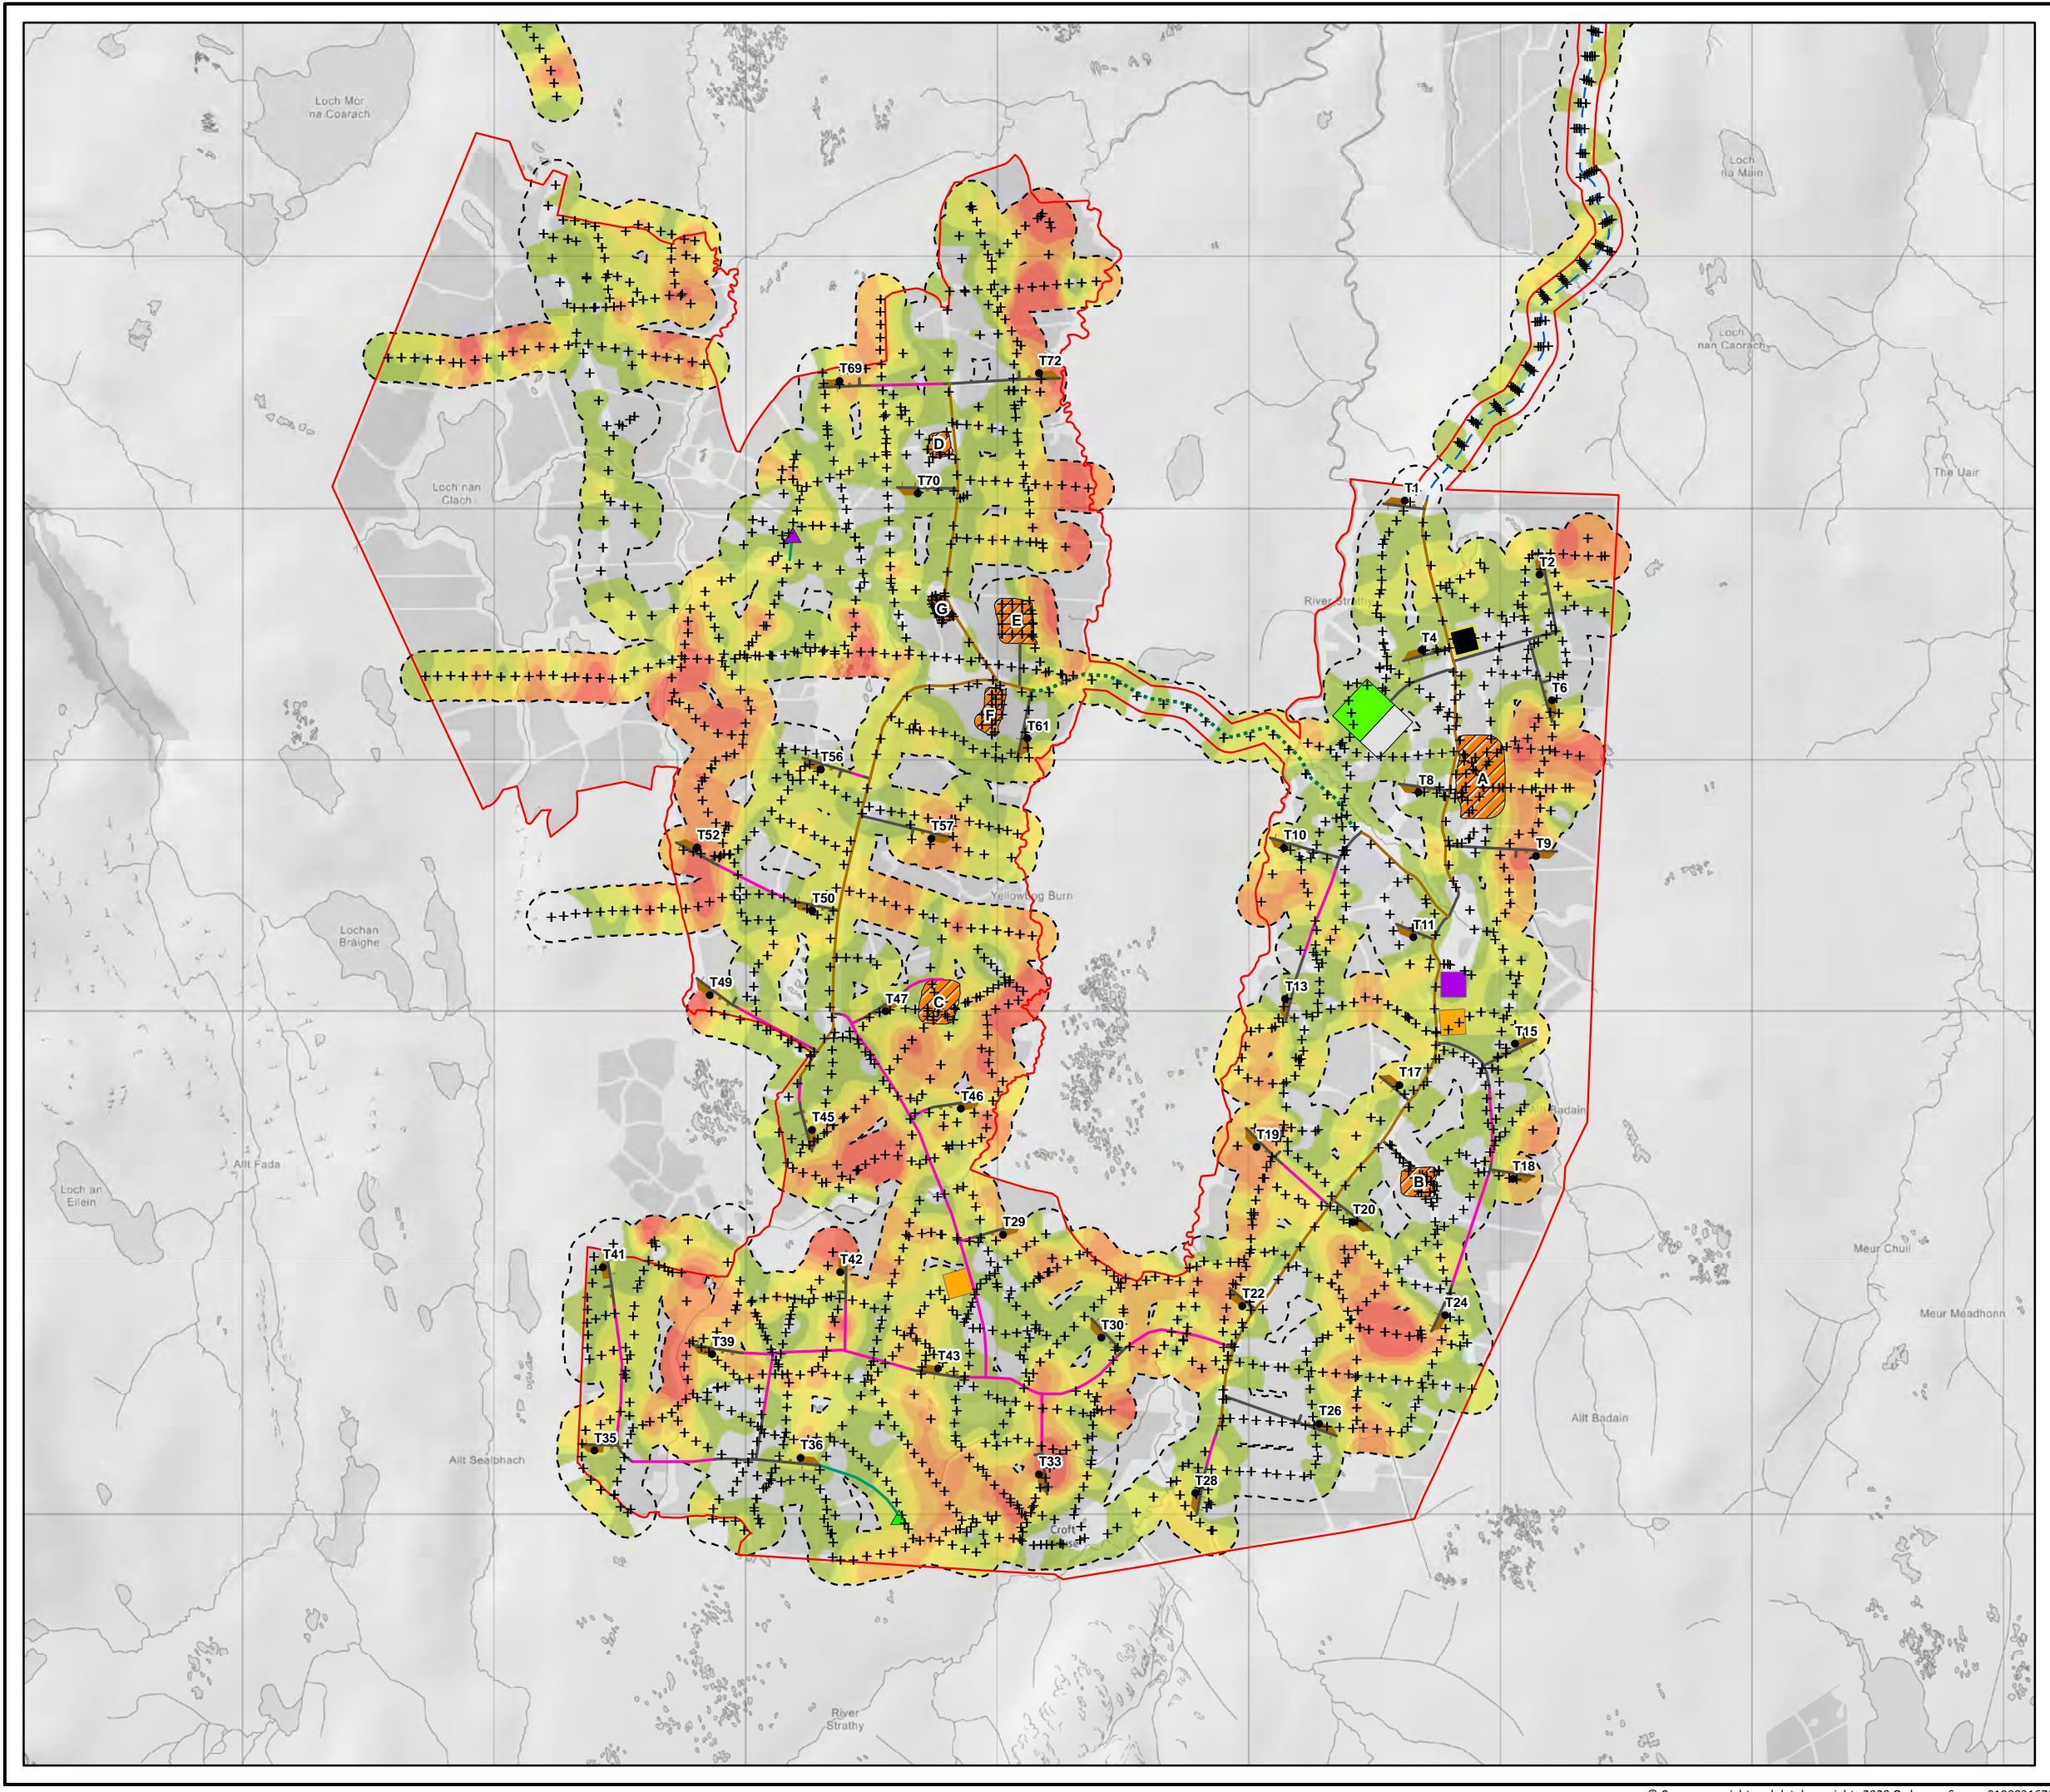
# FIGURE 10.1.5

# Peat Depth >0.5m

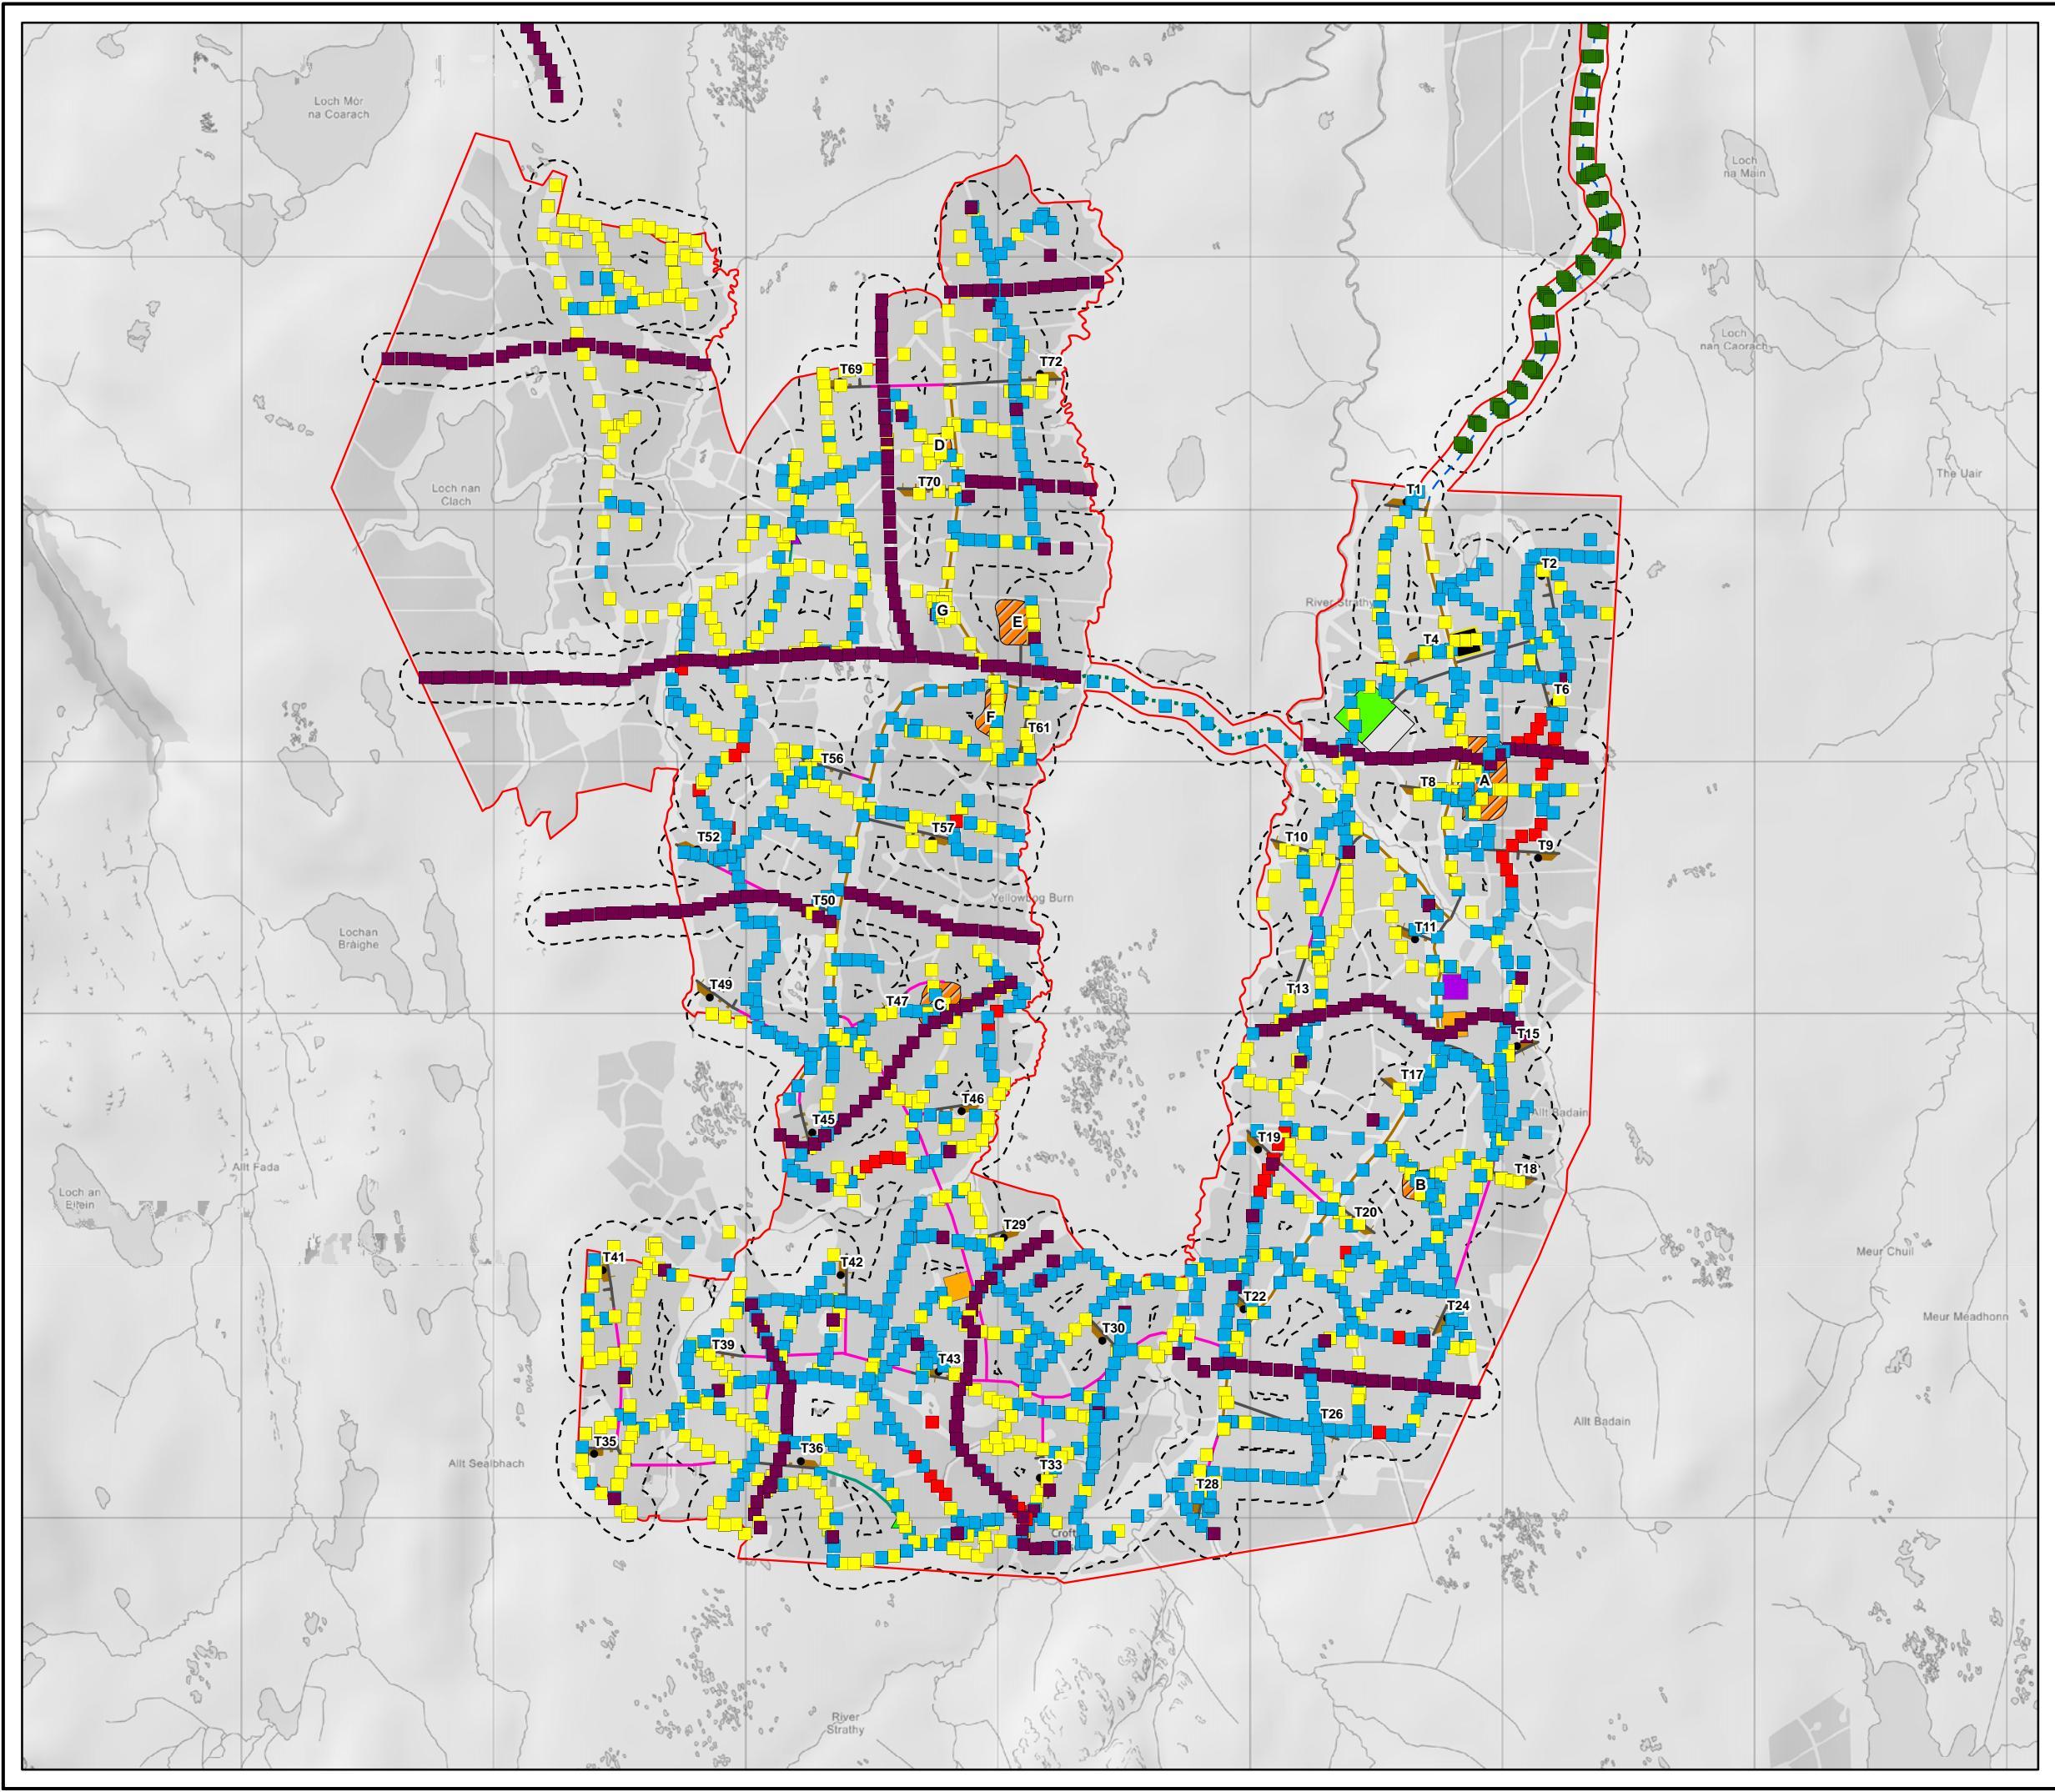
# **FIGURE 10.1.6**

# Interpreted Substrate

The interpreted substrate is shown in Figure 10.1.6.

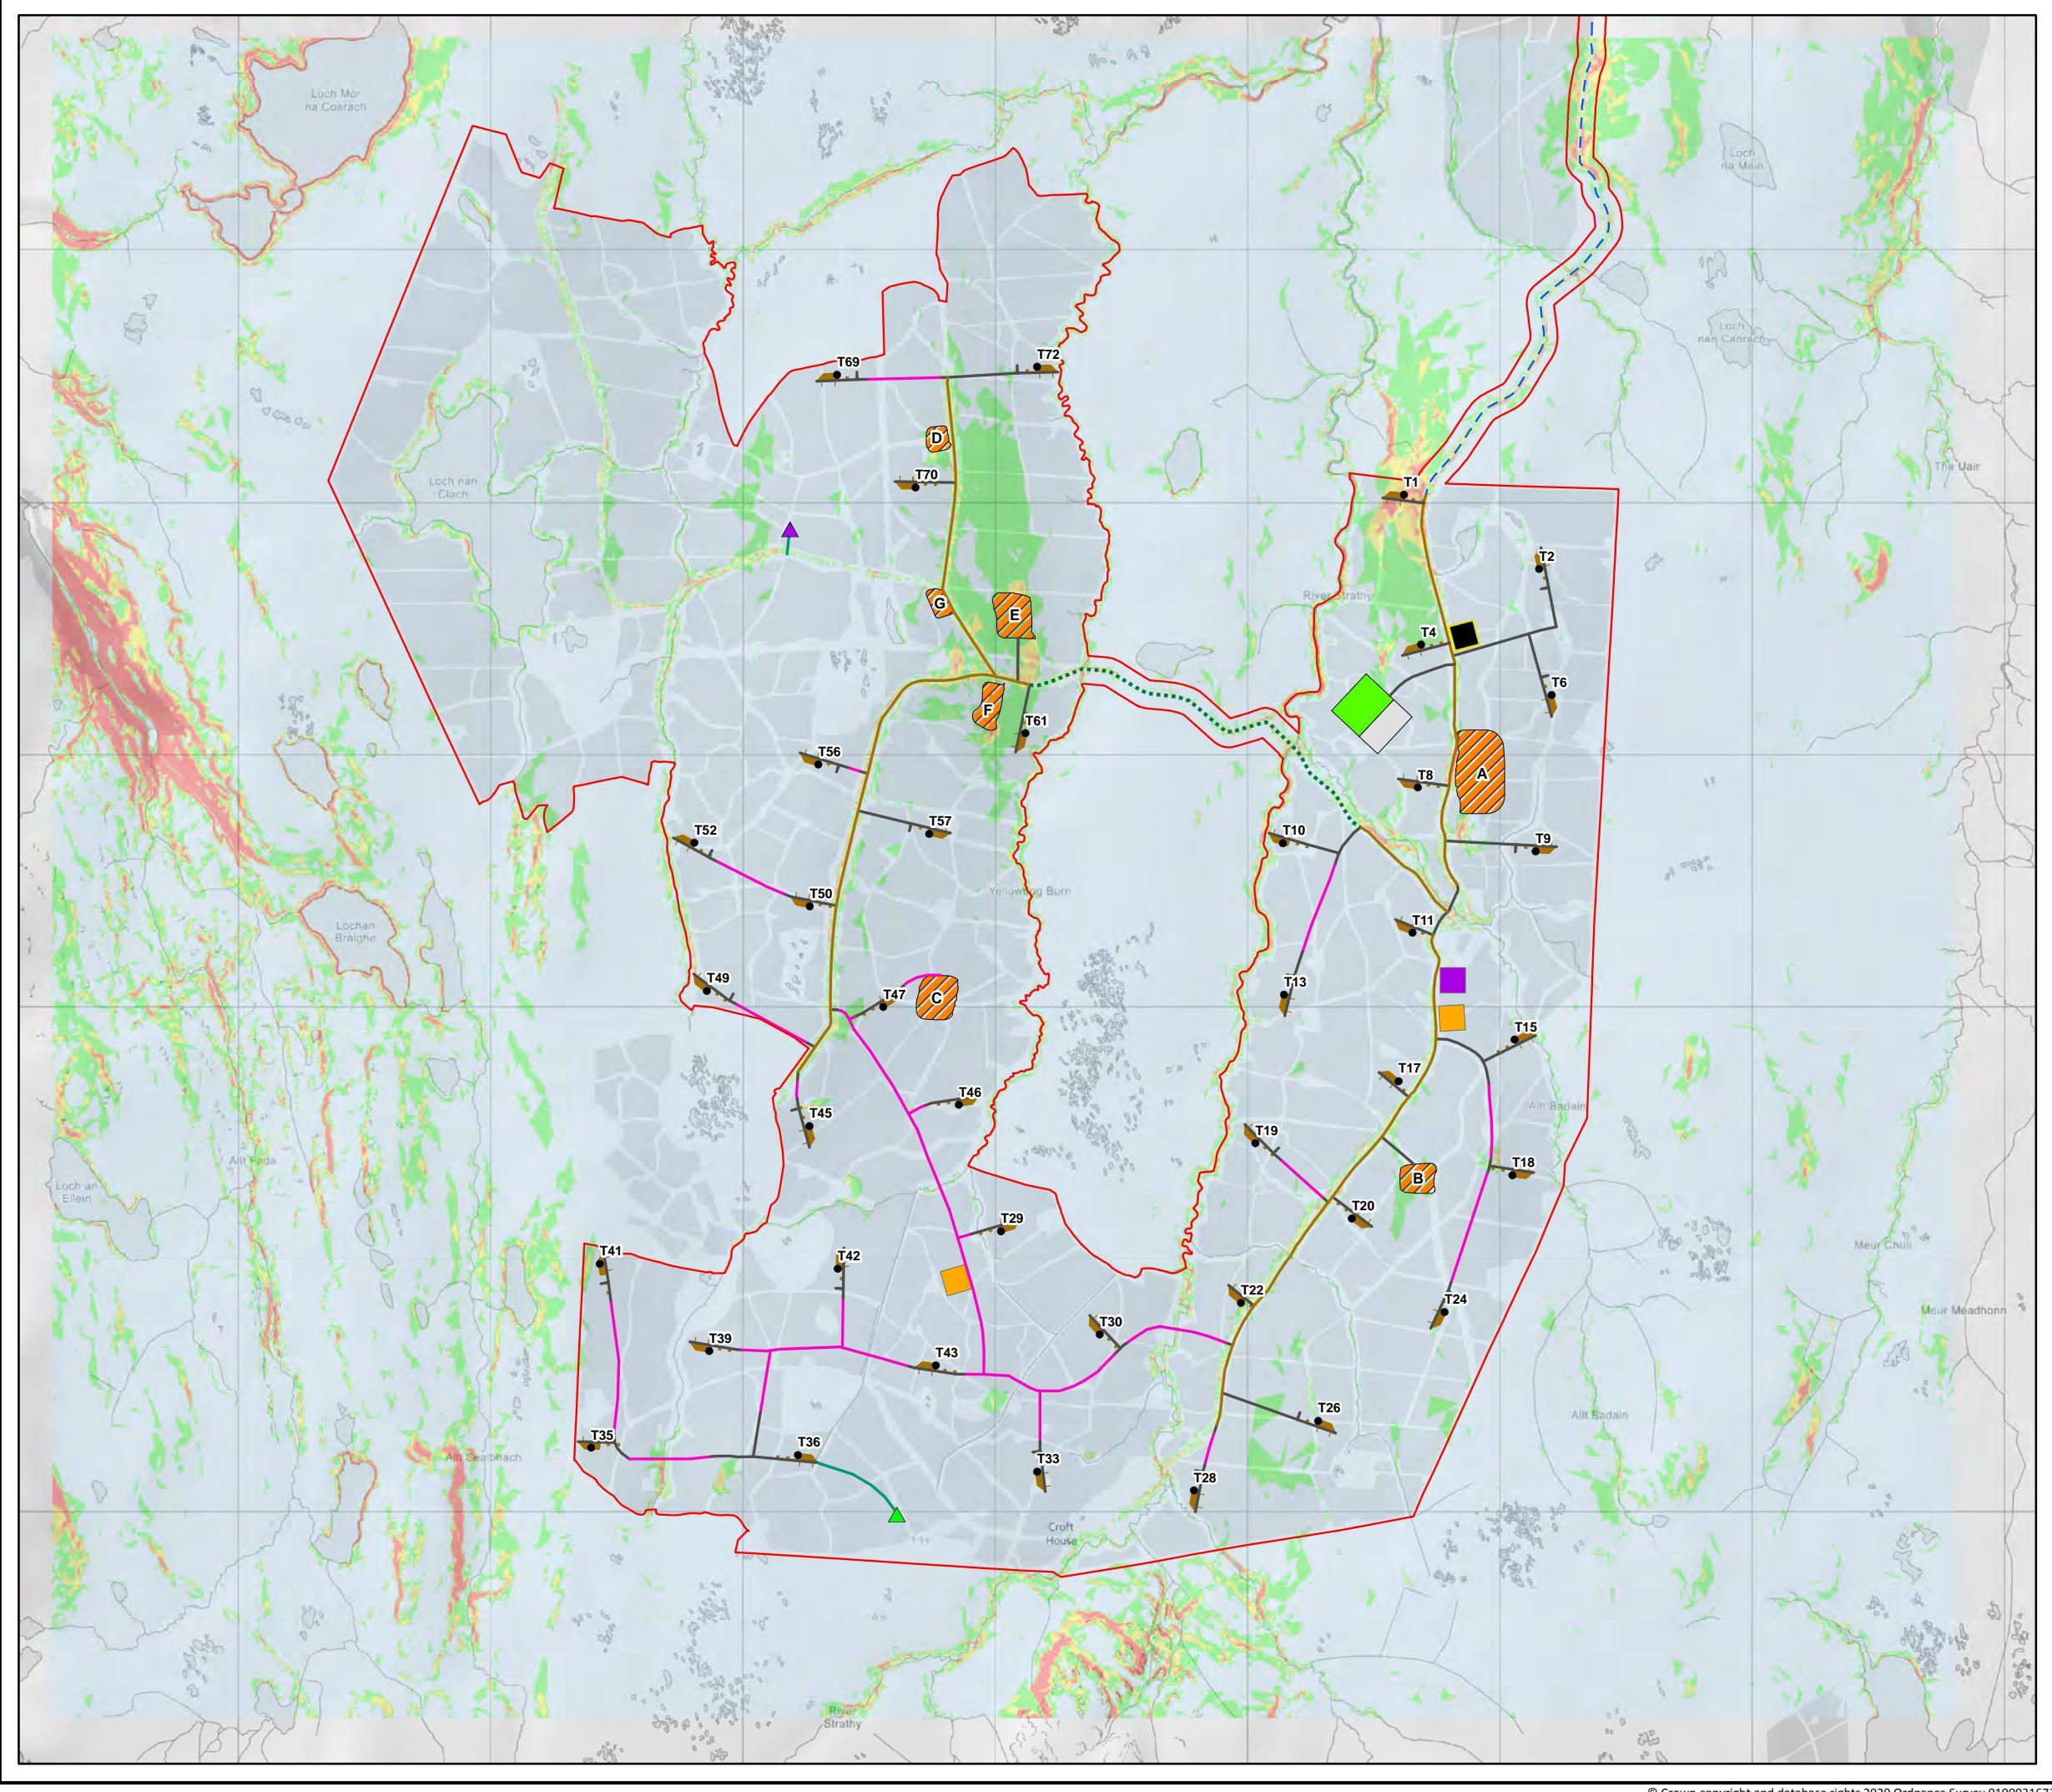
# FIGURE 10.1.7

# Slope

All of the surveys were based on 5 m Digital Terrain Model (DTM) data which was used to determine slopes across the site and to determine slope coefficient (score) factors at each probe hole location. The site has been characterised into slope classes and a slope plan produced to identify slope areas where potential gradients are more or less susceptible to slope failure mechanisms. The site is generally flat, predominately <5% gradient.
