# **TECHNICAL APPENDIX 10 – SOIL AND WATER**

SSE Generation Ltd Strathy South Wind Farm Peat Landslide and Hazard Risk Assessment

**Technical Appendix 10.1** Peat Landslide Hazard and Risk Assessment Prepared for: SSE Generation Ltd

SLR Ref: 428.00660.00070 Technical Appendix: 10.1 Version No: Rev 1 August 2020

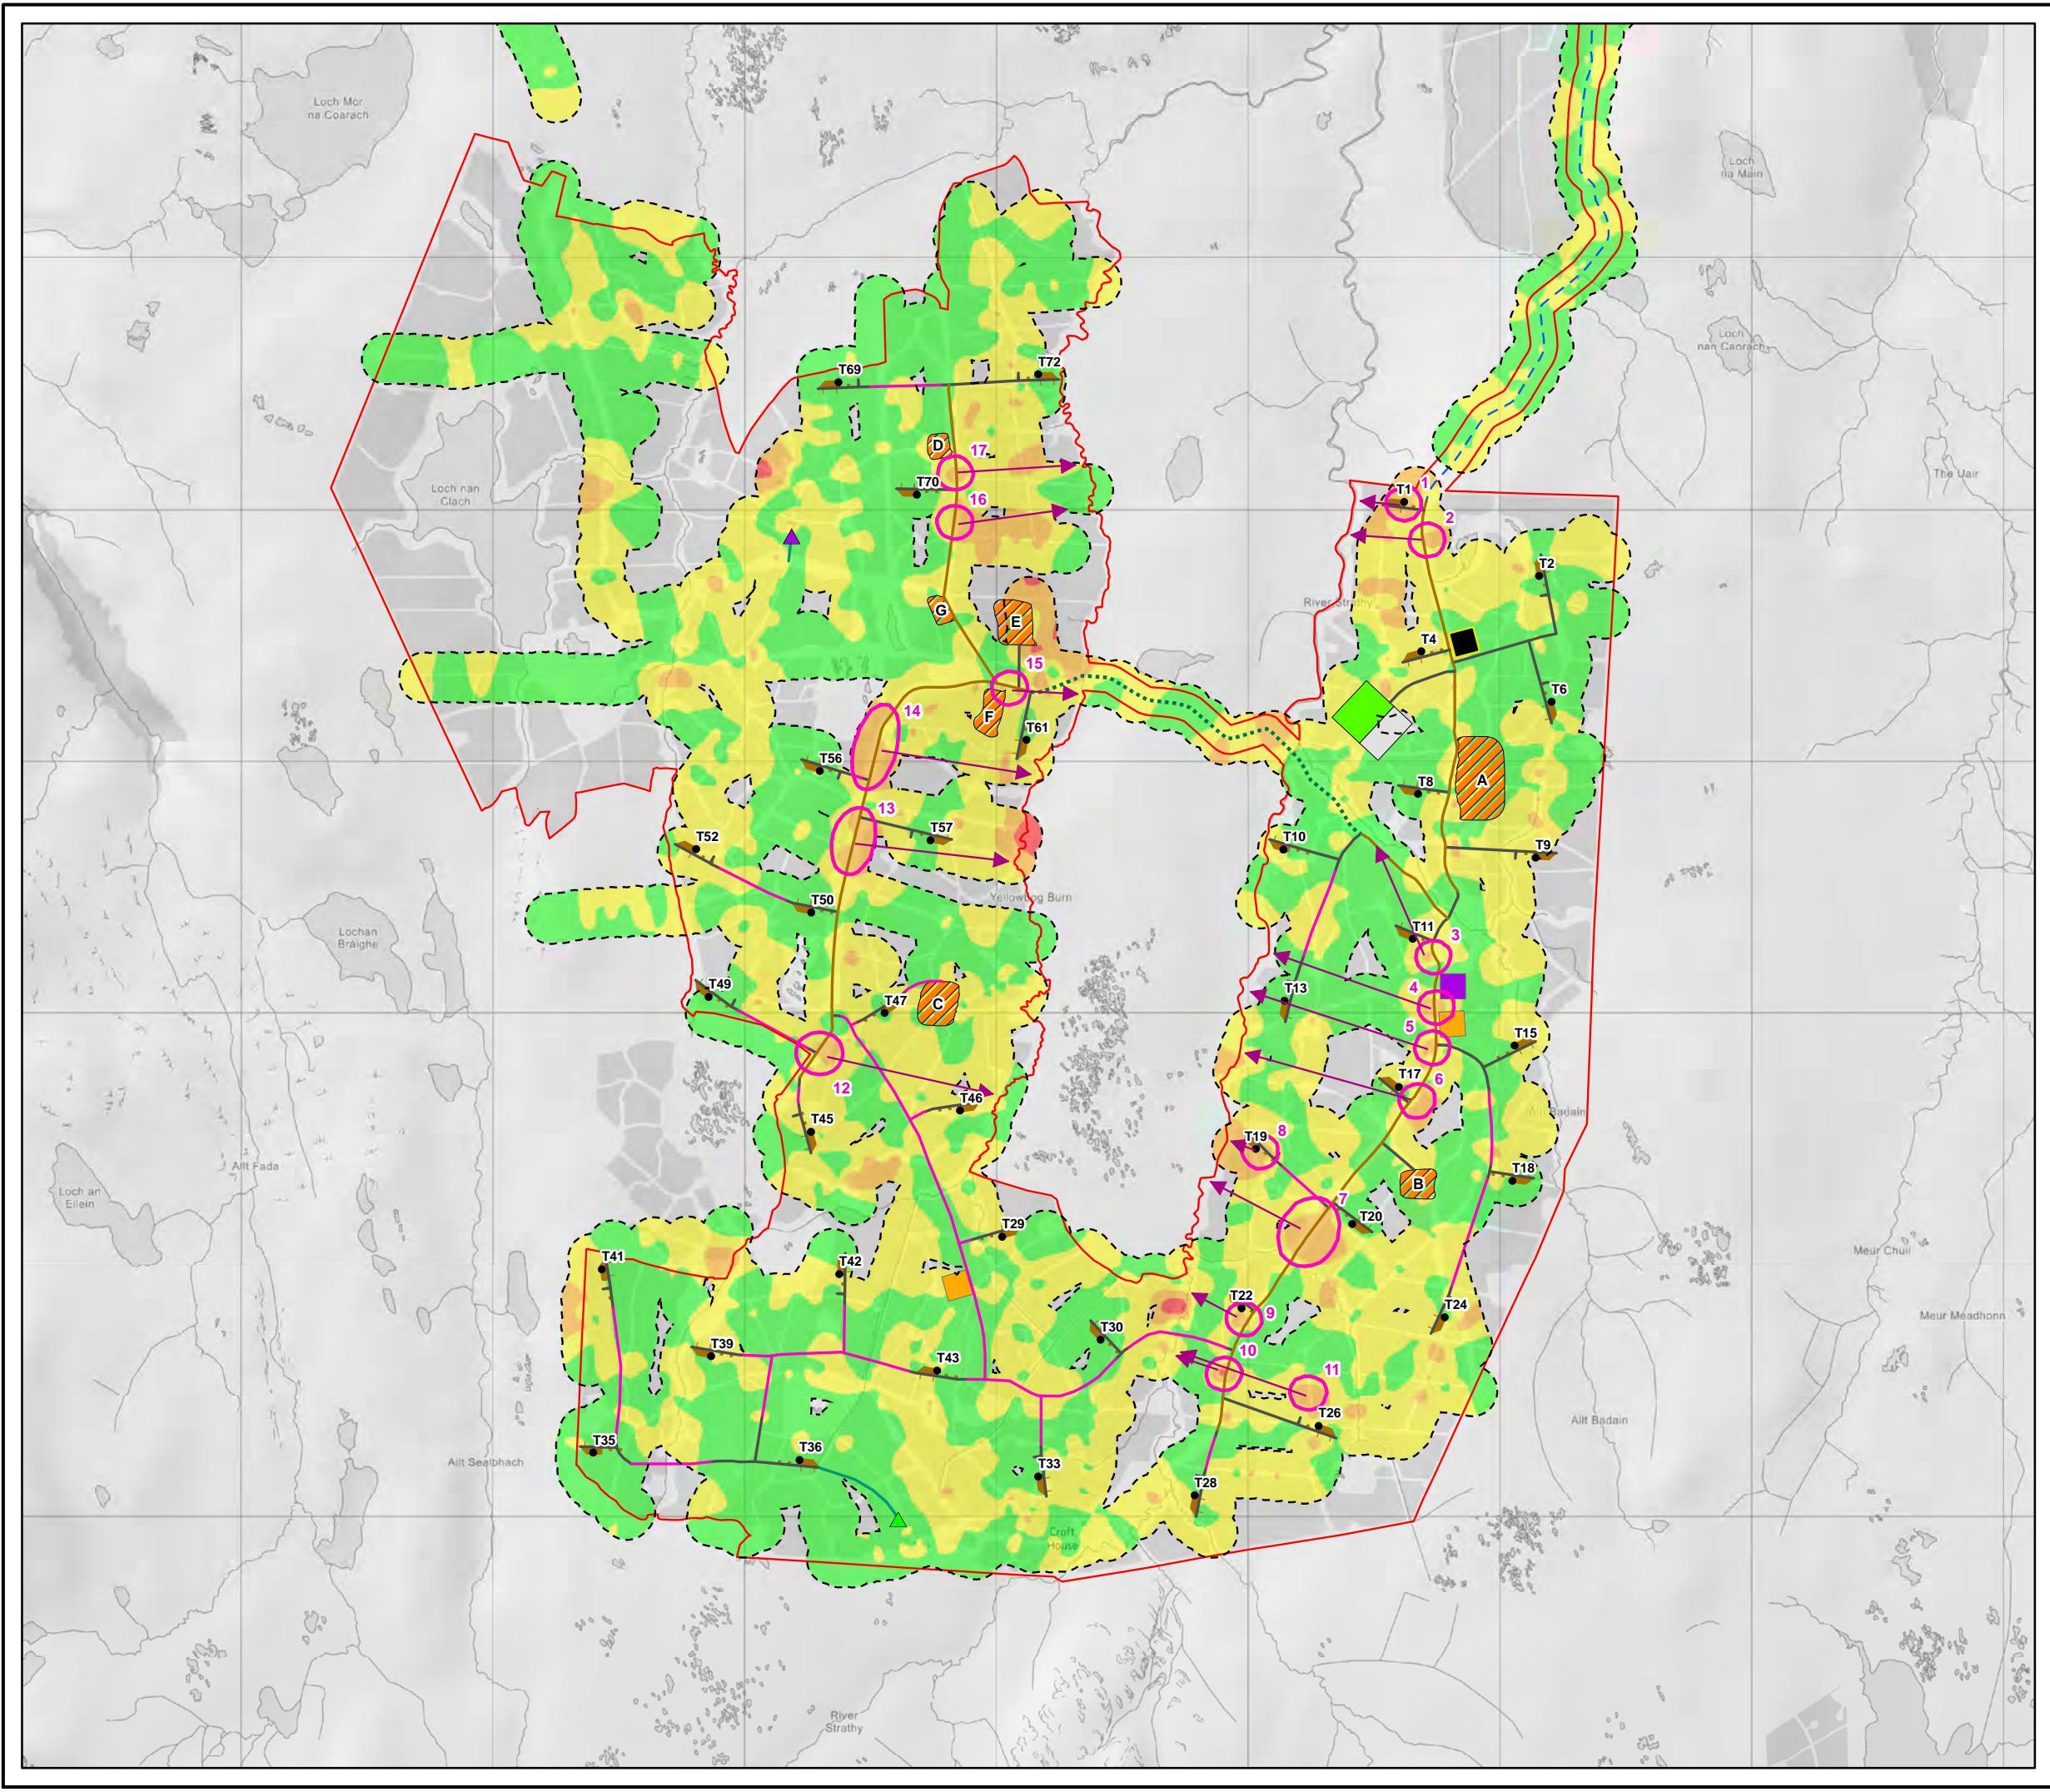
# FIGURE 10.1.8

# Peat Slide Risk

Probing has been undertaken in several phases and due to the dense forestry coverage, probing could not be completed on a grid. Rides and clearings were utilised to gain coverage across the main site and conditions between, where inaccessible, were inferred. The results have been used to produce a peat thickness (Figure 10.1.4) and peat landslide risk and hazard map (Figure 10.1.8). Further details are given in subsequent sections of this report.

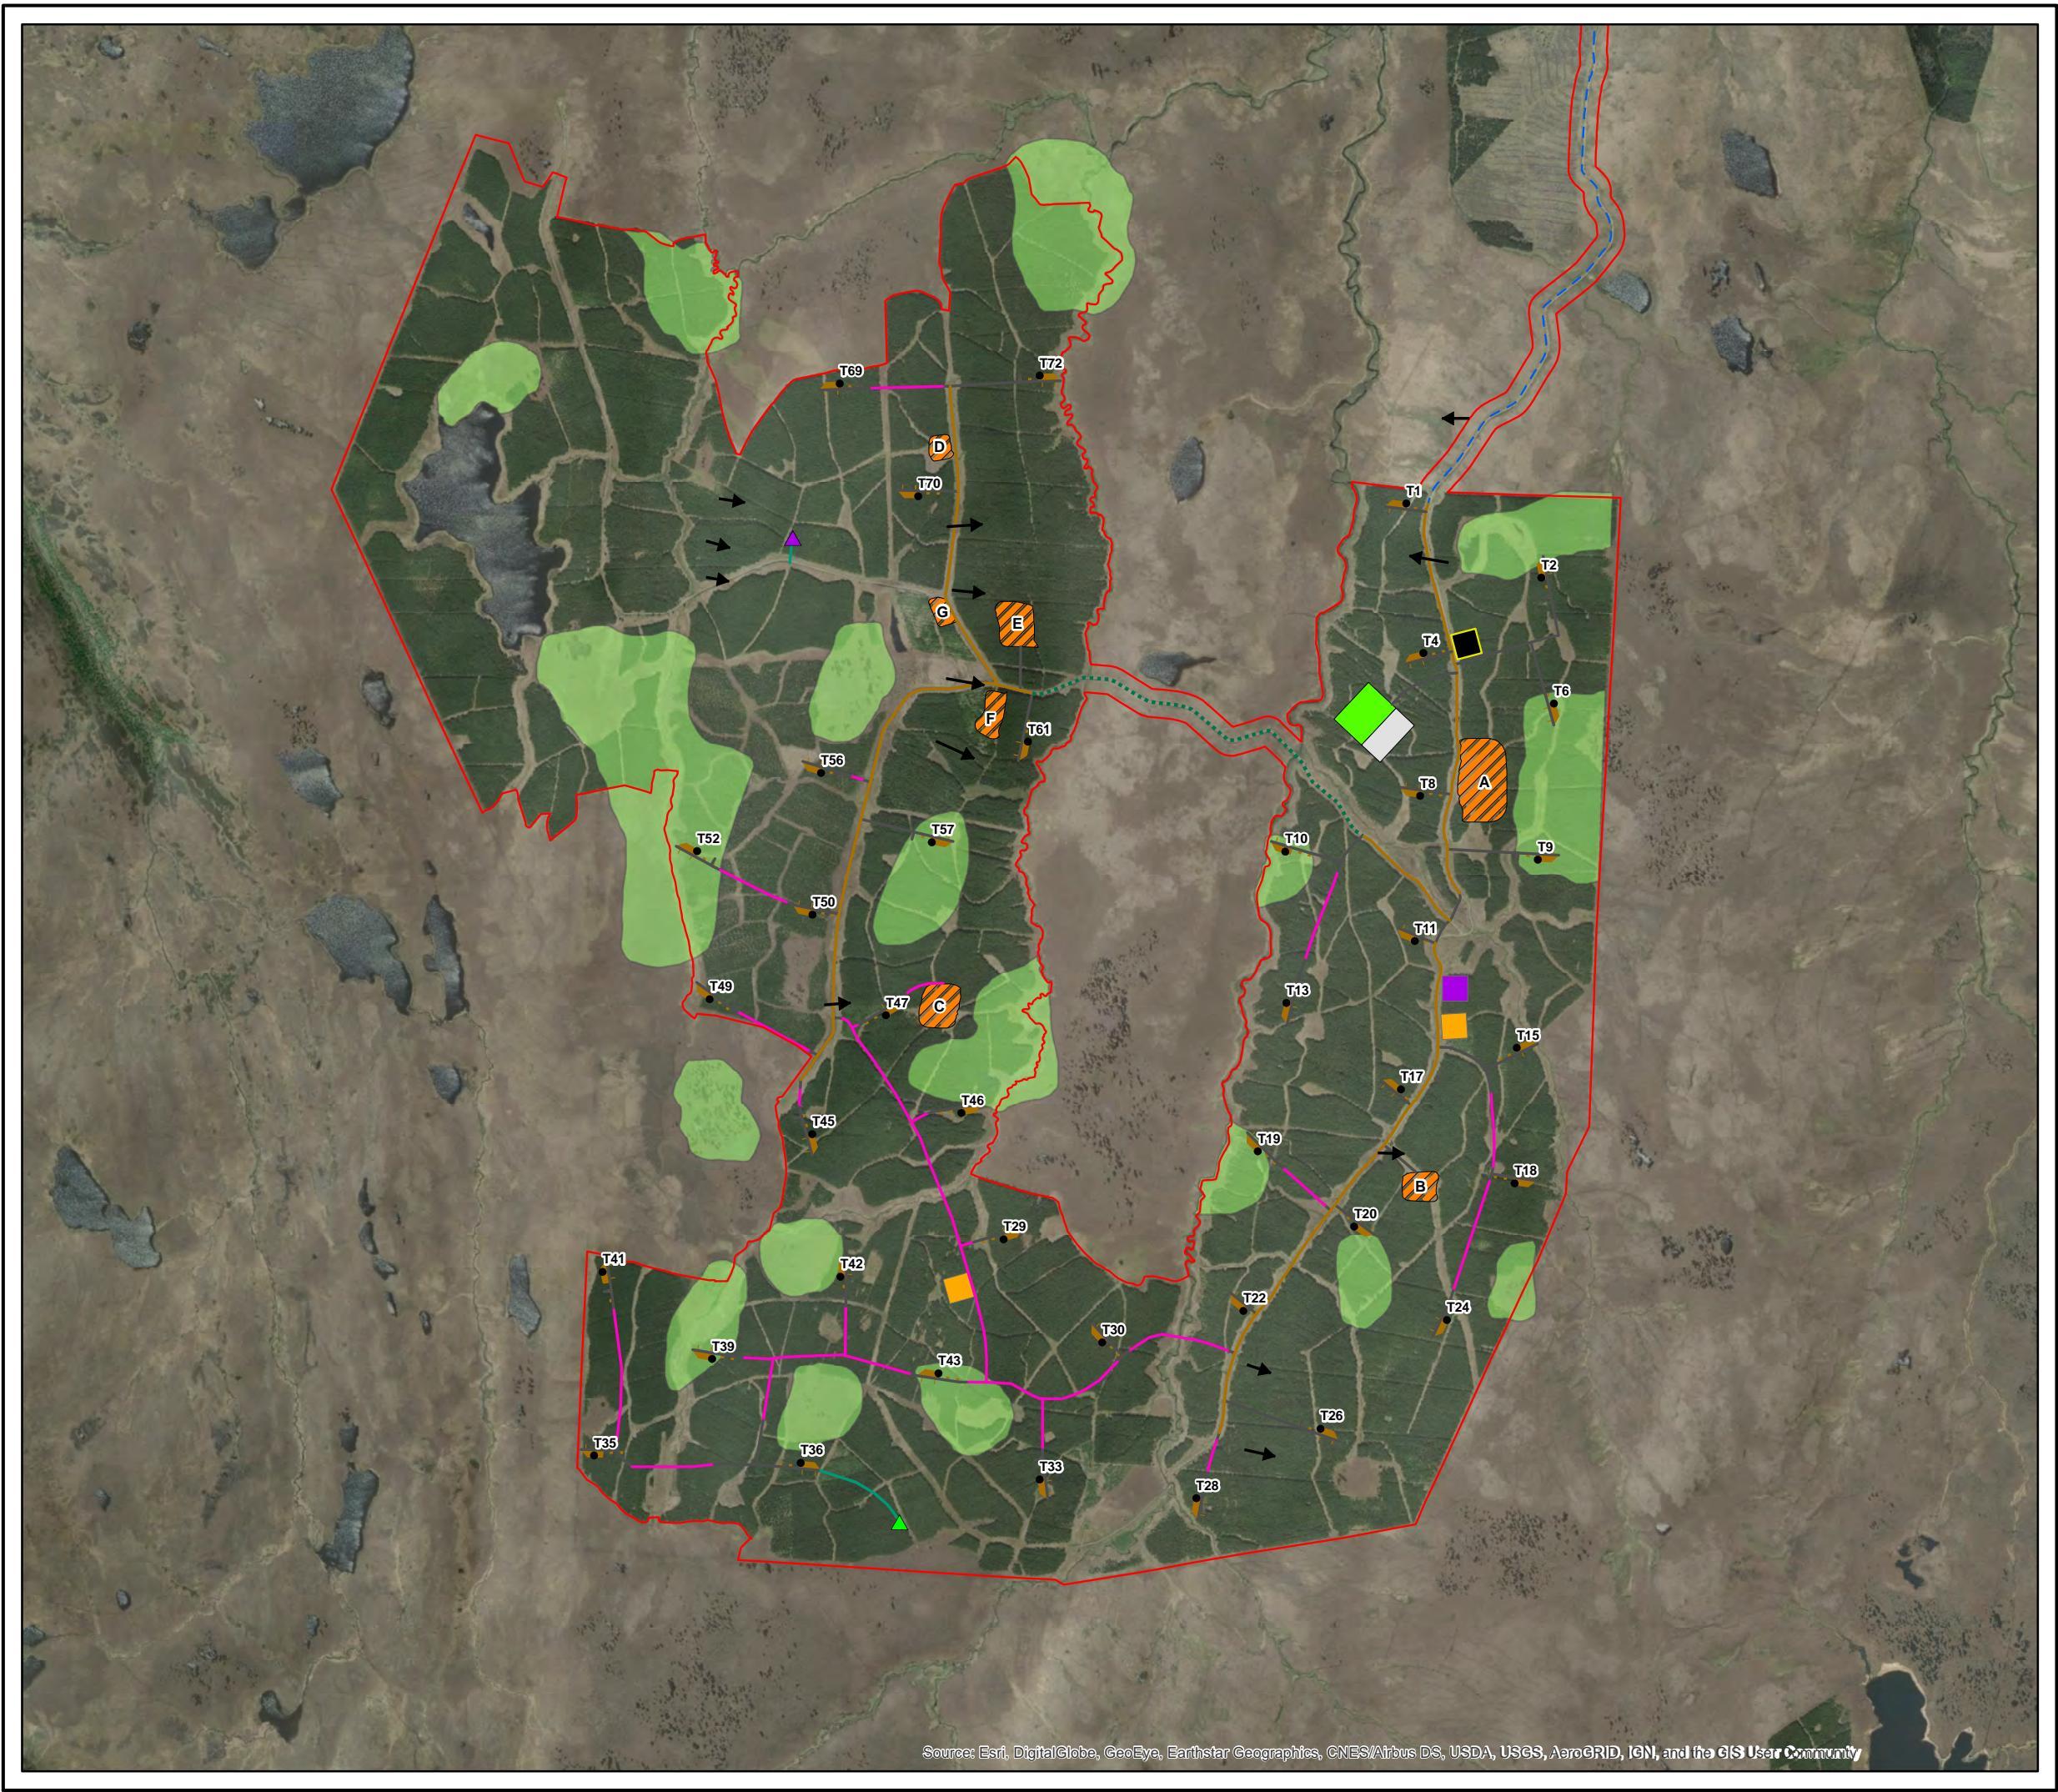
# **FIGURE 10.1.9**

Aerial Plan with Geomorphological Interpretation

There was no evidence visible in the aerial photographs of any extension or compression features in the peat. It was not possible to identify evidence of any significant historic peat failures or slides from the aerial photographs. Ground investigation proved that there were no significant features of this nature in the vicinity of the site and no slumping of peat was evident along existing track corridors.

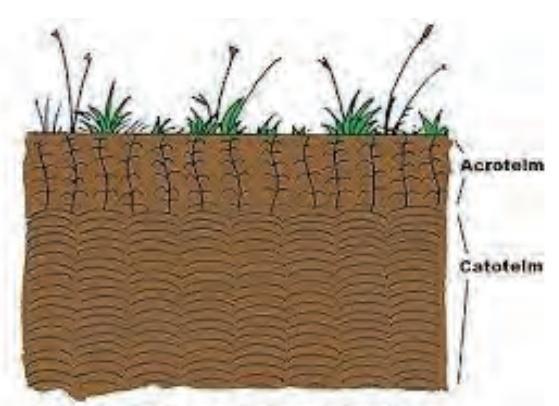
> Plate 1-1 **Hydrological Layers in Bogland Habitat**

**Hydrological Layers in Bogland Habitat**

The acrotelm layer is found in the upper layer of peat where conditions are relatively dry and comprises living vegetation and partially decomposed plant material. Hydraulic conductivity in this layer tends to be higher in relation to distance from the water table.

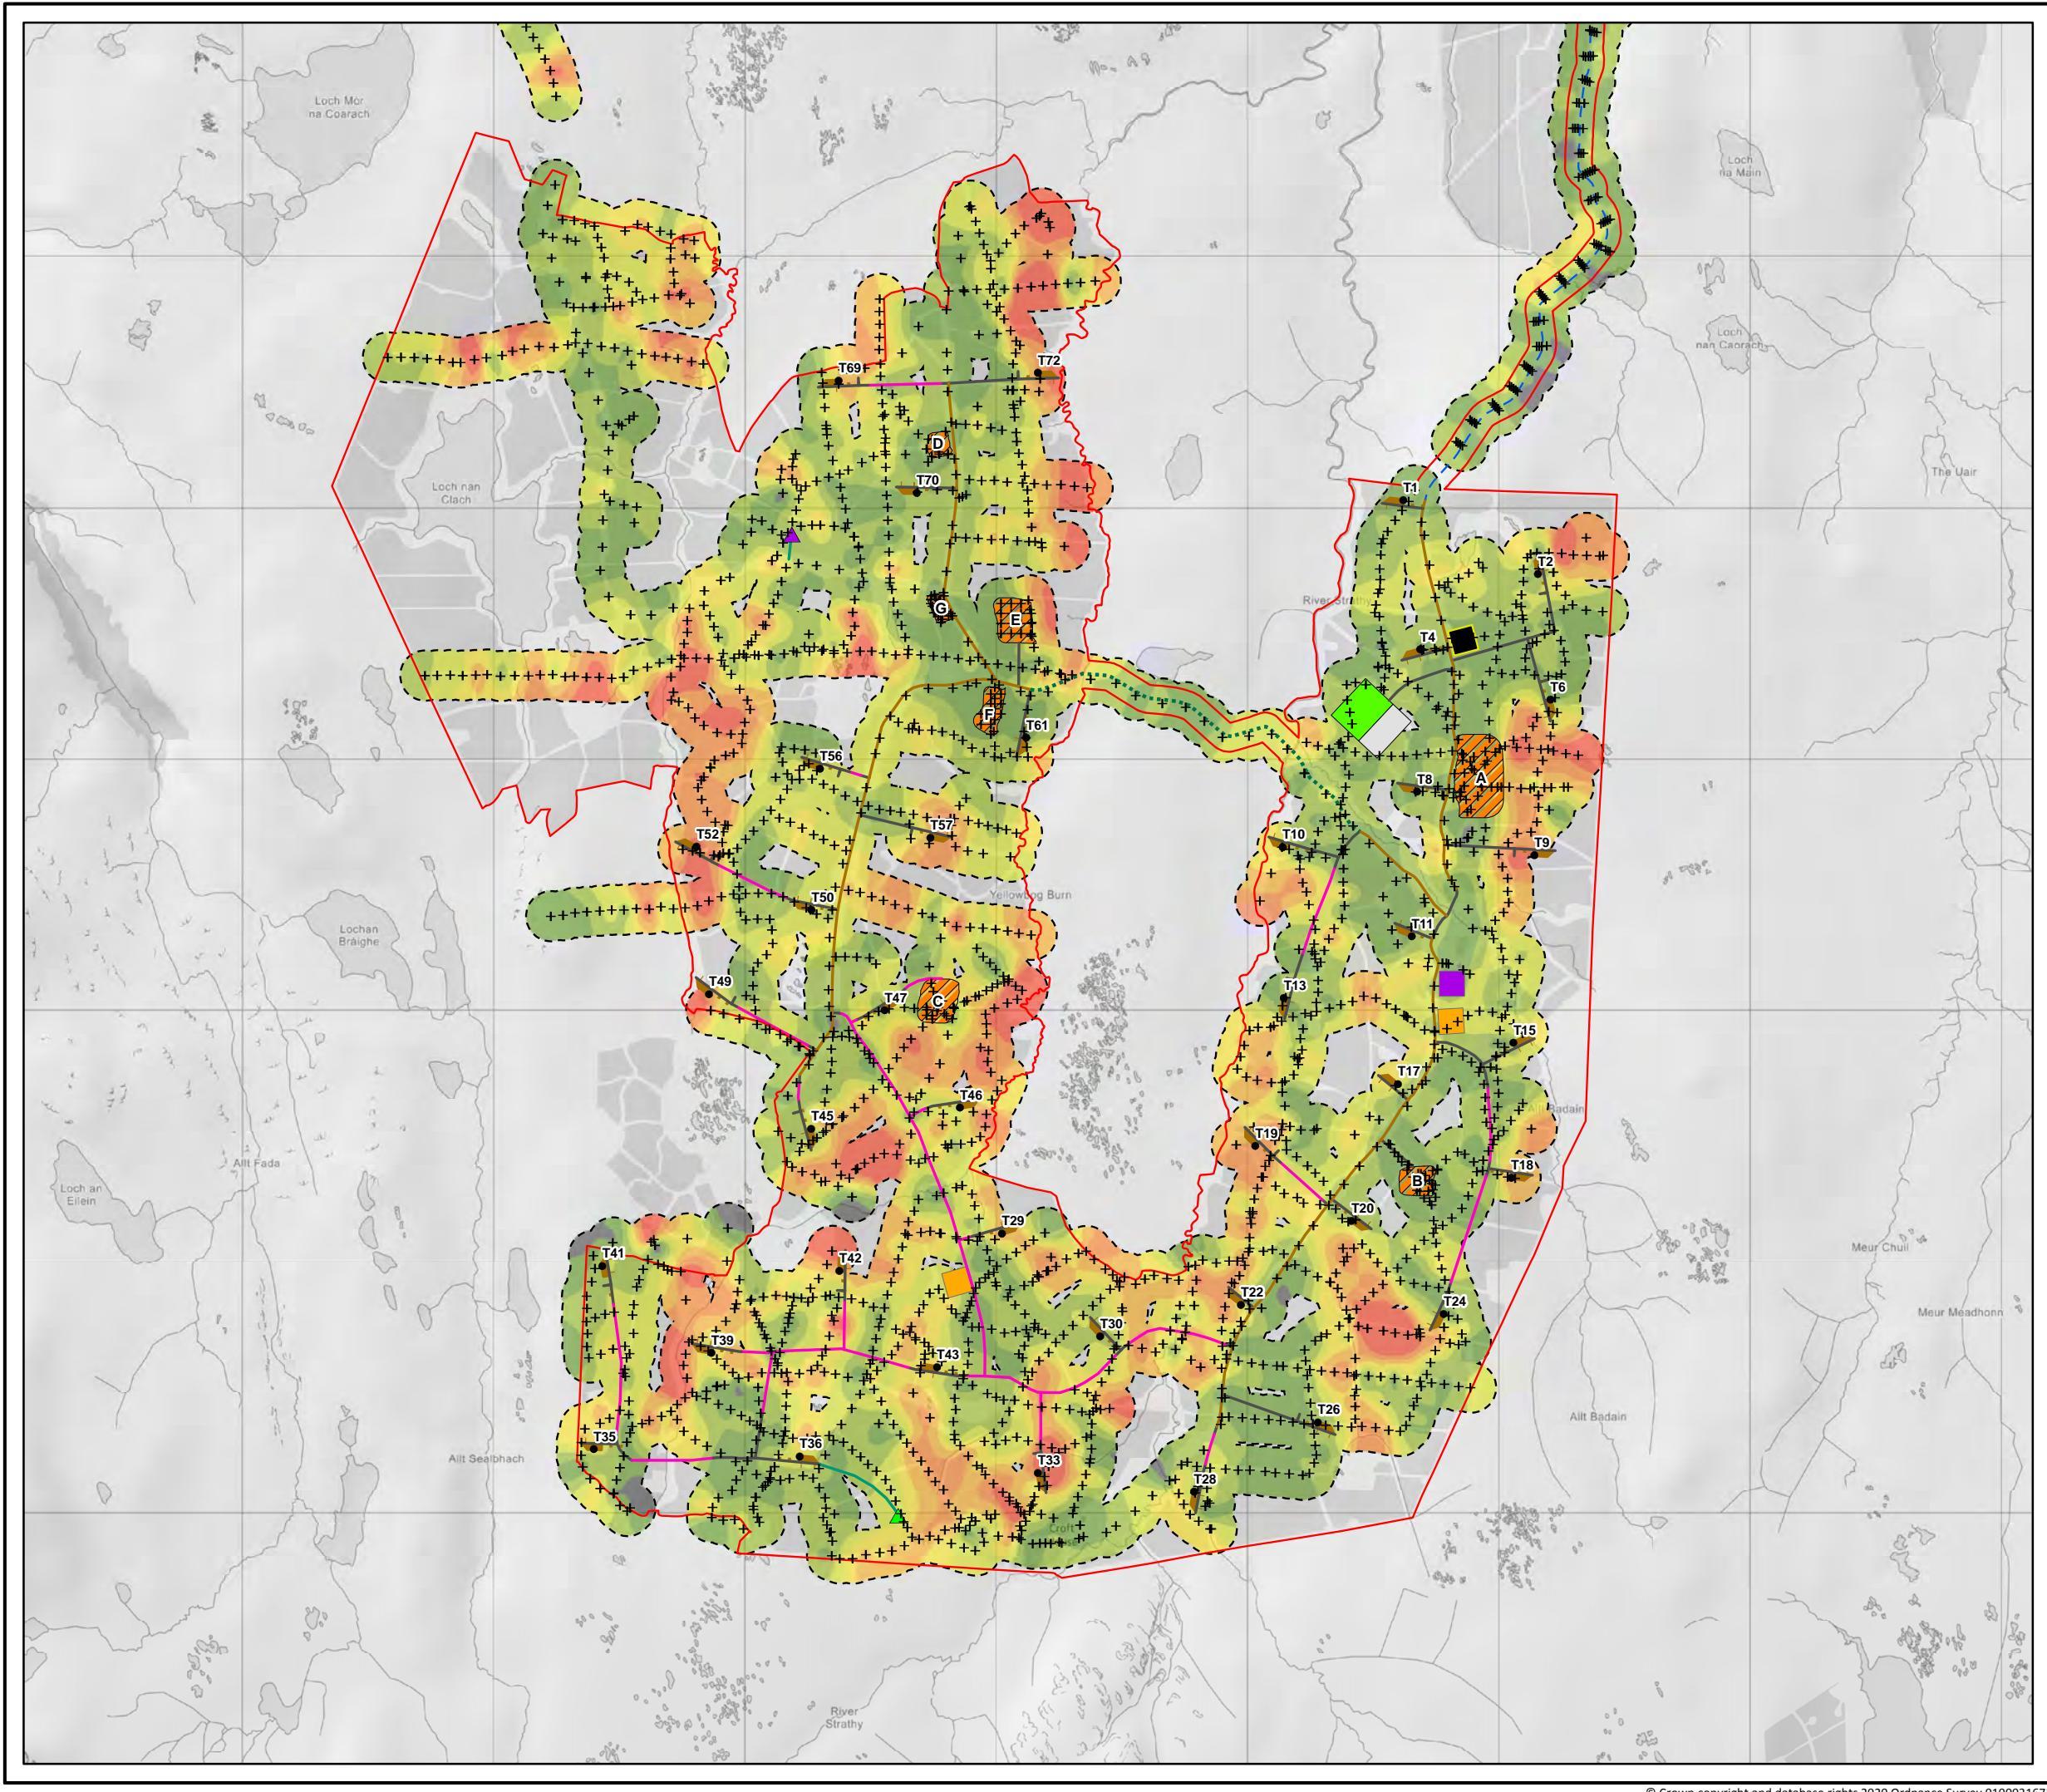
## Peat Depth

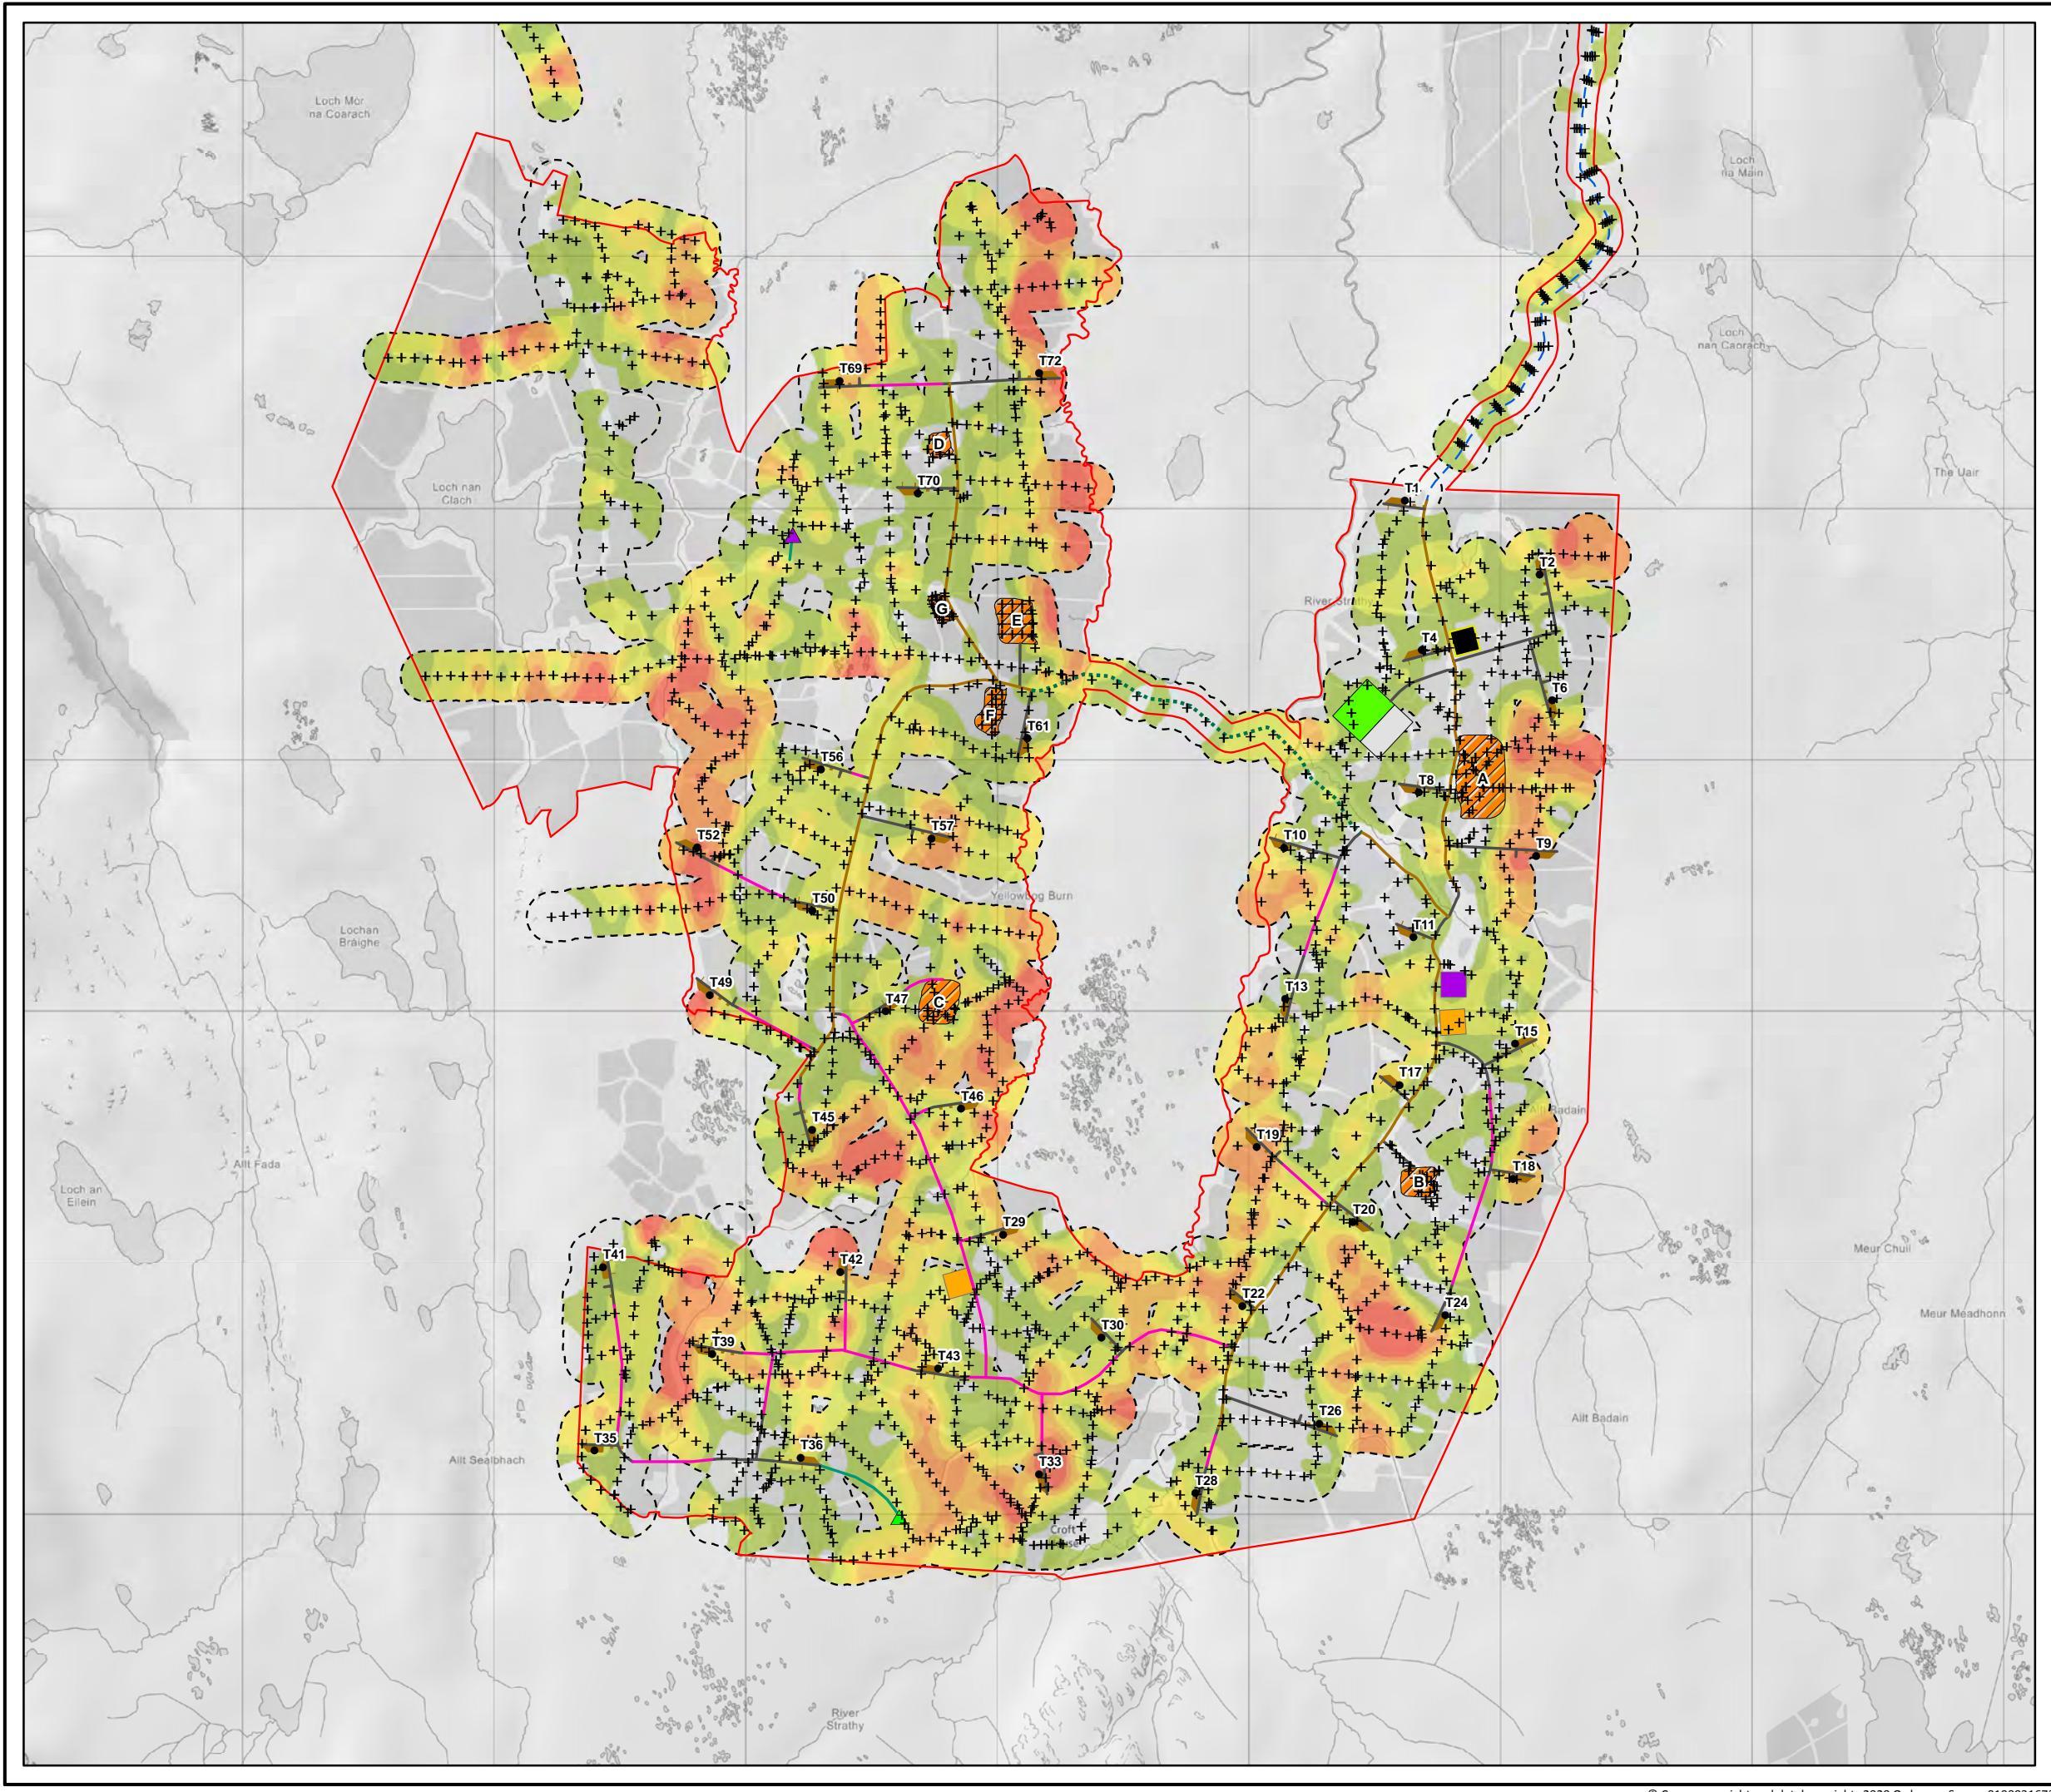
## Peat Depth >0.5m
