Abnormal Load Route Survey Supplementary Report

Gordonbush Extension Wind Farm

SSE Renewables Developments (UK) Ltd

June 2015

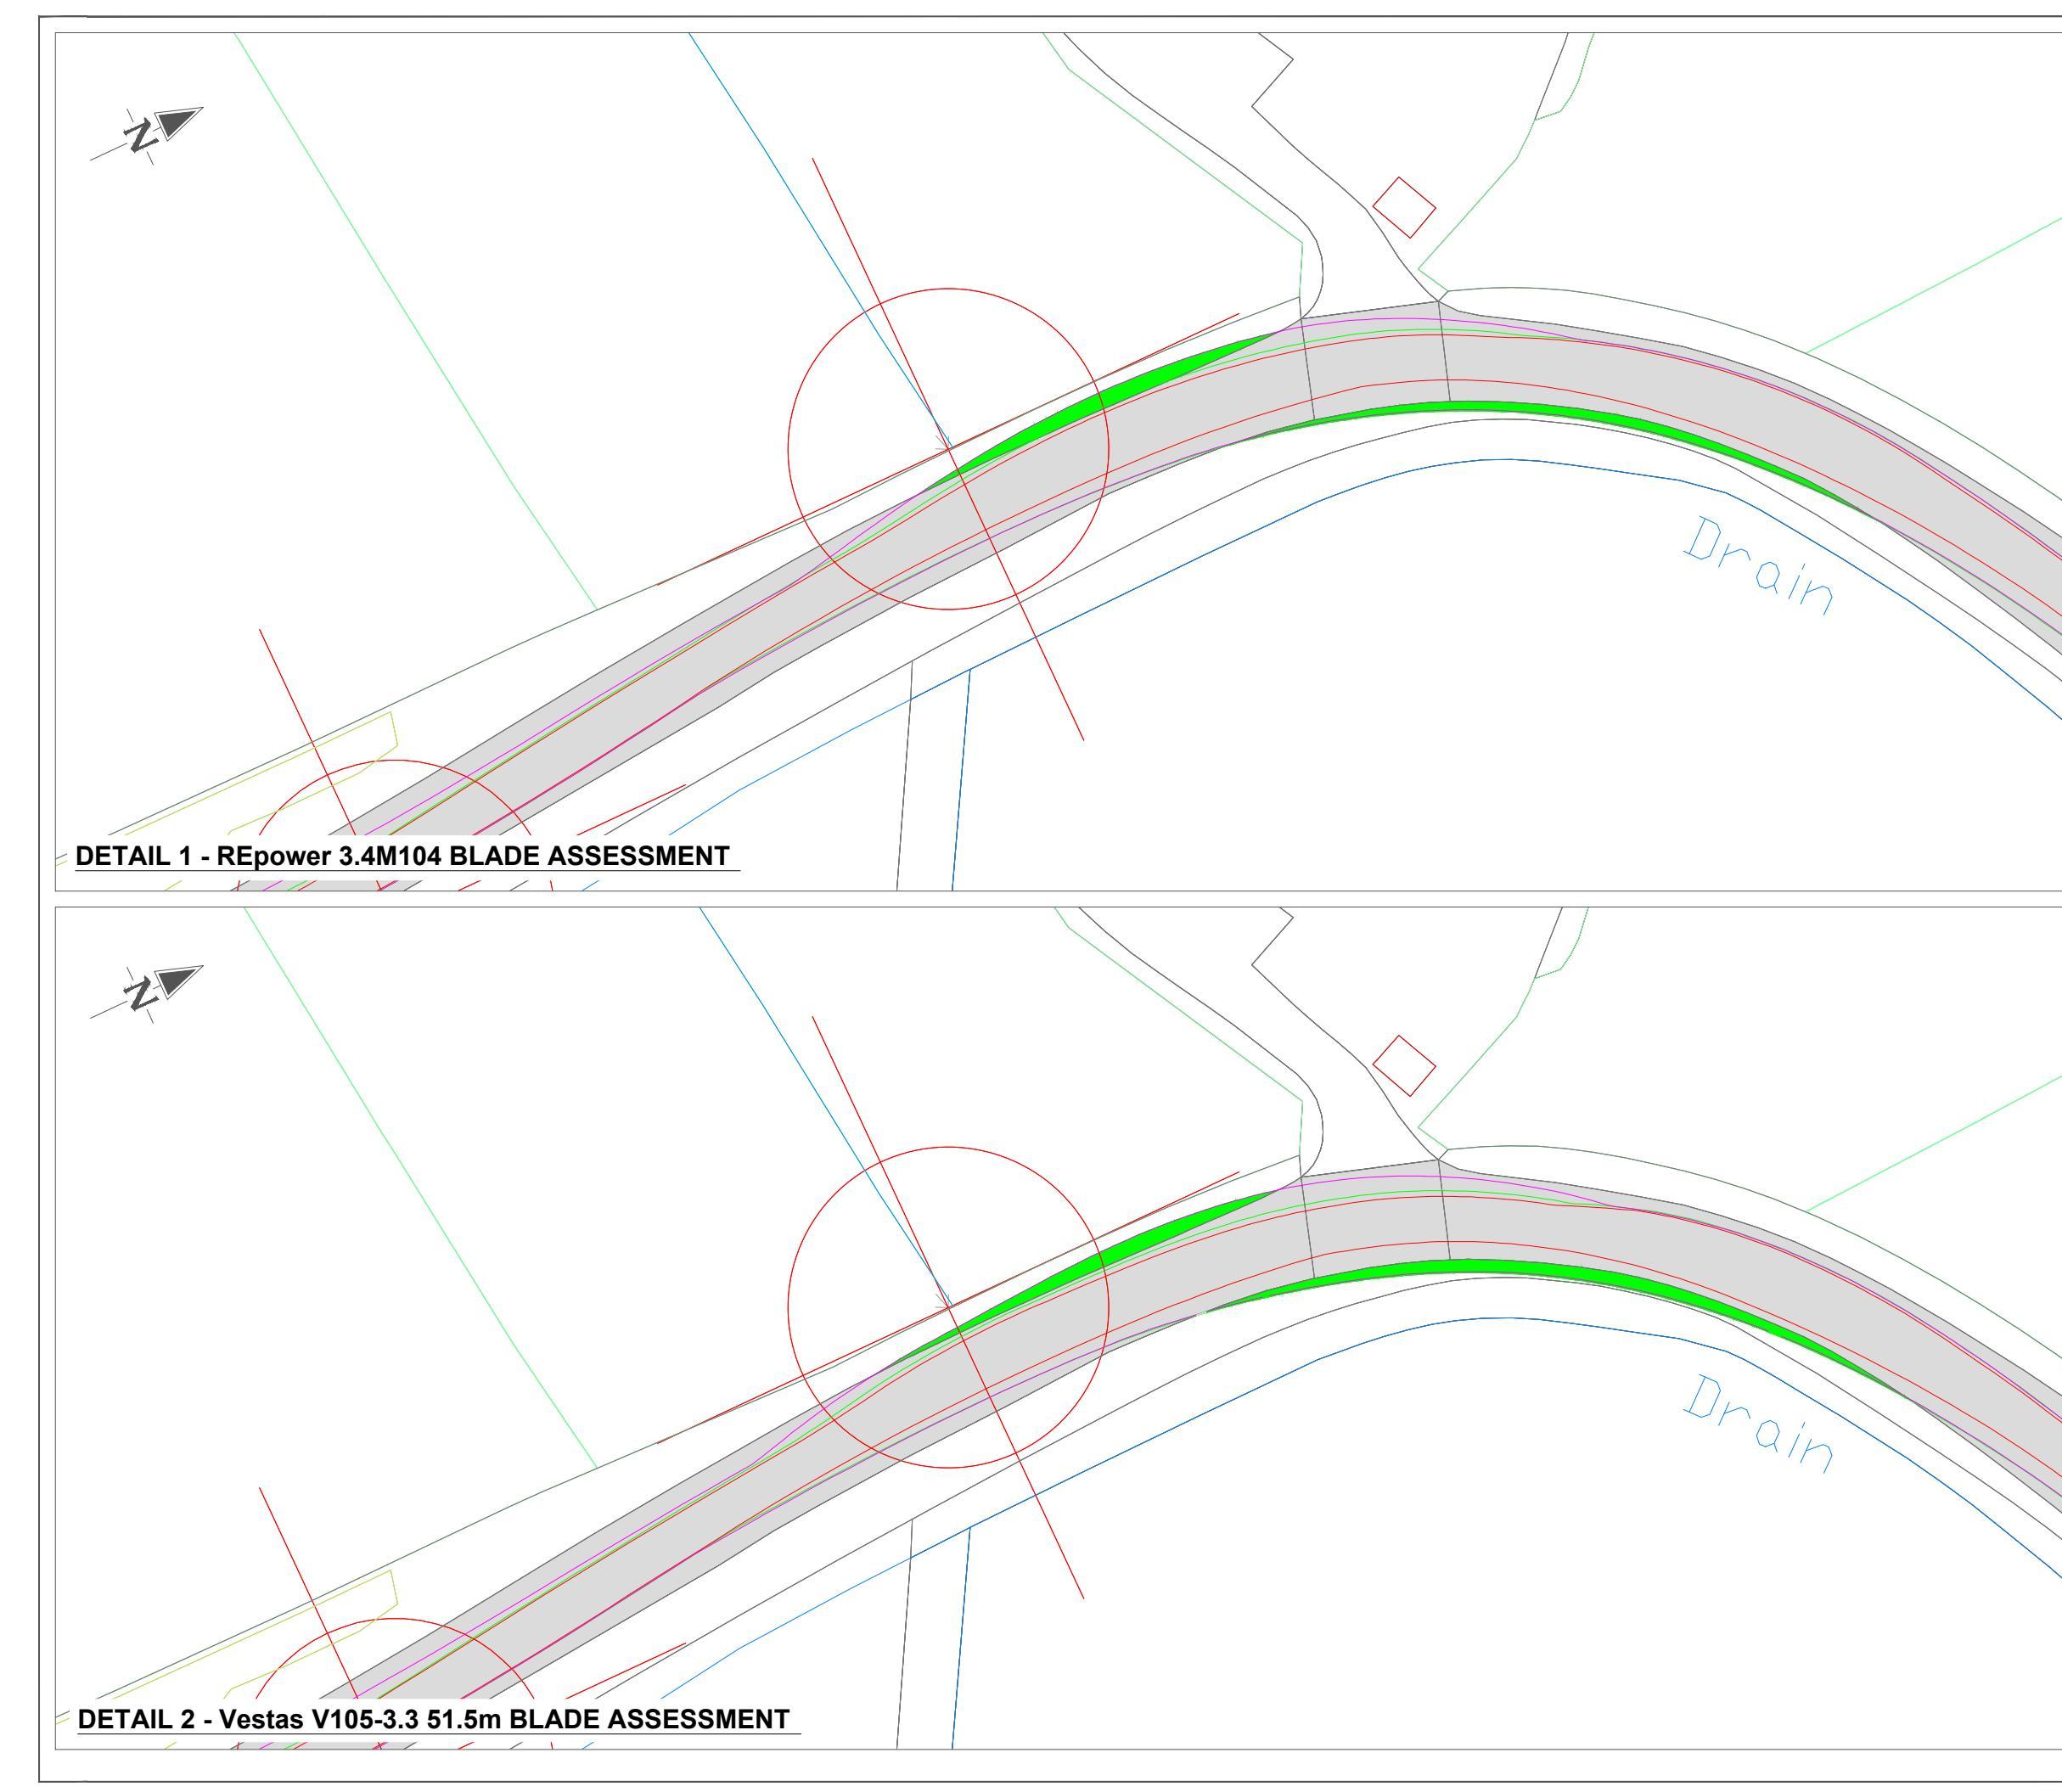
Existing Road
Previous Widening
Load Envelope
Vehicle Body Envelope
Vehicle Wheel Base
Tower Rear Wheel Steering
Blade Rear Wheel Steering
Tower Over-sail Area Highlight
Vehicle Overun Within Highways
Notes:
Reproduced from topographic survey data as supplied by SSE
Rev By Chkd Apprvd Date Description
Client
CH2M HILL 16 Abercromby Place, Edinburgh EH3 6LB
rei +44 (0)131 272 3307 Fax +44 (0)131 272 3301 www.ch2m.com
GORDONBUSH EXTENSION
WIND FARM
ROUTE SURVEY
POI 45, 51.5m BLADE
Drawn by: BT Date: 23/02/15
Checked by: AK Date: 23/02/15 Approved by: JP Date: 23/02/15
Drawing No. Revision
652994/AA.00.01 - 80
Drawing Scale: 1:500 at A3

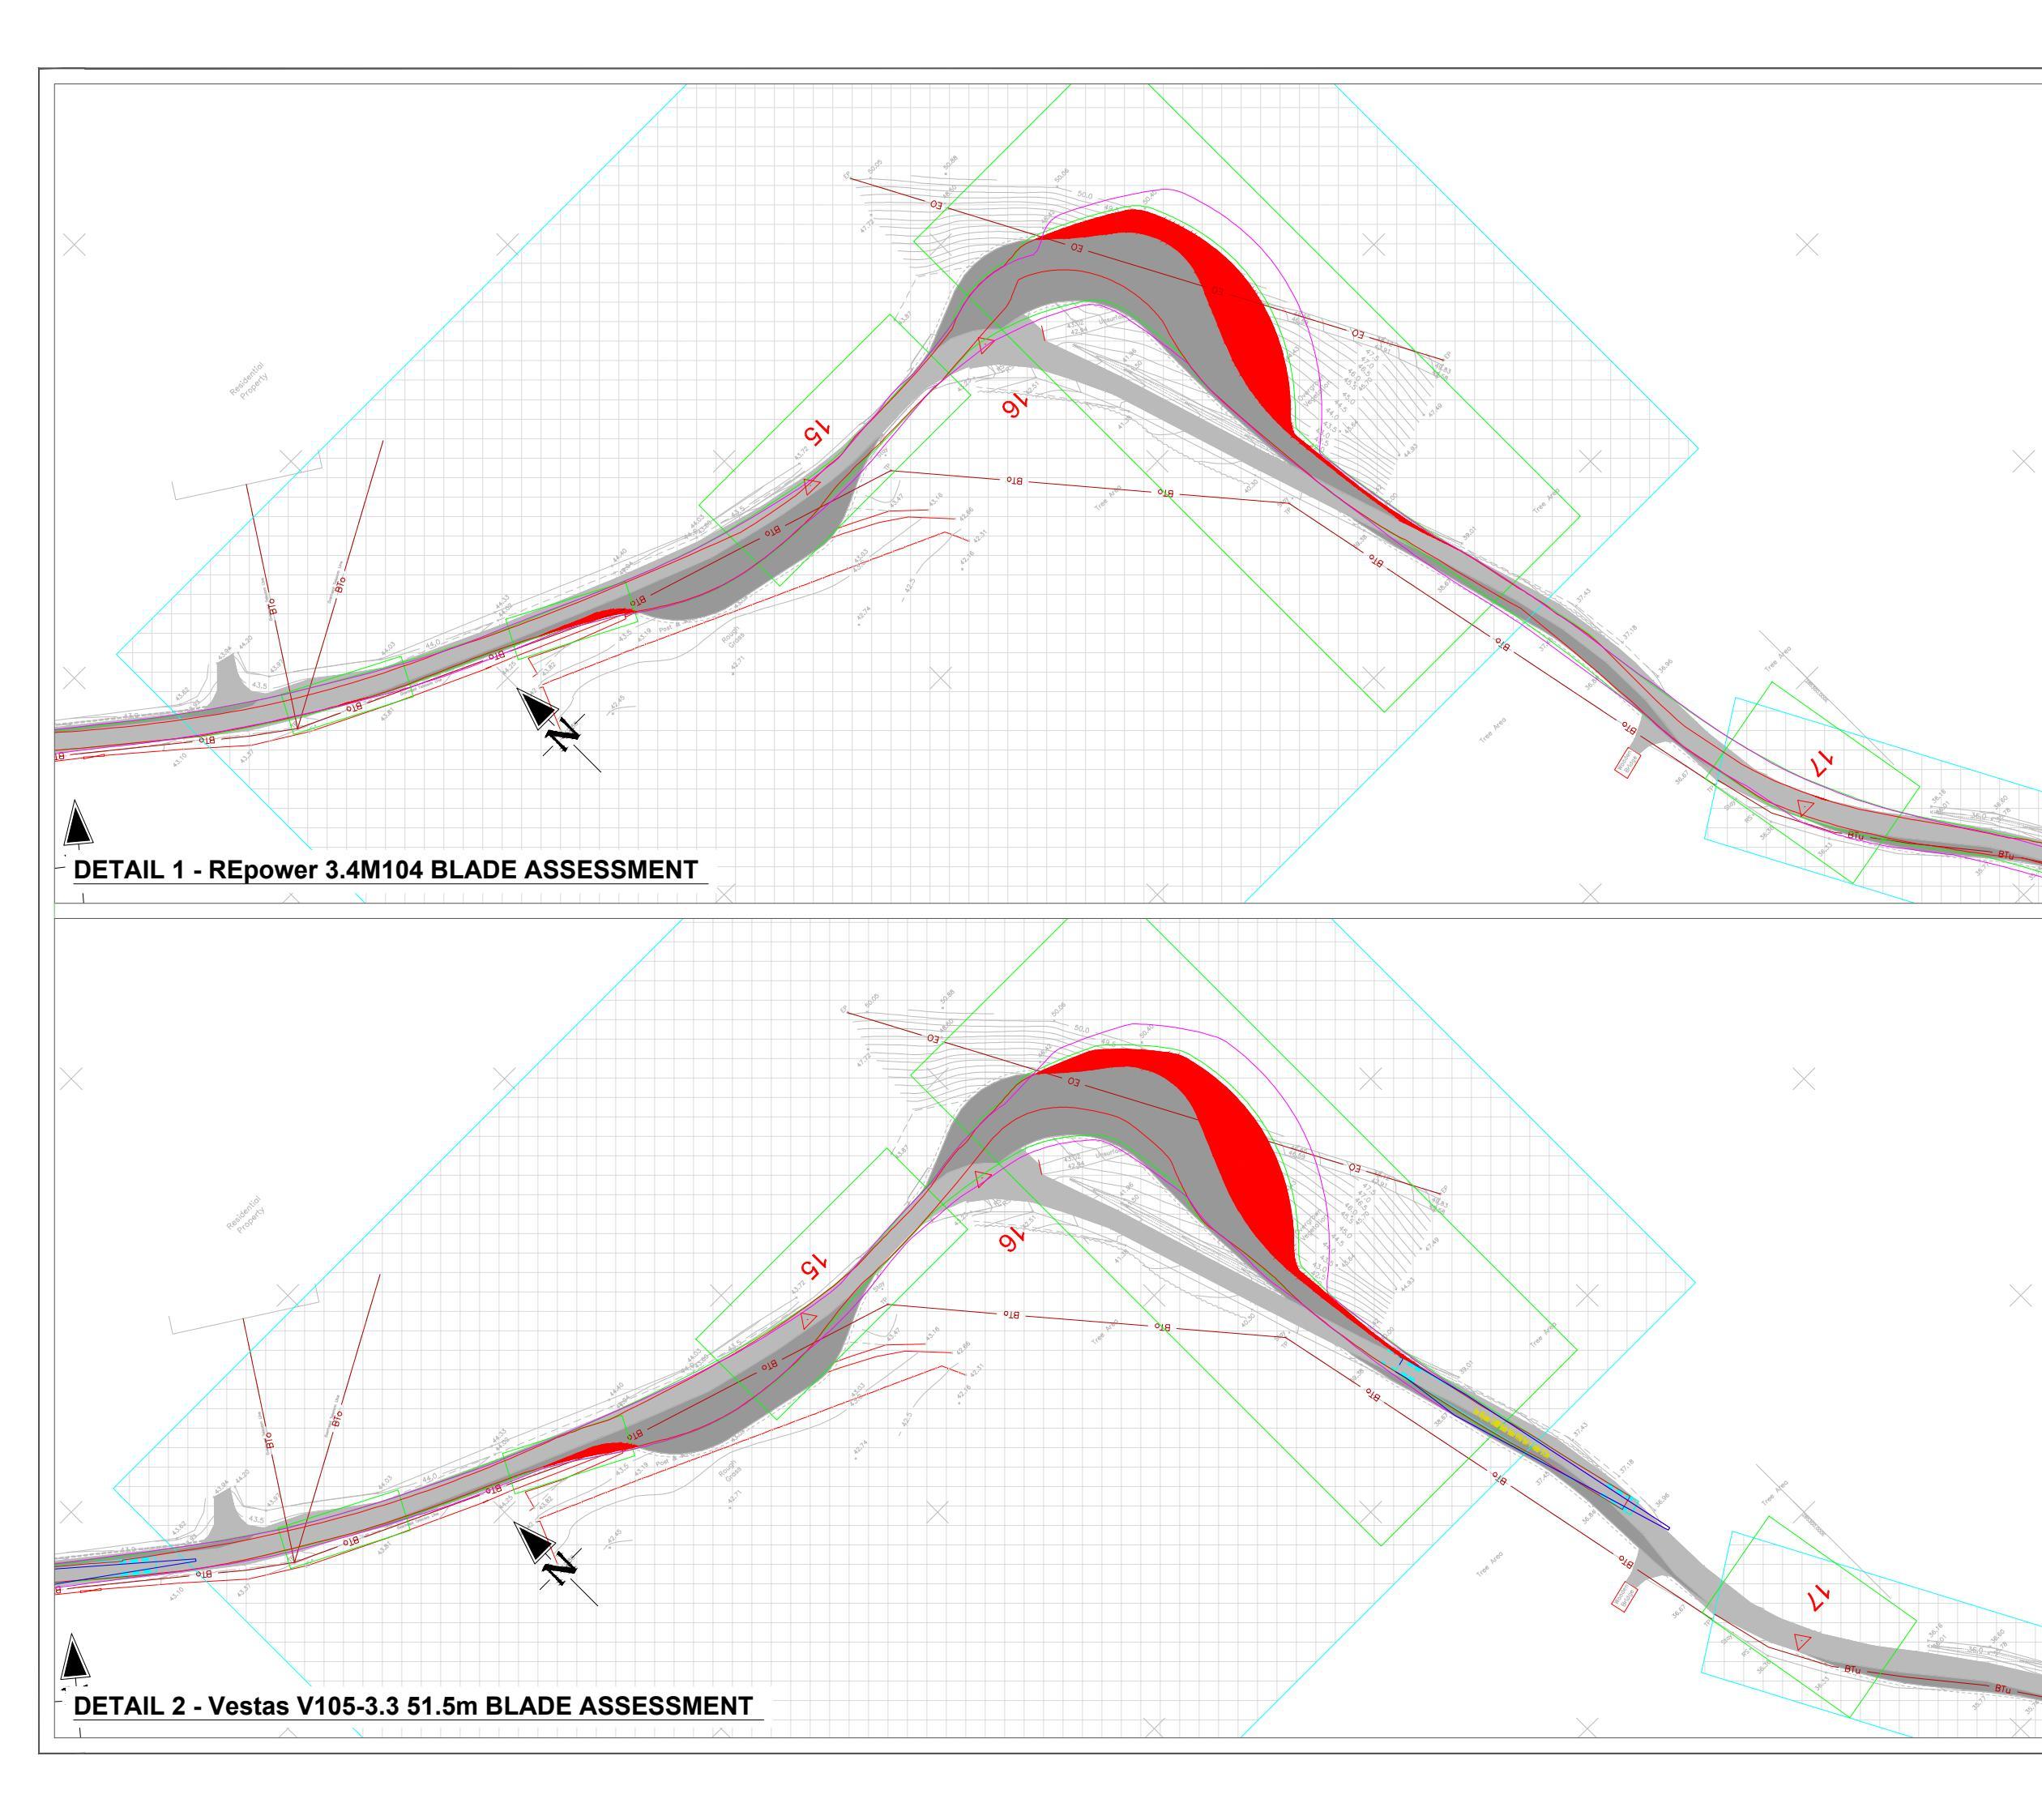
See Drawing 652994/AA.00.01 - 86

Left-hand Bend/Oldtown Bridge

Similar area of widening and over-sail areas required when compared with the original assessment from the initial assessment.

The widening will be additional to accommodate estimated over-run and over-sail beyond that already undertaken for the original Gordonbush development. Considerable excavation will be required.

Note, manual rear-wheel steering has been modelled.

Risk = 6, Medium Risk
