Figure 10.1.7a
Hydrological Assessment of GWDTE Potential

Achany Extension Wind Farm
EIA Report

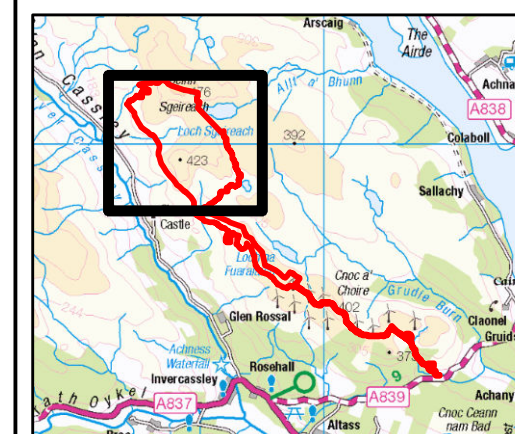
- Site Boundary
 - Turbine
 - LiDAR Compound Location
 - Floated Track
 - Founded/Cut Track
 - Substation, Welfare Facility and Store
 - Temp. Construction Compound, Security, Storage and Batching Plant
 - Hardstanding
 - Borrow Pit Search Area
 - Ephemeral Stream
 - Natural Watercourse
- Hydrological Assessment of GWDTE Potential**
- Not likely to be highly groundwater dependent

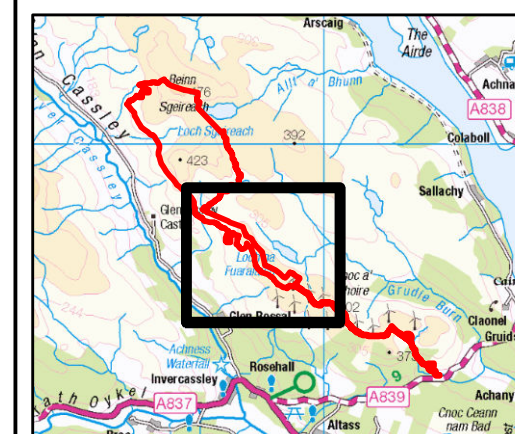
Figure 10.1.7b
Hydrological Assessment of GWDTE Potential

- Site Boundary
- Turbine
- Floated Track
- Founded/Cut Track
- Existing Track to be Upgraded
- Substation, Welfare Facility and Store
- Temp. Construction Compound, Security, Storage and Batching Plant
- Hardstanding
- Borrow Pit Search Area
- Ephemeral Stream
- Natural Watercourse

Hydrological Assessment of GWDTE Potential

- Not likely to be highly groundwater dependent
