Figure 9.4.3b **Common Access Mapped Areas** of Disturbed Ground

Strathy South Wind Farm EIAR 2020

Typical Access Track Diagram: Report 5b (RPS, 2013)

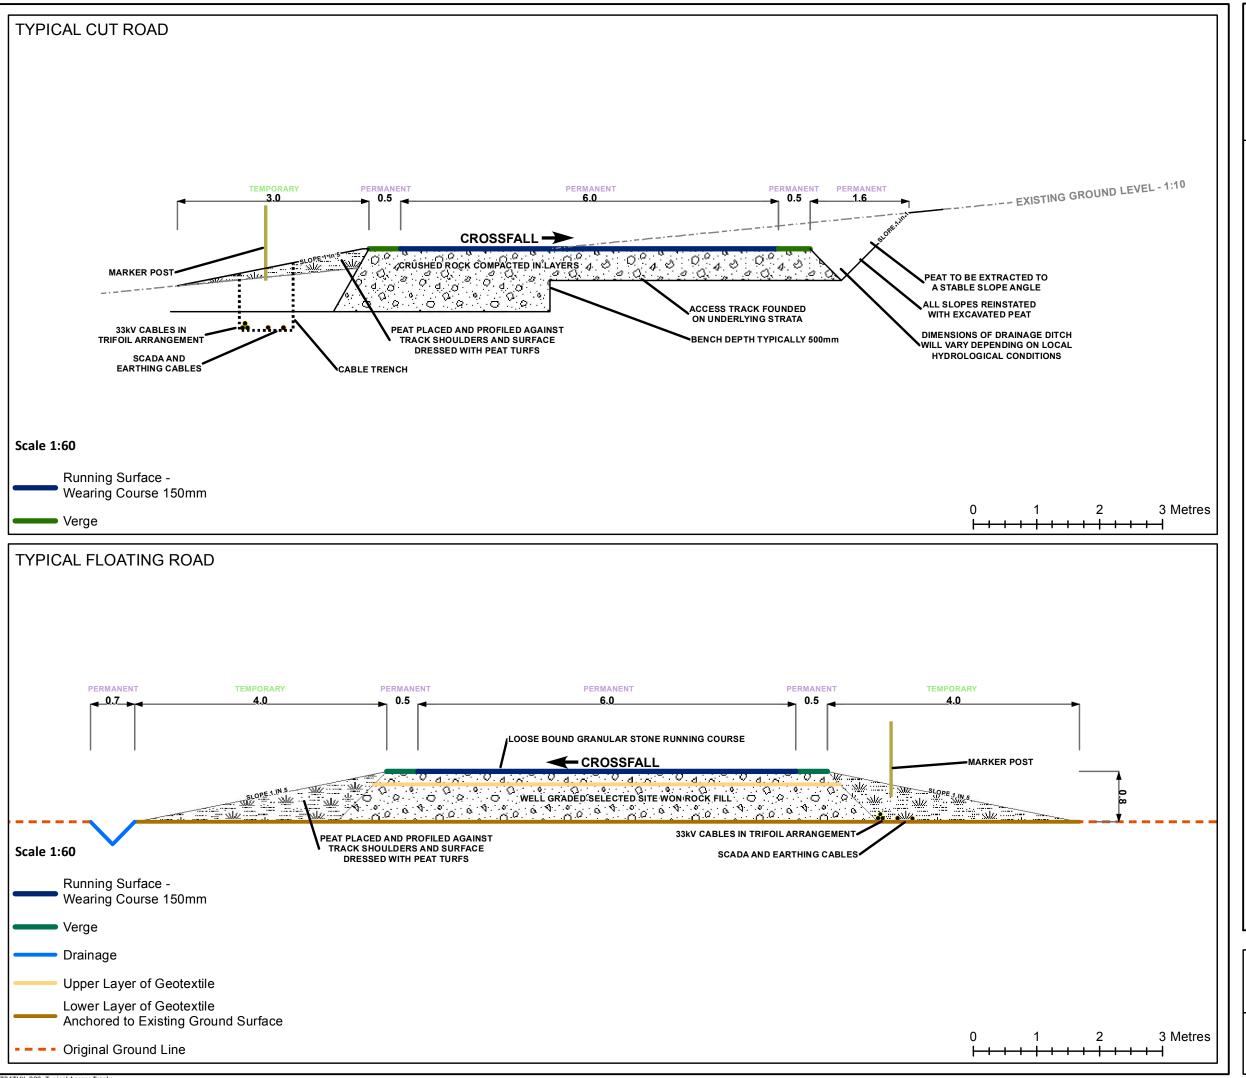
Figure *** **TYPICAL ACCESS TRACKS**

All dimensions in metres (accuracy 0.1m)

Depth of Construction of access tracks shown as typical depth. Actual depth to be finalised following detailed ground investigation

Cable arrangements shown for a single

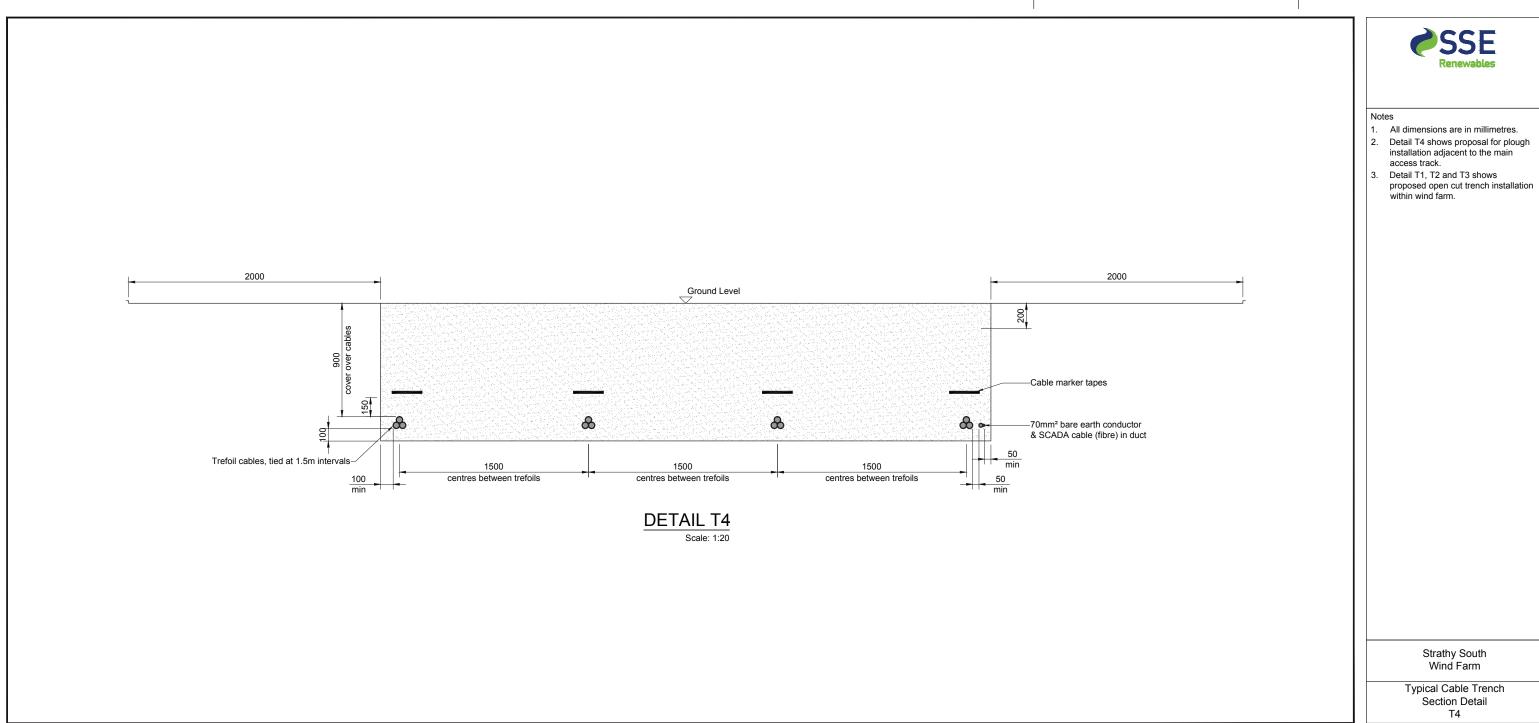
Typical Cable Trench Diagram: Report 5b (RPS, 2013)

- Detail T4 shows proposal for plough installation adjacent to the main

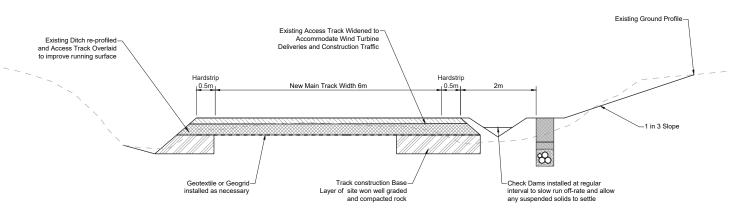
Schematic Diagram of the Proposed Construction Methods for the Common Access (Segment 2) of the Access Route

East Verge West Verge
